# **Principal Inspection Report**

Structure Name: Broadmead Road Viaduct

**Identifier:** B4

**Inspection Date:** 14/11/2023

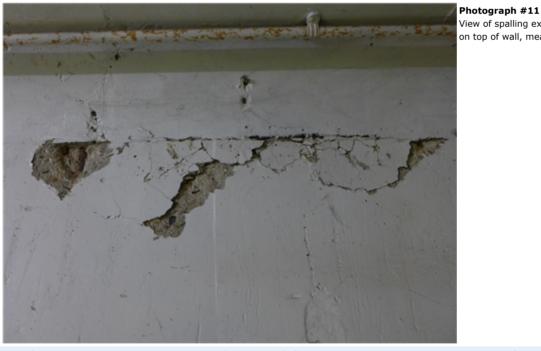
View of spalling exposing the reinforcement on top of wall, measured 800x250x20mm

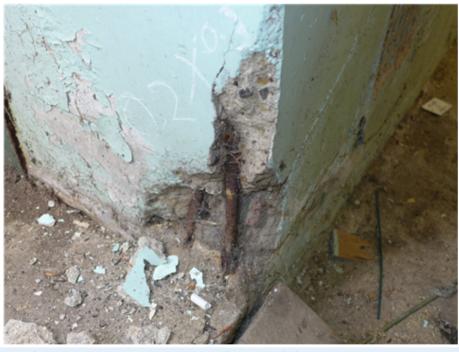
### Photograph #17 View of 200x300x40mm spal

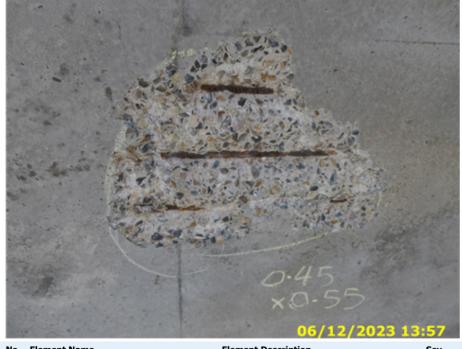
View of 450x550x25mm spalling exposing the reinforcement on the deck soffit

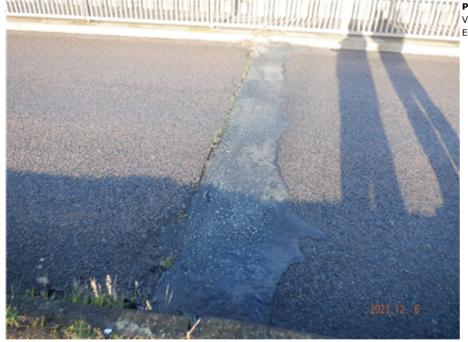
View of tracking and flow of binder of Eastbound carriageway joint

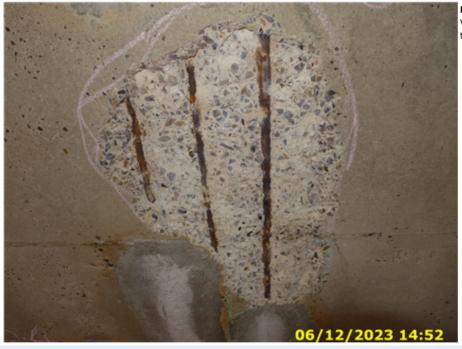
View of 800x500x40mm spalling exposing the reinforcement on the deck soffit

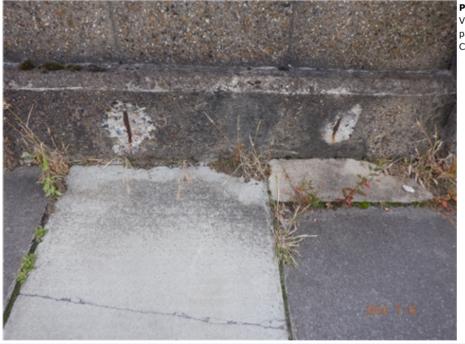
**Photograph #290** View of spalling on the base of North parapet, measured 180x130x50mm at Ch.124m

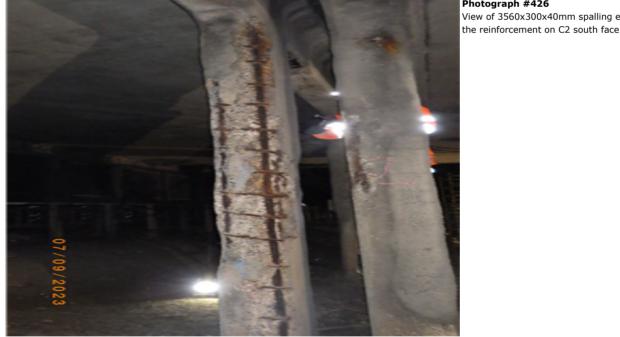
Photograph #426 View of 3560x300x40mm spalling exposing

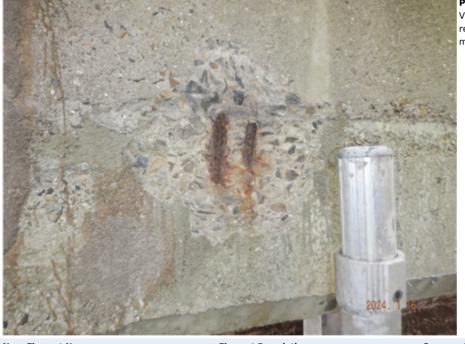
View of isolated spalling exposing the reinforcement on external face at North end, measured 300x300x25mm

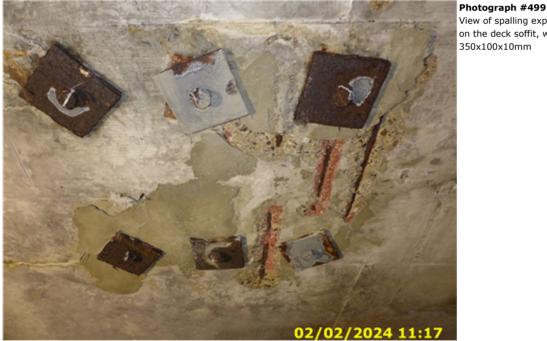
View of spalling exposing the reinforcement on the deck soffit, worse measured, 350x100x10mm
