# **Principal Inspection Report**

Structure Name: Broadmead Road Viaduct

**Identifier:** B4

**Inspection Date:** 14/11/2023

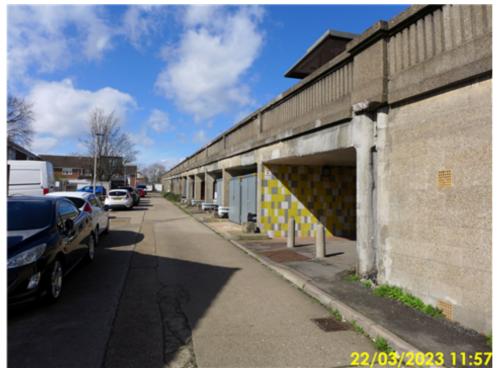
**General overview of the South elevation, looking NW.** GI of 2023.

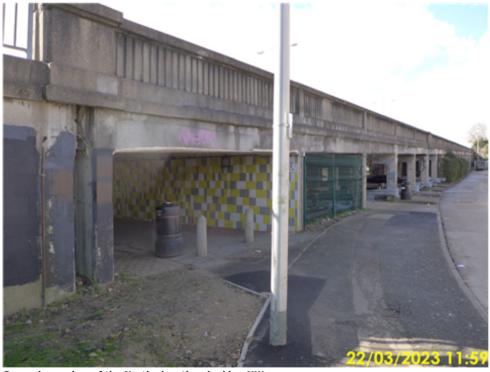
**General overview of the North elevation, looking NW.** GI of 2023.

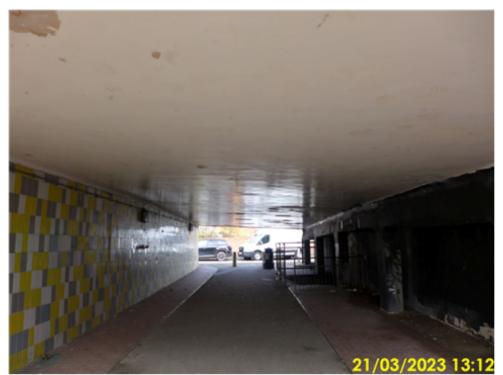
General overview of the soffit (photo taken from span 2), looking NE. GI of 2023.

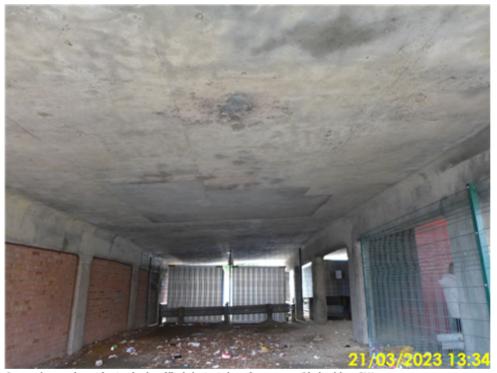
General overview of a typical soffit (photo taken from span 3), looking SW. GI of 2023.

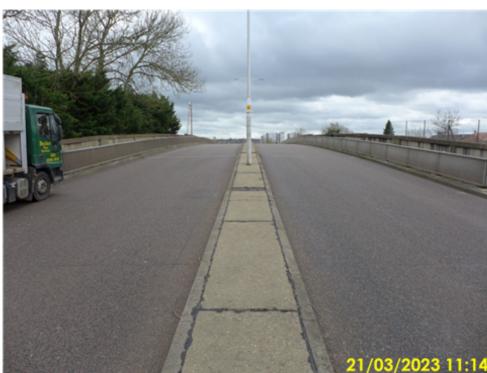
General overview of the carriageway surface, looking SE. GI of 2023.

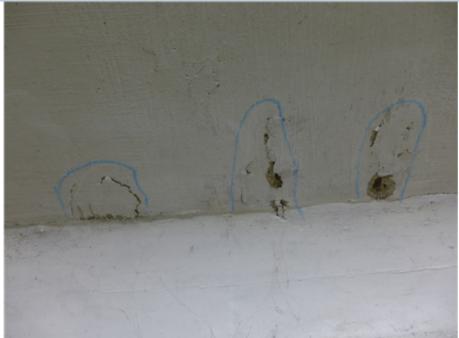
## Photograph #6

There were multiple minor spalling exposing the reinforcement on the deck soffit, measured 100x1250x15mm.

View of multiple minor spalling exposing the reinforcement on the deck soffit, measured 100x1250x15mm

Spalling should be broken out and the reinforcement cleaned back to bare metal before an anti-corrosion primer is applied. The affected locations should then be patch repaired with an appropriate cementitious material, ensuring that it is sufficiently 'keyed-in' to the parent concrete.

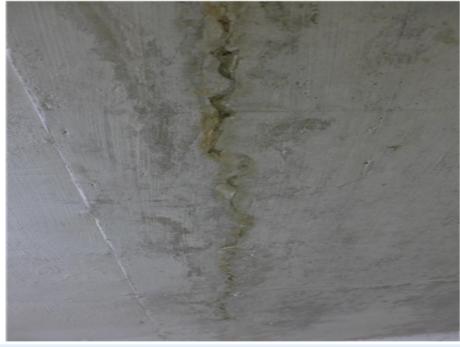
## Photograph #7

There was minor longitudinal hairline crack on the deck soffit up to 3.65m in length.

View of longitudinal hairline crack on the deck soffit up to 3.65m in length

Monitor defect at the next scheduled inspection

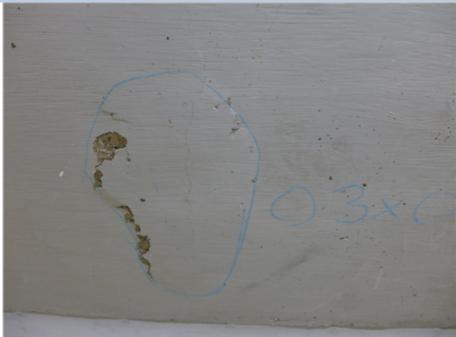
### Photograph #8

There was isolated area of 300x500mm minor spalling on the deck soffit and honeycombing, measured area 1000x400mm.

View of  $300 \times 500 \text{mm}$  minor spalling on the deck soffit

Monitor defect at the next scheduled inspection

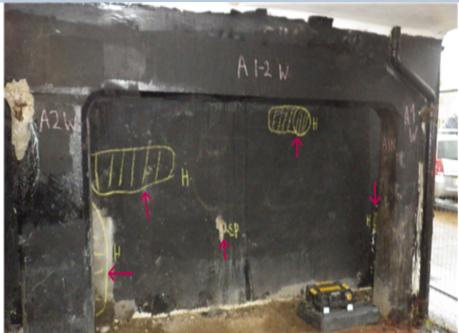
### Photograph #544

There were multiple hollow section areas and spalling exposing the reinforcement on the Western face of East support wall, measured 220x500mm, 370x850mm, 1070x460mm, 230x80mm, 180x120mm, 410x200x20mm and 200x120x5mm.

View of multiple areas of hollow section and isolated spalling on the West face of Eastern support wall, measured 220x500mm, 370x850mm, 1070x460mm, 230x120x20mm and 180x120mm

Spalling should be broken out and the reinforcement cleaned back to bare metal before an anti-corrosion primer is applied. The affected locations should then be patch repaired with an appropriate cementitious material, ensuring that it is sufficiently 'keyed-in' to the parent concrete.

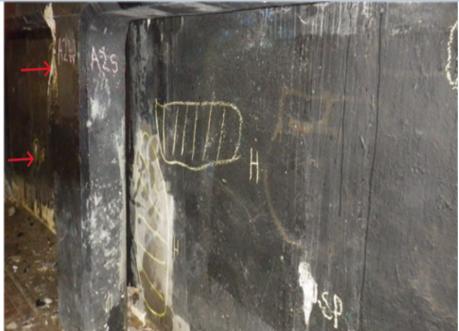
### Photograph #545

View of multiple spalling area on the West face of Eastern support wall, measured 490x200x20mm and 200x120x5mm

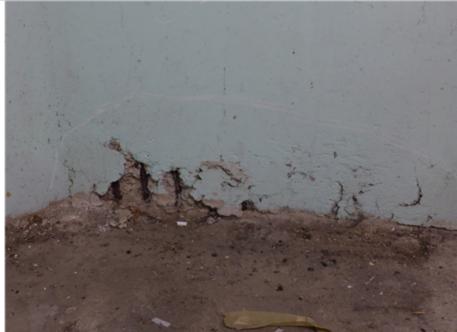
### Photograph #10

There were multiple spalling exposing the reinforcement on all chambers wall, measured 800x300x15mm on room #1, 800x250x20mm room #2 and 2No. on partition wall 250x250x40mm and 250x400x10mm room #3 and honeycombing on top of pier wall, measured 2200x300mm.

View of spalling exposing the reinforcement on the base of wall, measured 800x300x15mm

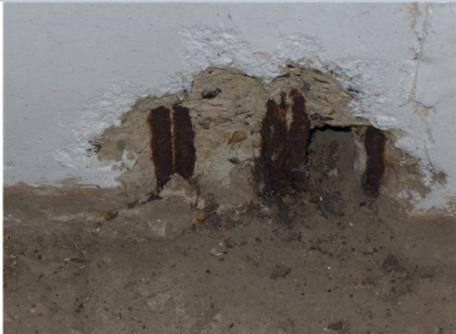
## Photograph #12

View of spalling exposing the reinforcement on the Northern partition wall, measured 250x250x40mm

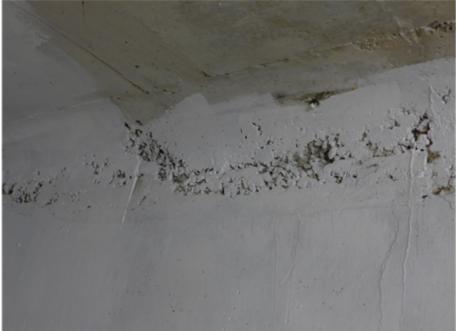
### Photograph #14

View of honeycombing on top of pier wall, measured 2200x300mm

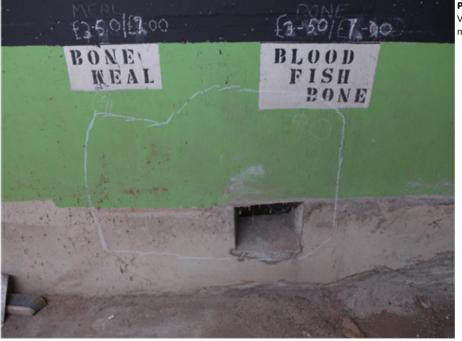
## Photograph #15

View of drummy section at base of wall, measured 1000x800mm

Monitor defect at the next scheduled inspection

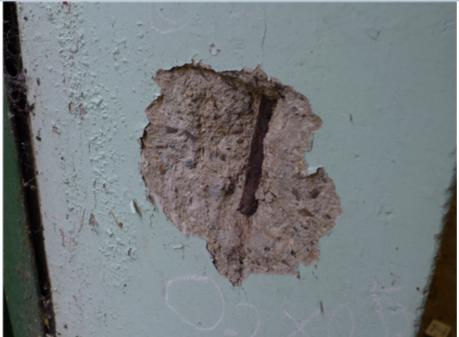
### Photograph #16

There were multiple spalling exposing the reinforcement on chambers No.1 & 2, measured 200x150x20mm room #1, 200x300x40mm room #1 and 250x125x20mm room #2

View of 200x150x20mm spalling exposing the reinforcement

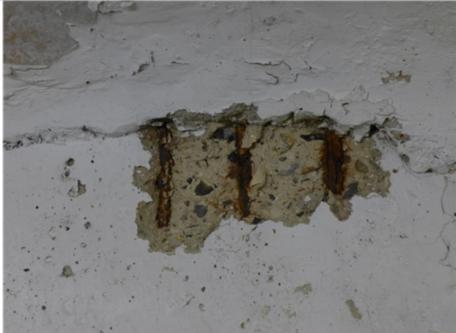
### Photograph #18

View of 250x125x20mm spalling exposing the reinforcement on top of pier wall

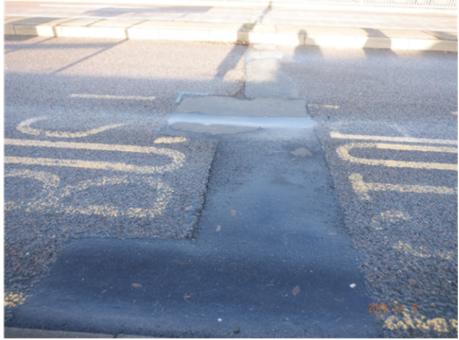
### Photograph #19

View of longstanding tracking and flow of binder on the Westbound carriageway surfacing

There was longstanding moderate tracking and flow of binder on both eastbound and westbound carriageway surfacing leading to extensive water leakage onto the elements below.. This is consistent with 2023 GI.

Replace the existing asphalt plug joint at both ends

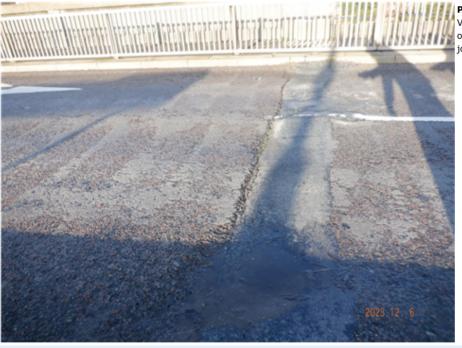
### Photograph #21

There was a longstanding area of de-bonding and loss of top surface on the Eastbound carriageway expansion joint leading to extensive leakage onto the elements below. This is consistent with 2023 GI

View of de-bonding and loss of top surface on the Eastbound carriageway expansion

Undertake repairs to the defective areas of surfacing using an approved bituminous material.

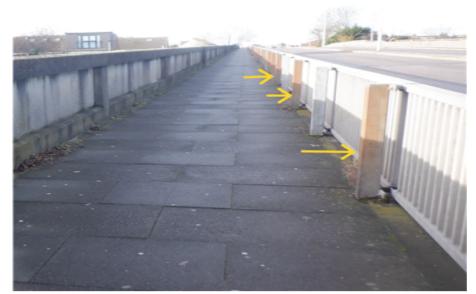
### Photograph #22

There were multiple location with loss of galvanised protection noted on both parapets. This is consistent with 2023 GI

View of loss of galvanized protection on South steel parapet

Monitor defect at the next scheduled inspection

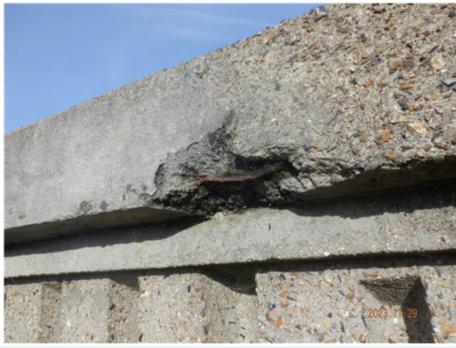
### Photograph #23

There were multiple location where spalling exposing the reinforcement was noted on the Southern RC parapet coping. The defects measured  $600 \times 70 \times 35$  mm at Ch.29.3m from East,  $70 \times 200 \times 20$  mm,  $50 \times 130 \times 30$  mm and  $40 \times 330 \times 50$  mm. Also, 50 mm x 320 mm x full depth spalling on the external face of South parapet noted.

View of spalling exposing the reinforcement on South parapet coping, measured 70x200x20mm

Spalling should be broken out and the reinforcement cleaned back to bare metal before an anti-corrosion primer is applied. The affected locations should then be patch repaired with an appropriate cementitious material, ensuring that it is sufficiently 'keyed-in' to the parent concrete.

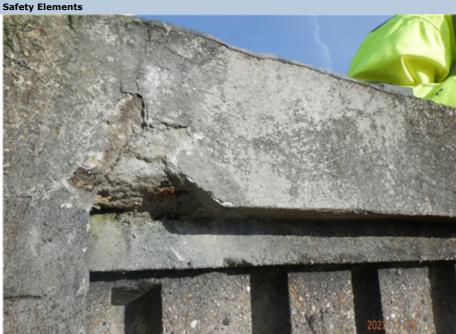
### Photograph #24

View of spalling exposing the reinforcement on South parapet coping, measured 50x130x30mm

Spalling should be broken out and the reinforcement cleaned back to bare metal before an anti-corrosion primer is applied. The affected locations should then be patch repaired with an appropriate cementitious material, ensuring that it is sufficiently 'keyed-in' to the parent concrete.

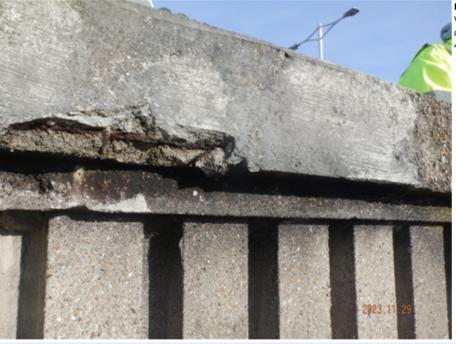
### Photograph #25

View of spalling exposing the reinforcement on South parapet coping, measured 40x330x50mm

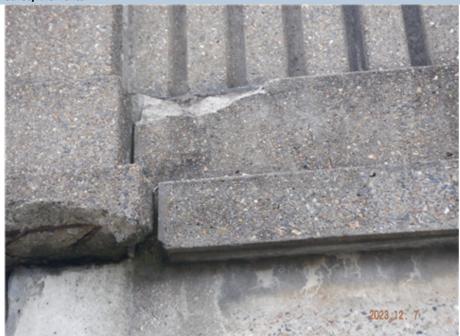
### Photograph #26

View of spalling on external face of South parapet upstand, measured approximately 50mm x 320mm x full depth.

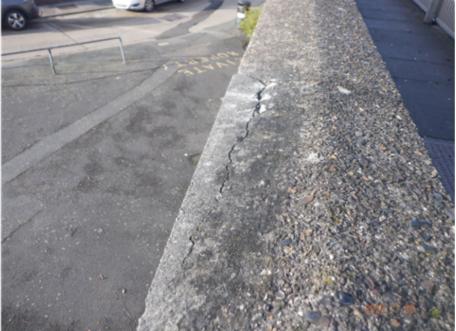
### Photograph #28

Isolated area of crack on top of South parapet coping, measured 480mm in length x 2mm wide

View of crack along the top of South parapet coping, measured 480mm in length  $x\ 2$ mm wide

Seal crack using an approved cementitous material

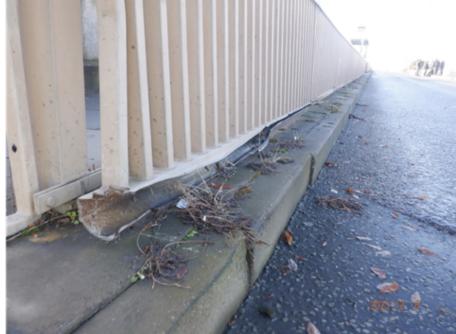
### Photograph #29

There was isolated area of impact damage on the South parapet bottom rail and North parapet vertical infill.

View of impact damage on the South steel parapet bottom rail at east

Repair/ replace section of damaged parapet on both parapets

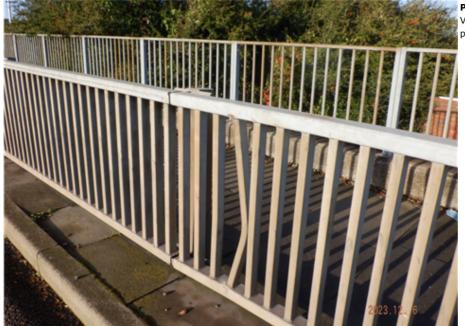
### Photograph #30

View of impact damage on the North steel parapet vertical infill

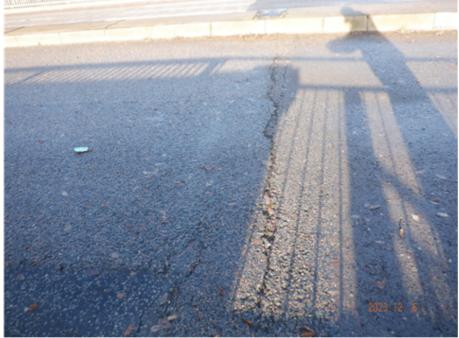
### Photograph #31

Isolated area of full width transverse crack noted on Westbound carriageway surfacing

View of full width transverse crack on Westbound carriageway surfacing

Break out the area of to the carriageway surfacing and repair with a suitable mastic asphalt patch repair.

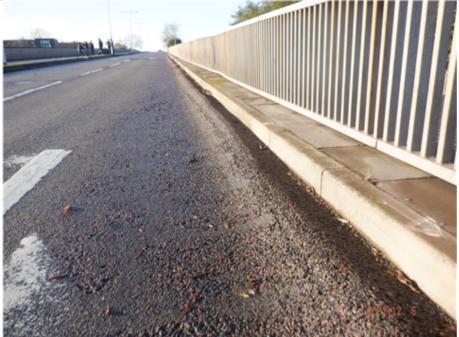
### Photograph #32

View of uneven surface on Eastbound carriageway

Seal the cracks through the surfacing using an appropriate cementitous material

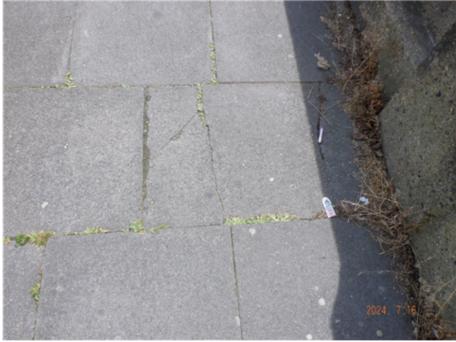
Photograph #35

No	Element Name	Sev	Ext	Defect	Works	Priority	Cost £k
25	Footway/verge/footbridge surfacing	2	В	3.5		L	
Comn	nent						
There	were multiple cracked paving slabs on the Southern footway surfacing at Ch.35m

View of cracked paving slab at Ch.35m

Monitor defect during next schedule inspection **Remedial Works**

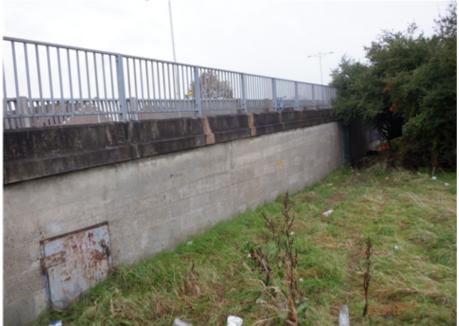
### Photograph #36

View of surface corrosion on the Northern access door

Abrade, treat and repaint the affected area of corrosion to the access doors on the North and South approach elevations.

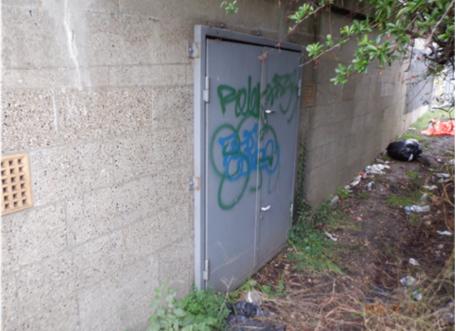
### Photograph #38

View of non-offensive graffiti on the North access door

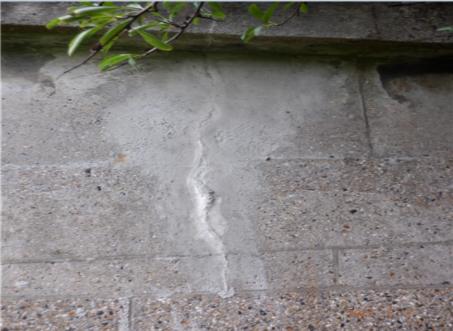
### Photograph #40

View of 600x1mm vertical shrinkage crack, associated with leachate on the Northern infill blockwork wall.

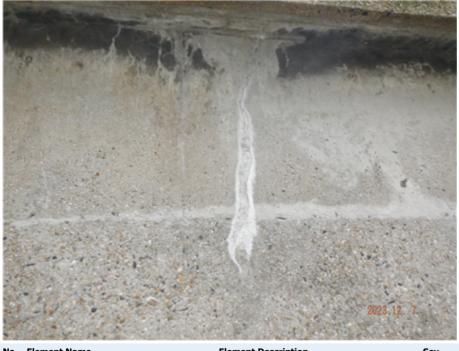
### Photograph #41

View of 1mm vertical shrinkage crack, associated with leachate on the Northern infill blockwork wall.

There were 3No. 1mm vertical shrinkage cracks with associated leachate staining on the Northern infill blockwork wall. This is consistent with 2023 GI

Monitor defect at the next scheduled inspection

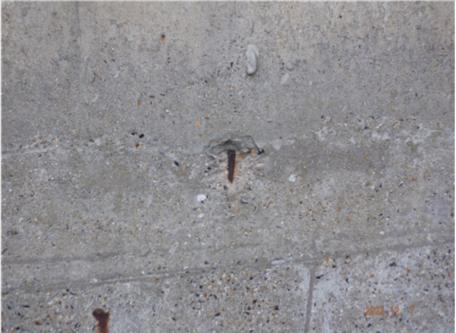
### Photograph #42

View of isolated spalling exposing the reinforcement on the Northern infill blockwork wall, measured 95x95x20mm.

There were multiple areas of spalling exposing the reinforcement on the Southern and Northern infill blockwork wall. The defects measured 95x95x10mm, 160x150x10mm and 165x155x10mm.

Refer to element #1 for remedial works recommendation

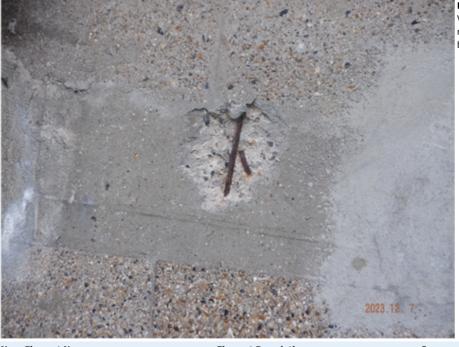
### Photograph #43

View of isolated spalling exposing the reinforcement on the Southern infill blockwork wall, measured 200x180x20mm.

There were multiple areas of spalling exposing the reinforcement on the Southern and Northern infill blockwork wall. The defects measured 95x95x10mm, 160x150x10mm and 165x155x10mm.

Refer to element #1 for remedial works recommendation

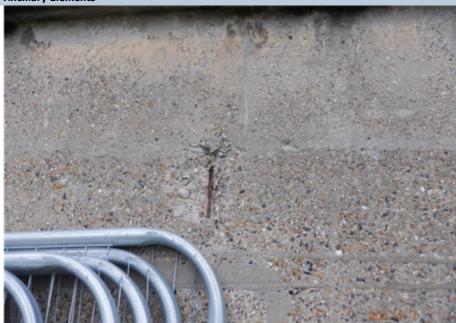
### Photograph #44

View of isolated spalling exposing the reinforcement on the Southern infill blockwork wall, measured 150x100x20mm.

There were multiple areas of spalling exposing the reinforcement on the Southern and Northern infill blockwork wall. The defects measured 95x95x10mm, 160x150x10mm and 165x155x10mm.

Refer to element #1 for remedial works recommendation

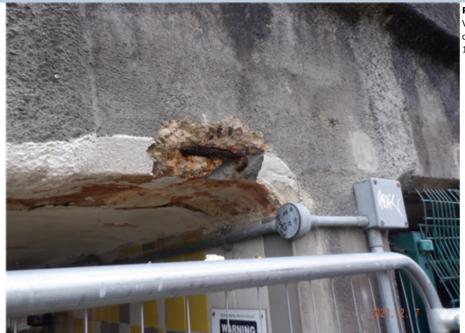
### Photograph #45

View of spalling exposing the reinforcement on the external face at North end, measured 140x230x40mm

There multiple severe spalling area exposing the reinforcement on the deck soffit, and isolated area on the external face at North end, measured 140x230x40mm, 1300x1100x65mm, 800x600x55mm and 300x300x40mm

The reinforcement should clean back to bare metal before an anti-corrosion primer is applied. The areas should be patch repaired with an appropriate cementitious material, ensuring that it is sufficiently 'keyed-in' to the parent concrete.

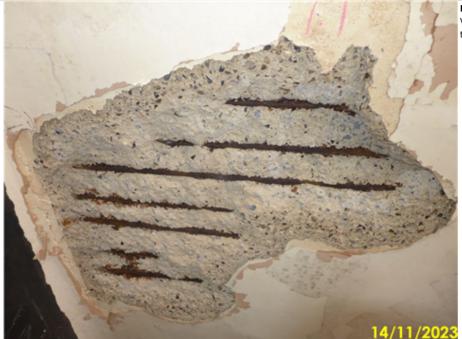
### Photograph #47

View of 1300x1100x65mm spalling exposing the reinforcement on the deck soffit

There multiple severe spalling area exposing the reinforcement on the deck soffit, and isolated area on the external face at North end, measured 140x230x40mm, 1300x1100x65mm, 800x600x55mm and 300x300x40mm

The reinforcement should clean back to bare metal before an anti-corrosion primer is applied. The areas should be patch repaired with an appropriate cementitious material, ensuring that it is sufficiently 'keyed-in' to the parent concrete.

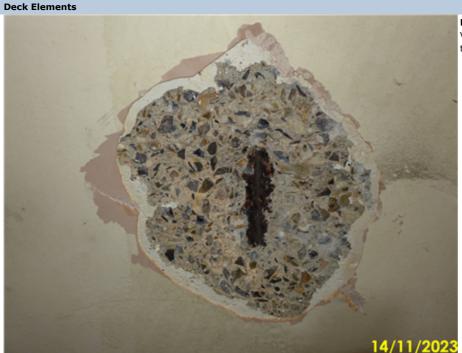
### Photograph #49

View of 300x300x40mm spalling exposing the reinforcement on the deck soffit

There multiple severe spalling area exposing the reinforcement on the deck soffit, and isolated area on the external face at North end, measured 140x230x40mm, 1300x1100x65mm, 800x600x55mm and 300x300x40mm

The reinforcement should clean back to bare metal before an anti-corrosion primer is applied. The areas should be patch repaired with an appropriate cementitious material, ensuring that it is sufficiently 'keyed-in' to the parent concrete.

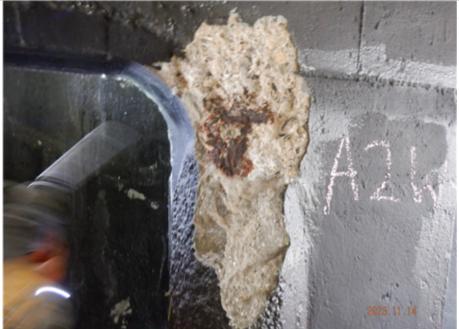
### Photograph #51

View of 460x170x20mm spalling exposing the reinforcement on C2 west face

There were multiple spalling exposing the reinforcement on the columns #2 and #3, measured 460x170x20mm, 600x500x70mm, 850x560x20mm and 900x150x30mm.

Refer to element #1 for remedial works recommendation

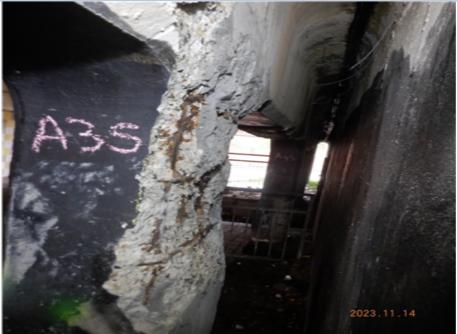
### Photograph #53

View of 850x560x20mm spalling exposing the reinforcement on C3 east face

There were multiple spalling exposing the reinforcement on the columns #2 and #3, measured 460x170x20mm, 600x500x70mm, 850x560x20mm and 900x150x30mm.

Refer to element #1 for remedial works recommendation

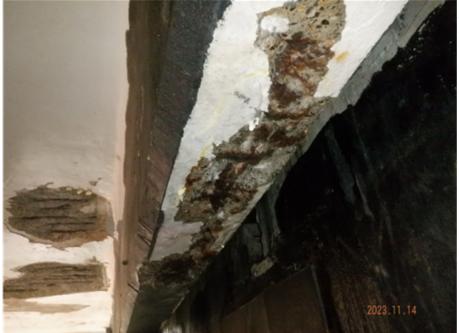
### Photograph #55

View of 265x1360x50mm spalling exposing the reinforcement on the cross head between C4 and C5

There were multiple spalling exposing the reinforcement on the cross head between C1 to C5, measured 265x1360x50mm, 180x500x50mm and 250x260x10mm.

Refer to element #1 for remedial works recommendation

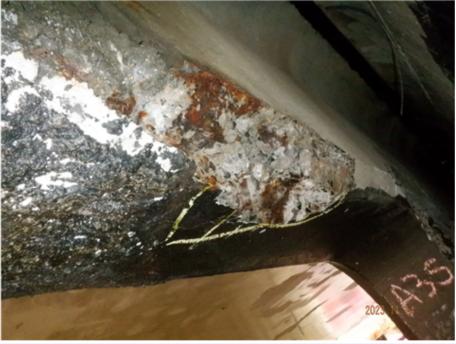
### Photograph #56

View of 180x500x50mm spalling exposing the reinforcement on the cross head between C2 and C3

There were multiple spalling exposing the reinforcement on the cross head between C1 to C5, measured 265x1360x50mm, 180x500x50mm and 250x260x10mm.

Refer to element #1 for remedial works recommendation

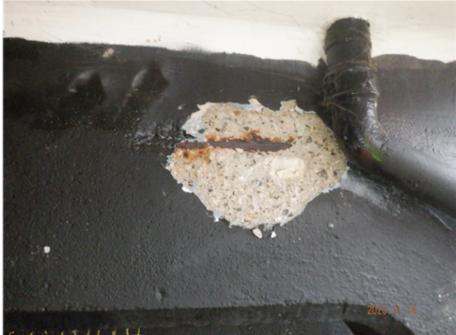
### Photograph #57

View of 250x260x10mm spalling exposing the reinforcement on the cross head west face between C1 and C2

There were multiple spalling exposing the reinforcement on the cross head between C1 to C5, measured 265x1360x50mm, 180x500x50mm and 250x260x10mm.

Refer to element #1 for remedial works recommendation

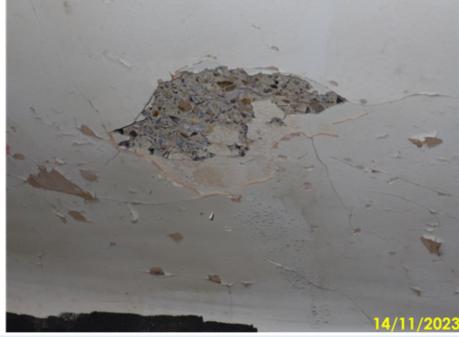
View of flaking paintwork on the deck soffit

There was loss and flaking paintwork on the deck soffit.
 Strip to defective

Strip to defective area of paintwork and apply a proprietary protective paint system to the deck soffit

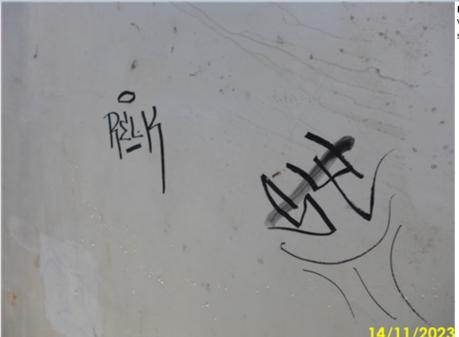
### Photograph #59

View of non-offensive graffiti on the deck

Isolated area of non-offensive graffiti within public view noted on the deck soffit

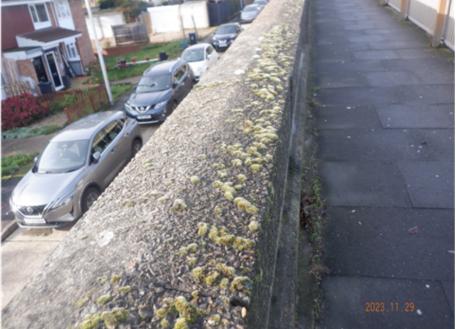
### Photograph #61

View of moss growth along the parapet coping

There was moss growth, algal and general staining throughout both RC parapet walls.

Monitor defect during next schedule inspection

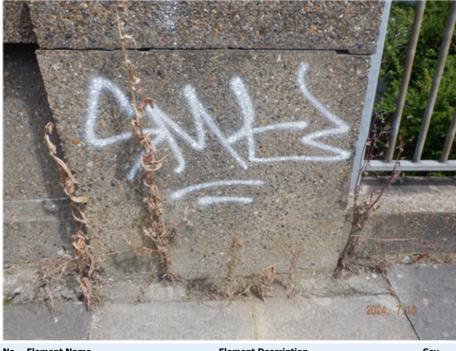
### Photograph #62

View of non-offensive graffiti on the Northern parapet post at Ch.30m

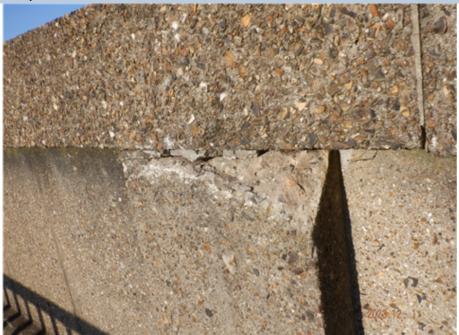
### Photograph #63

View of 90x220x40mm isolated spalling on North parapet post internal face at Ch.37.2m

There was spalling on North parapet post internal and external face, measured 90x220x40mm at Ch.37.2m

Undertake patch repairs with an appropriate cementitious material, ensuring that it is sufficiently 'keyed-in' to the parent concrete.

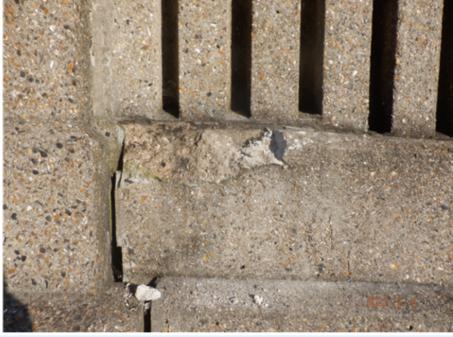
### Photograph #64

View of 150x230x130mm spalling on North parapet post external face

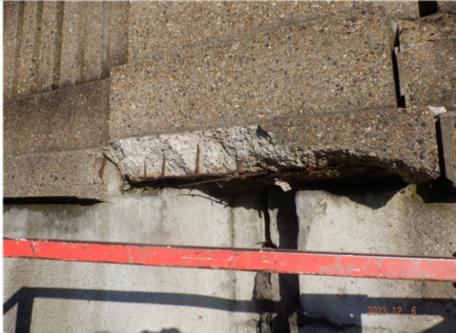
### Photograph #65

View of localised deep spalling exposing the reinforcement on the parapet post between the span #1 and approach ramp at North, measured 160x1005x160mm

### Refer to element #1 for remedial works recommendation

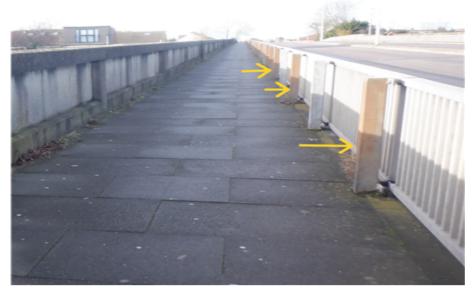
### Photograph #67

View of surface corrosion on South parapet

Abrade, treat and repaint the affected areas of surface corrosion on the parapet South and North parapet post.

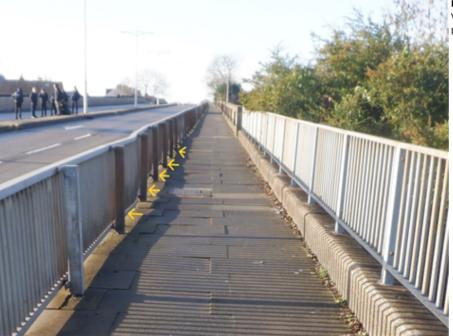
### Photograph #68

View of surface corrosion on North parapet

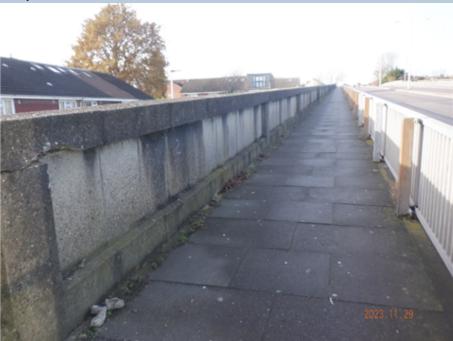
### Photograph #71

View of minor vegetation and debris accumulation along the South footway surfacing

Monitor defect during next schedule inspection

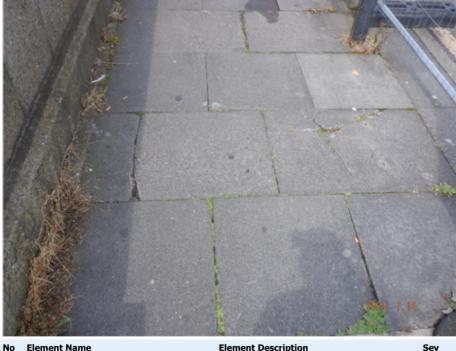
Photograph #72

View of cracked paving slab at Ch.38m

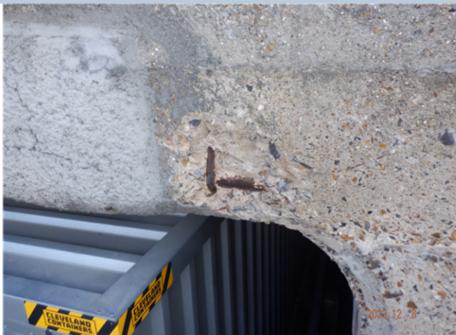
### Photograph #73

View of spalling exposing the reinforcement on external face at South end, measured 150x150x25mm

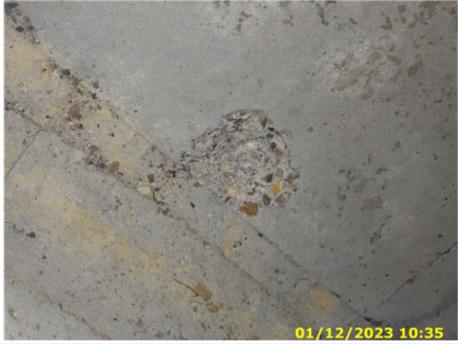
### Photograph #74

View of minor spalling on the deck soffit, measured 330x30x20mm

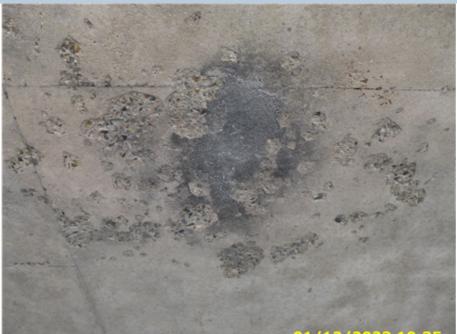
### Photograph #75

View of isolated area of fire damage on the deck soffit, measured 600x600mm

Monitor defect during next schedule inspection

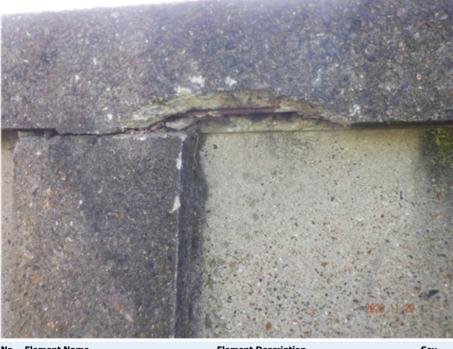
### Photograph #76

View of spalling exposing the reinforcement on South parapet coping, measured 70x370x70mm at Ch.36.2

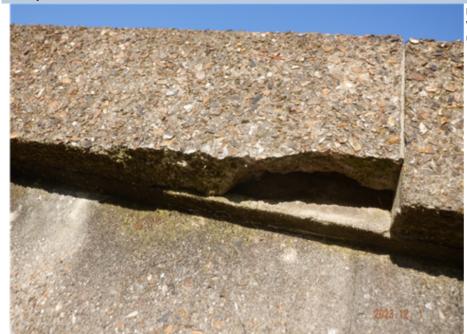
### Photograph #77

View of spalling on North parapet coping, measured 40x300x70mm at Ch.40m

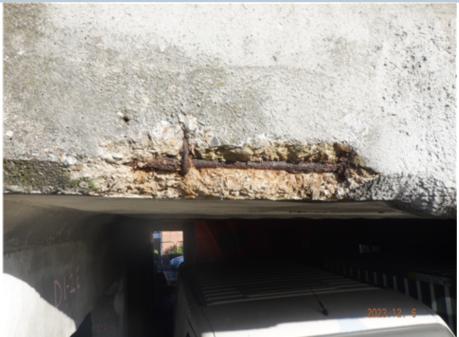
### Photograph #78

View of 100x530x35mm spalling exposing the reinforcement on external face at South end

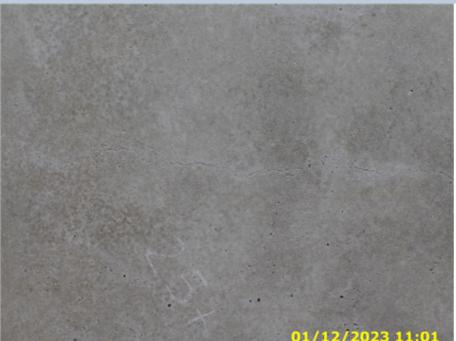
### Photograph #80

View of shrinkage crack on the deck soffit up to 4.6m in length

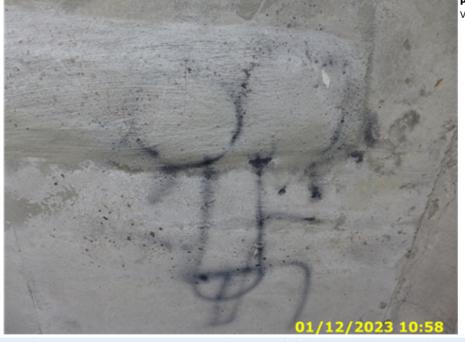
View of offensive graffiti on the deck soffit

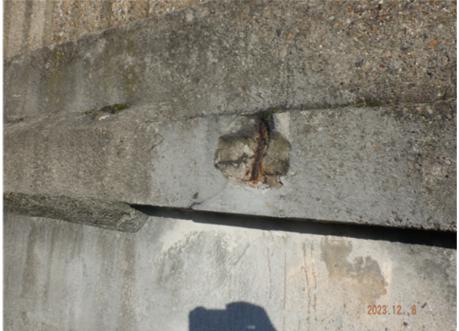
### Photograph #82

View of 130x90x20mm spalling exposing the reinforcement on external face at South end

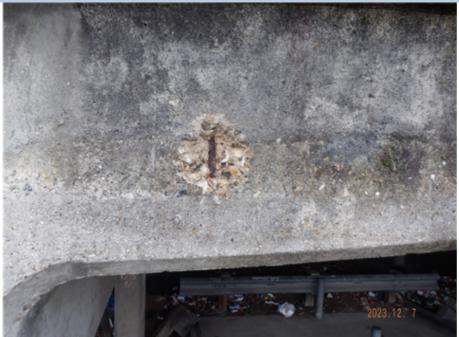
### Photograph #83

View of minor spalling exposing the reinforcement on the North face, measured 100x100x20mm

The reinforcement should clean back to bare metal before an anti-corrosion primer is applied. The areas should be patch repaired with an appropriate cementitious material, ensuring that it is sufficiently 'keyed-in' to the parent concrete.

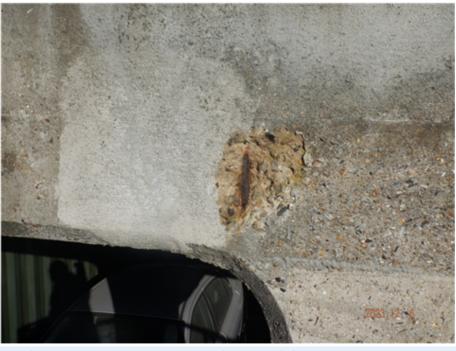
### Photograph #84

View of 160x160x25mm spalling exposing the reinforcement on the South face

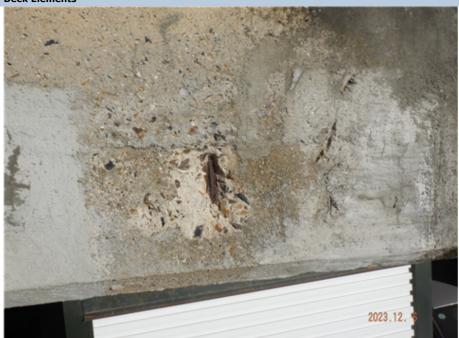
### Photograph #85

View of 160x150x20mm spalling exposing the reinforcement on the South face

The reinforcement should clean back to bare metal before an anti-corrosion primer is applied. The areas should be patch repaired with an appropriate cementitious material, ensuring that it is sufficiently 'keyed-in' to the parent concrete.

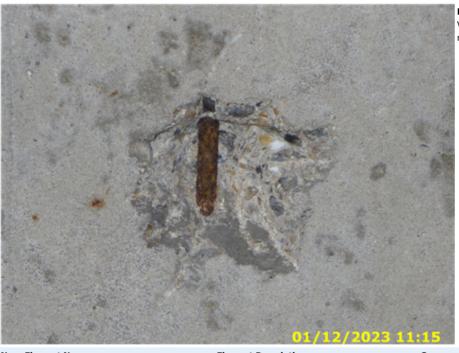
### Photograph #86

View of 50x50x20mm spalling exposing the reinforcement on the deck soffit

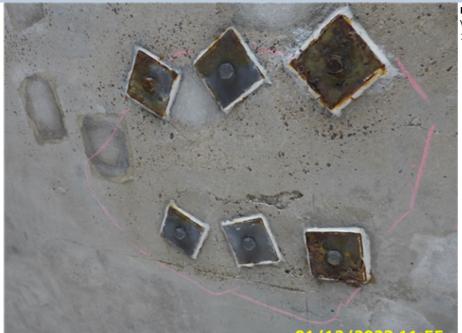
### Photograph #87

View of hollowness area, measured 1900x90mm

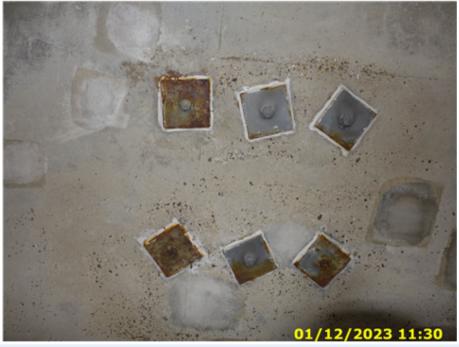
### Photograph #88

View of surface corrosion on the holding down bolts and plates

Comment **Remedial Works** Surface corrosion on the holding down bolts and plates.

Monitor defect during next schedule inspection

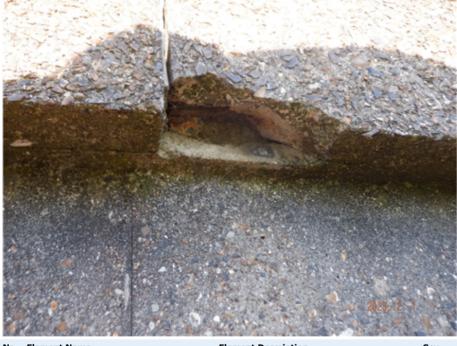
### Photograph #90

View of spalling exposing the reinforcement on North RC parapet coping, measured 30x150x60mm at Ch.54.9m

Spalling exposing the reinforcement on North RC parapet coping and on external face at South, measured 30x150x60mm and 150x430x15mm.

Refer to element #1 for remedial works recommendation

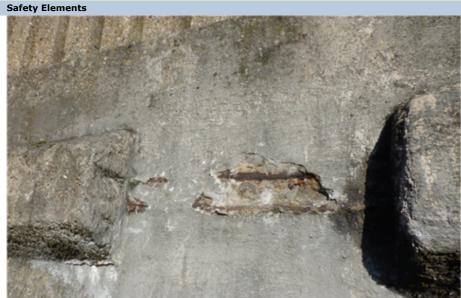
### Photograph #91

View of spalling exposing the reinforcement on external face at South end, measured 150x430x15mm

Spalling exposing the reinforcement on North RC parapet coping and on external face at South, measured 30x150x60mm and 150x430x15mm.

Refer to element #1 for remedial works recommendation

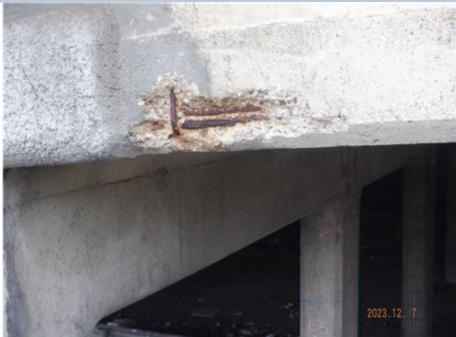
### Photograph #92

View of spalling exposing the reinforcement on the North face, measured 160x370x35mm

There were multiple areas of spalling exposing the reinforcement on the North and South edges measuring 160x370x35mm, 180x200x25mm and 180x200x25mm. Also, an isolated spalled area exposing the reinforcement on the deck soffit, measuring 100x100x20mm

The reinforcement should clean back to bare metal before an anti-corrosion primer is applied. The areas should be patch repaired with an appropriate cementitious material, ensuring that it is sufficiently 'keyed-in' to the parent concrete.

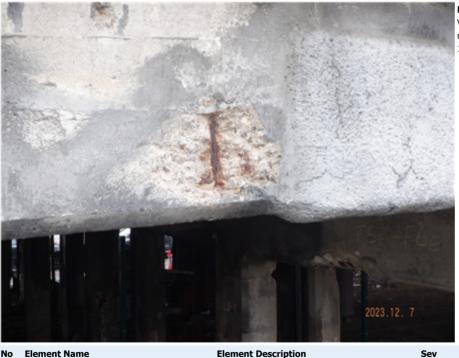
### Photograph #93

View of minor spalling exposing the reinforcement on the North face, measured 180x200x25mm

There were multiple areas of spalling exposing the reinforcement on the North and South edges measuring 160x370x35mm, 180x200x25mm and 180x200x25mm. Also, an isolated spalled area exposing the reinforcement on the deck soffit, measuring 100x100x20mm

The reinforcement should clean back to bare metal before an anti-corrosion primer is applied. The areas should be patch repaired with an appropriate cementitious material, ensuring that it is sufficiently 'keyed-in' to the parent concrete.

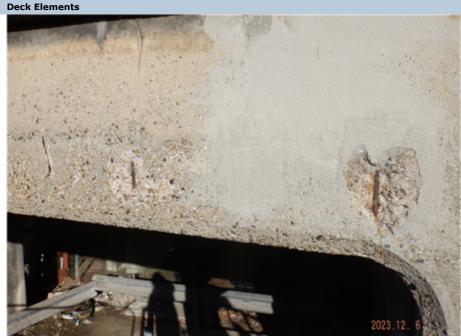
### Photograph #94

View of 180x200x25mm spalling exposing the reinforcement on the South face

There were multiple areas of spalling exposing the reinforcement on the North and South edges measuring 160x370x35mm, 180x200x25mm and 180x200x25mm. Also, an isolated spalled area exposing the reinforcement on the deck soffit, measuring 100x100x20mm

The reinforcement should clean back to bare metal before an anti-corrosion primer is applied. The areas should be patch repaired with an appropriate cementitious material, ensuring that it is sufficiently 'keyed-in' to the parent concrete.

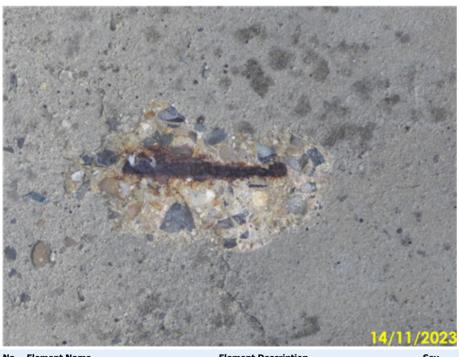
### Photograph #95

View of 100x100x20mm spalling exposing the reinforcement on the deck soffit

There were multiple areas of spalling exposing the reinforcement on the North and South edges measuring 160x370x35mm, 180x200x25mm and 180x200x25mm. Also, an isolated spalled area exposing the reinforcement on the deck soffit, measuring 100x100x20mm

The reinforcement should clean back to bare metal before an anti-corrosion primer is applied. The areas should be patch repaired with an appropriate cementitious material, ensuring that it is sufficiently 'keyed-in' to the parent concrete.

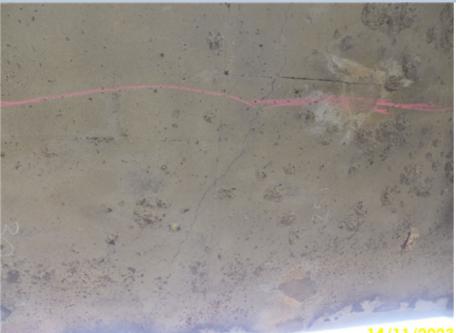
Photograph #96

View of shrinkage crack up 1.2m in length on the deck soffit

Minor shrinkage crack up to 1.2m in length noted on the deck soffit.

Monitor defect during next schedule inspection

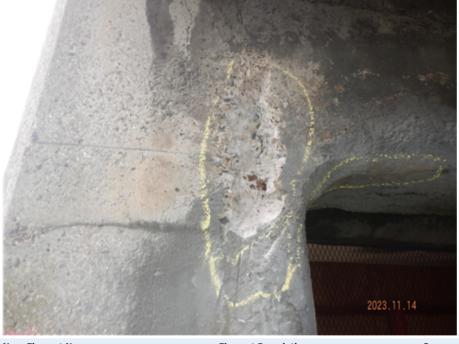
Photograph #97

View of 400x120x25mm spalling exposing the reinforcement on C1 east face

There were multiple areas of deep spalling exposing the reinforcement on both C1 and C2, measuring 400x120x25mm, 450x260x15mm, full height x 350 x 60mm, 390x390x70mm, 470x100x55mm and 600x100x50mm.

Refer to element #1 for remedial works recommendation

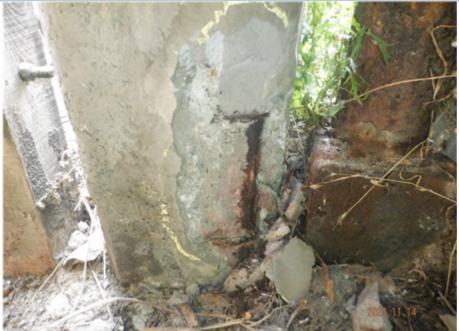
### Photograph #98

View of 450x260x15mm spalling exposing the reinforcement at the bottom of C1 north face

There were multiple areas of deep spalling exposing the reinforcement on both C1 and C2, measuring 400x120x25mm, 450x260x15mm, full height x 350 x 60mm, 390x390x70mm, 470x100x55mm and 600x100x50mm.

Refer to element #1 for remedial works recommendation

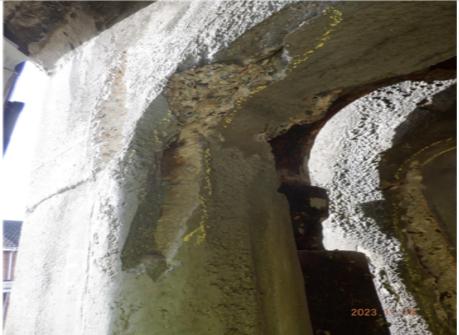
### Photograph #100

View of 470x100x55mm spalling exposing the reinforcement at top of C1 north face extending to the underside of of cross head

There were multiple areas of deep spalling exposing the reinforcement on both C1 and C2, measuring  $400 \times 120 \times 25 \, \text{mm}$ ,  $450 \times 260 \times 15 \, \text{mm}$ , full height x 350 x  $60 \, \text{mm}$ ,  $390 \times 390 \times 70 \, \text{mm}$ ,  $470 \times 100 \times 55 \, \text{mm}$  and  $600 \times 100 \times 50 \, \text{mm}$ .

Refer to element #1 for remedial works recommendation

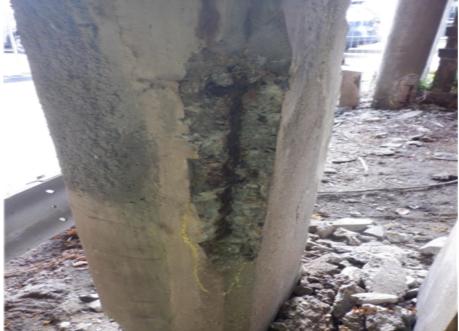
### Photograph #102

View of 600x100x50mm spalling exposing the reinforcement on C2 north face

There were multiple areas of deep spalling exposing the reinforcement on both C1 and C2, measuring 400x120x25mm, 450x260x15mm, full height x 350 x 60mm, 390x390x70mm, 470x100x55mm and 600x100x50mm.

Refer to element #1 for remedial works recommendation

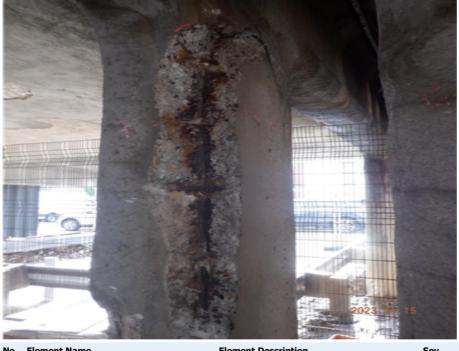
### Photograph #103

View of 1001x200x45mm spalling exposing the reinforcement on C3 north and west face

There were multiple areas of deep spalling exposing the reinforcement on both C3 and C4, measured 1001x200x45mm, 450x100x40mm,470x160x60mm, 1020x280x50mm and 1090x400x60mm

Refer to element #1 for remedial works recommendation

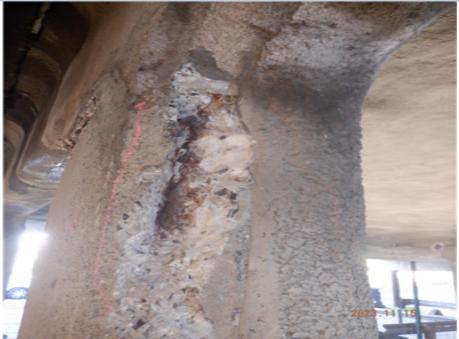
### Photograph #104

View of 450x100x40mm spalling exposing the reinforcement at top of C3 south face

There were multiple areas of deep spalling exposing the reinforcement on both C3 and C4, measured 1001x200x45mm, 450x100x40mm,470x160x60mm, 1020x280x50mm and 1090x400x60mm

Refer to element #1 for remedial works recommendation

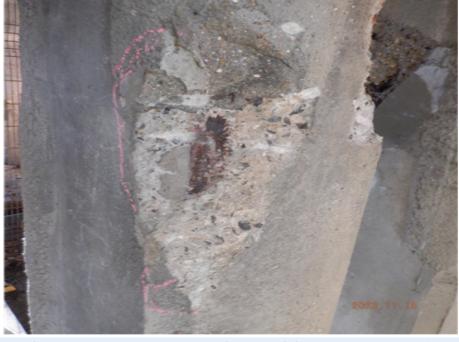
# Photograph #105

View of 470x160x60mm spalling exposing the reinforcement on C3 east face

There were multiple areas of deep spalling exposing the reinforcement on both C3 and C4, measured

Refer to element #1 for remedial works recommendation

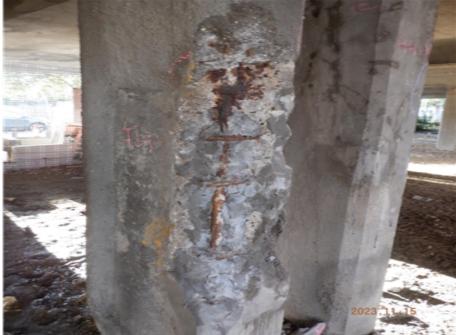
### Photograph #106

View of 1020x280x50mm spalling exposing the reinforcement on C4 north face

There were multiple areas of deep spalling exposing the reinforcement on both C3 and C4, measured 1001x200x45mm, 450x100x40mm,470x160x60mm, 1020x280x50mm and 1090x400x60mm

Refer to element #1 for remedial works recommendation

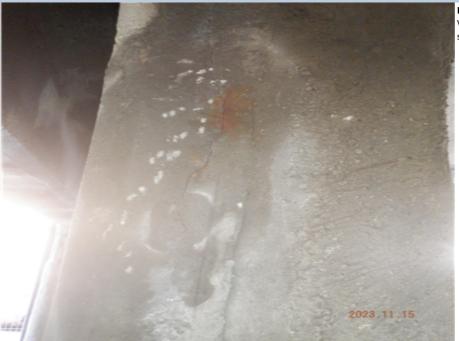
### Photograph #108

View of 300x1-2mm vertical crack on C5 south face.

There was an isolated 300x1-2mm vertical crack on C5 south face.

Monitor defect during next schedule inspection

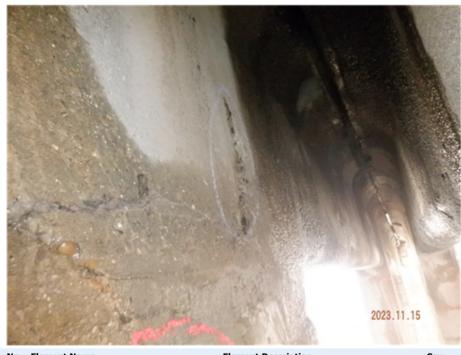
### Photograph #109

View of 230x20x5mm isolated spalling on the west face between C3 and C4

There was deep spalling exposing the reinforcement on the cross head between C5 and C6 and an isolated area of spalling on the west face between C3 and C4, measuring 640x190x65mm and 230x20x5mm

Refer to element #1 for remedial works recommendation

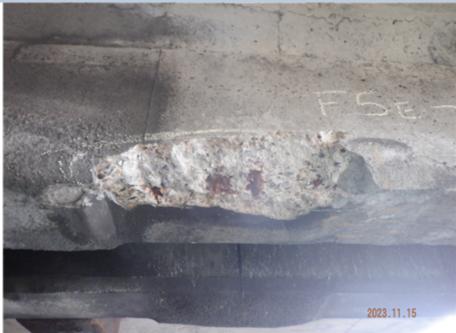
### Photograph #110

View of 640x190x65mm spalling exposing the reinforcement on the cross head between C5 and C6

There was deep spalling exposing the reinforcement on the cross head between C5 and C6 and an isolated area of spalling on the west face between C3 and C4, measuring 640x190x65mm and 230x20x5mm

### Refer to element #1 for remedial works recommendation

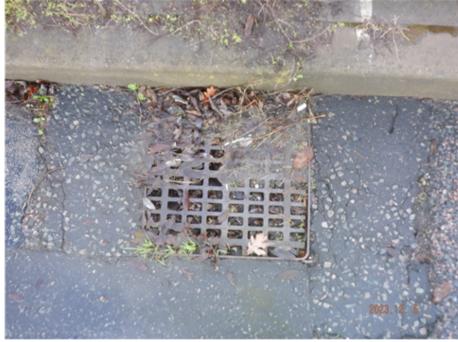
View of fully blocked carriageway gully

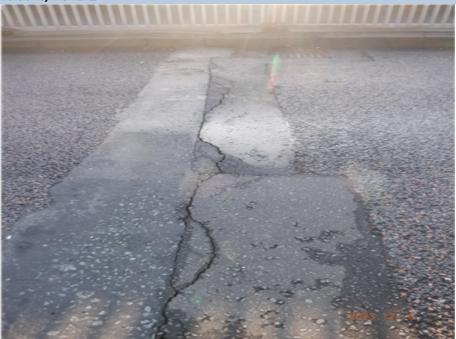
### Photograph #112

View of debonding and cracks between the plug joint and road surface on Westbound carriageway

There was debonding and cracks between the plug joint and road surface on Westbound carriageway leading to extensive leakage onto the elements below. This is consistent with 2023 GI

Undertake repairs to the defective areas of expansion joint using an approved bituminous material.

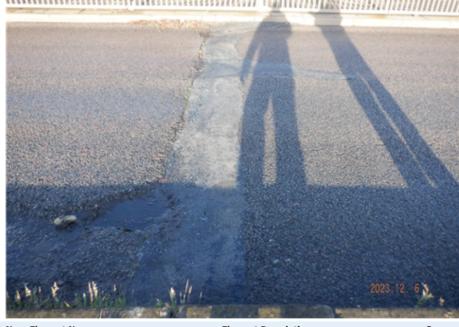
View of tracking and flow of the binder on expansion joint Eastbound carriageway.

Note: Pothole forming.

Longstanding tracking and flow of the binder of expansion joint on Eastbound carriageway leading to extensive leakage onto the elements below. Also, pothole forming noted.

Undertake repairs to the defective areas of expansion joint using an approved bituminous material.

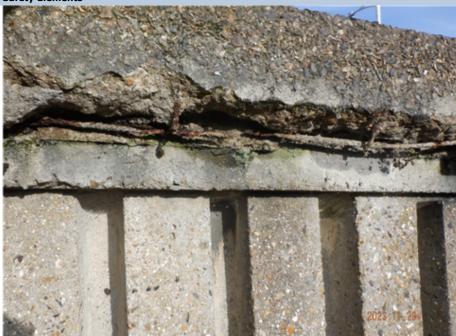
### Photograph #114

View of spalling exposing the reinforcement on South parapet coping, measured 50x650x60mm

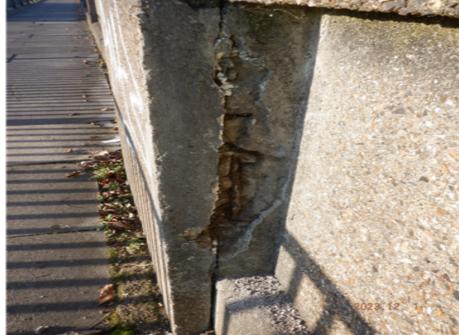
View of spalling exposing the reinforcement on North parapet post, measured 550x100x40mm

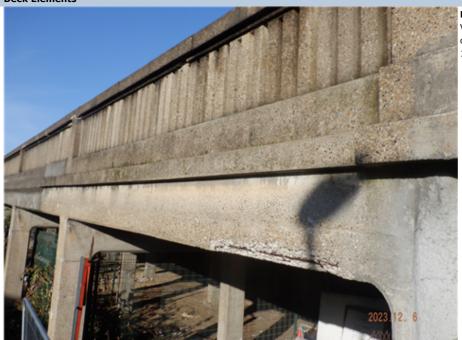
### Photograph #117

View of spalling exposing the reinforcement on external face at South end, measured 150x910x25mm

The reinforcement should clean back to bare metal before an anti-corrosion primer is applied. The areas should be patch repaired with an appropriate cementitious material, ensuring that it is sufficiently 'keyed-in' to the parent concrete.

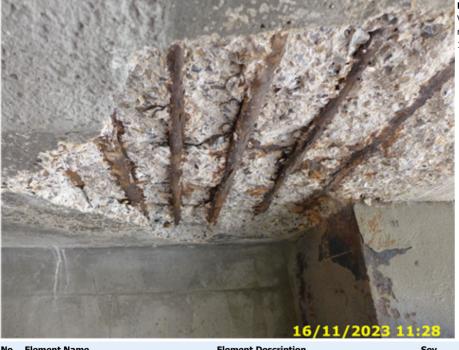
### Photograph #118

View of deep spalling exposing the reinforcement on the deck soffit, measured 1400x1300x75mm

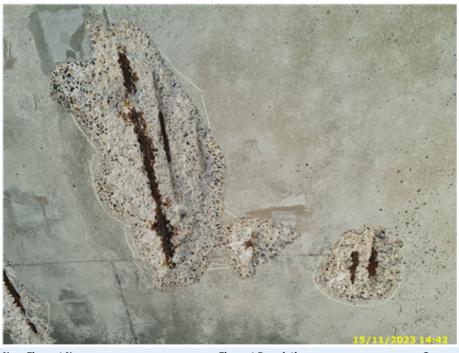
### Photograph #120

View of spalling exposing the reinforcement on the deck soffit, measured 600x1300x50mm

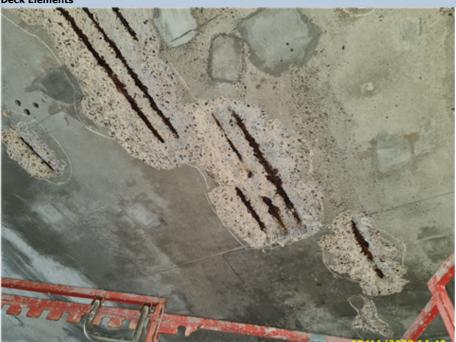
### Photograph #121

View of spalling exposing the reinforcement on the deck soffit, measured 600x2200x45mm

The reinforcement should clean back to bare metal before an anti-corrosion primer is applied. The areas should be patch repaired with an appropriate cementitious material, ensuring that it is sufficiently 'keyed-in' to the parent concrete.

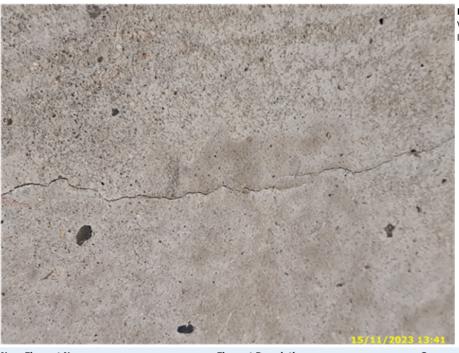
### Photograph #122

View of shrinkage crack up to 1100mm in length on the deck soffit

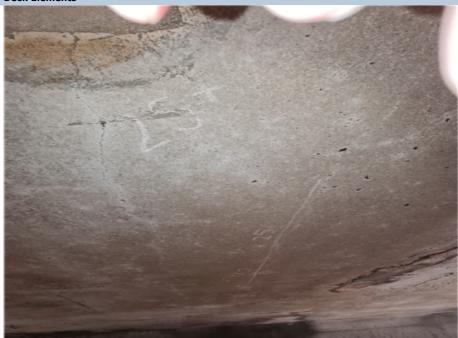
### Photograph #123

View of shrinkage crack up to 1300mm in length on the deck soffit

Monitor defect during next schedule inspection

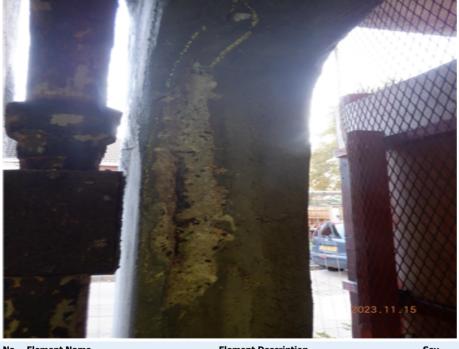
### Photograph #124

View of 720x130x30mm spalling exposing the reinforcement on C1 north face
