# **Principal Inspection Report**

Structure Name: Broadmead Road Viaduct

**Identifier:** B4

**Inspection Date:** 14/11/2023

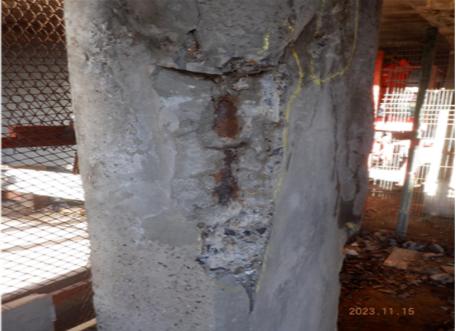
### Photograph #125

View of 500x160x40mm spalling exposing the reinforcement on C2 north face extending to east

There were multiple areas of spalling exposing the reinforcement on C1, C2 and C3 north and east face, measuring 720x130x30mm, 500x160x40mm, 520x120x20mm, 1205x260x40mm and 570x320x50mm

C1-C3 Refer to element #1 for remedial works recommendation

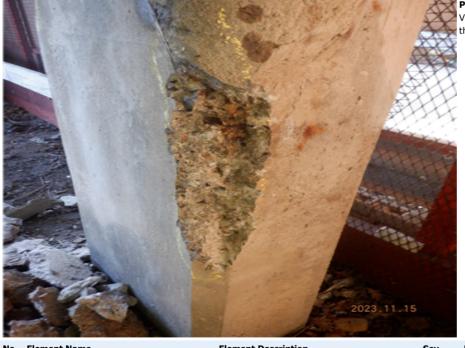
# Photograph #126

View of 520x120x20mm spalling exposing the reinforcement at bottom of C2 east face

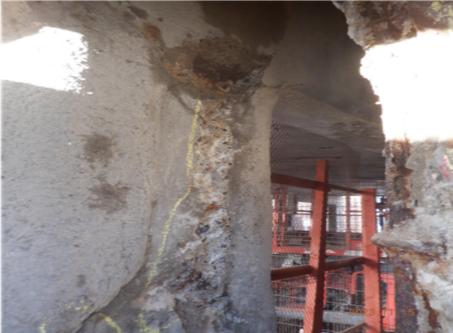
### Photograph #127

View of 1205x260x40mm spalling exposing the reinforcement on C2 east face

There were multiple areas of spalling exposing the reinforcement on C1, C2 and C3 north and east face, measuring 720x130x30mm, 500x160x40mm, 520x120x20mm, 1205x260x40mm and 570x320x50mm

C1-C3 Refer to element #1 for remedial works recommendation

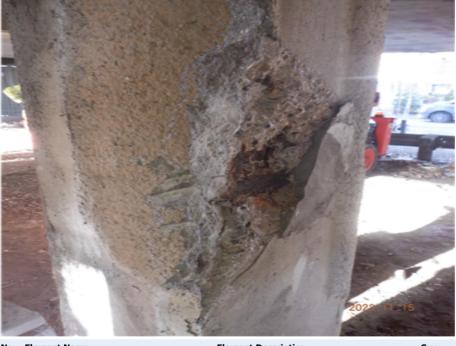
View of 570x320x50mm deep spalling exposing the reinforcement on C3 east face

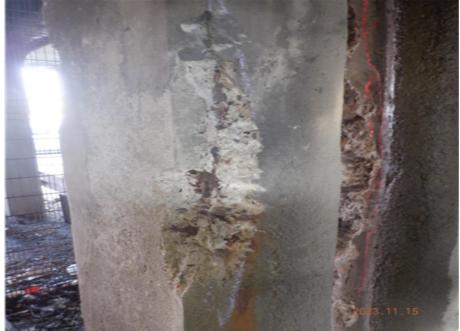
### Photograph #129

View of 700x160x70mm spalling exposing the reinforcement on C4 SW face

There was 2No. areas of spalling exposing the reinforcement on C4 SW face and North face, measuring 700x160x70mm and 450x140x30mm

C4-C6 Refer to element #1 for remedial works recommendation

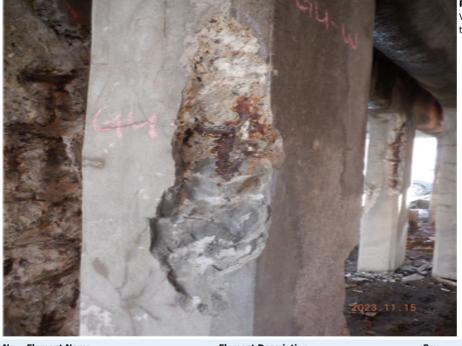
# Photograph #130

View of 450x140x30mm spalling exposing the reinforcement on C4 north face

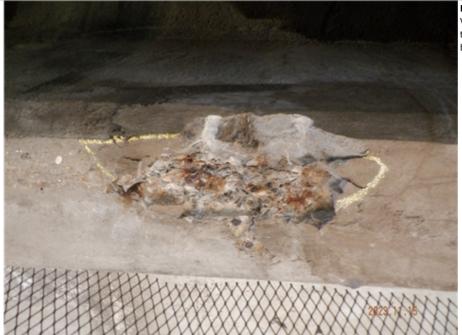
### Photograph #131

View of 160x320x20mm spalling exposing the reinforcement on the cross head between C2 and C3

There was 2No. areas of spalling exposing the reinforcement on the cross head between C2 and C3, measuring 160x320x20mm and 1000x300x40mm

(East of Span) Refer to element #1 for remedial works recommendation

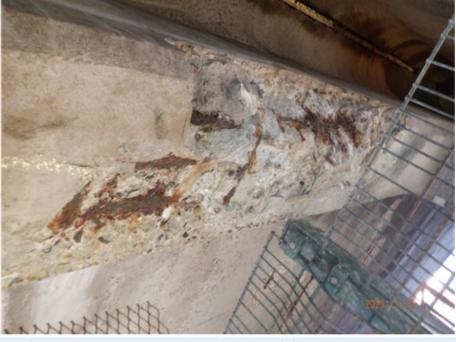
### Photograph #132

View of 1000x300x40mm spalling exposing the reinforcement on the cross head between C2 and C3

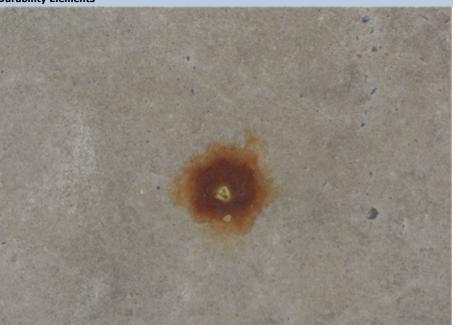
### Photograph #133

View of iron pyrite staining on the deck soffit

Minor rust staining noted on the deck soffit. [none]

Monitor defect during next schedule inspection

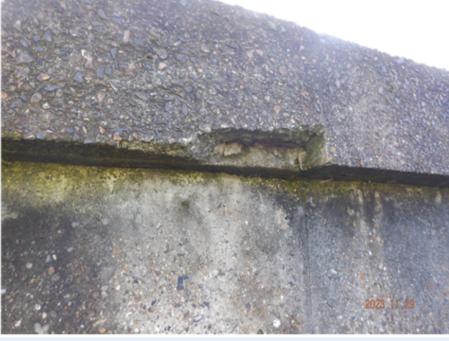
# Photograph #134

View of spalling exposing the reinforcement on South parapet coping at Ch.62.8m, measured 50x200x50mm

Multiple areas of spalling exposing the reinforcement on South parapet coping, measured 50x200x50mm at

Remedial Works
Refer to element #1 for remedial works recommendation

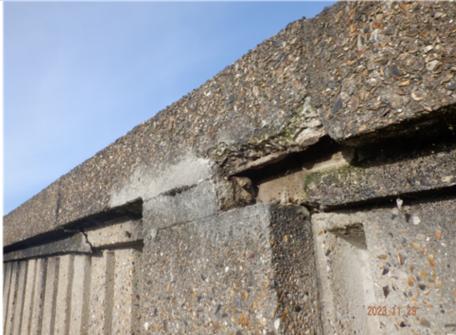
### Photograph #135

View of spalling exposing the reinforcement on South parapet coping, measured 90x200x80mm

Multiple areas of spalling exposing the reinforcement on South parapet coping, measured 50x200x50mm at Ch.62.8m and 90x200x80mm.

Refer to element #1 for remedial works recommendation

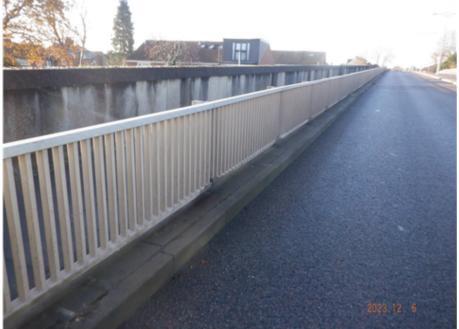
### Photograph #137

There was minor moss growth and dirty staining on top of Southern parapet coping. Refer to photograph #137

General view of South steel parapet

There were multiple location where surface corrosion was noted on South and North parapet post. This is consistent with 2023 GI

Abrade, treat and repaint the affected areas of surface corrosion on the parapet South and North parapet post.

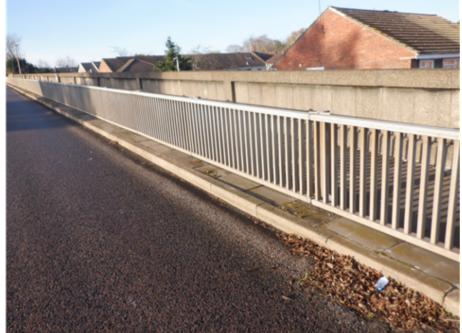
# Photograph #138

General view of North steel parapet

There were multiple location where surface corrosion was noted on South and North parapet post. This is consistent with 2023 GI

Abrade, treat and repaint the affected areas of surface corrosion on the parapet South and North parapet post.

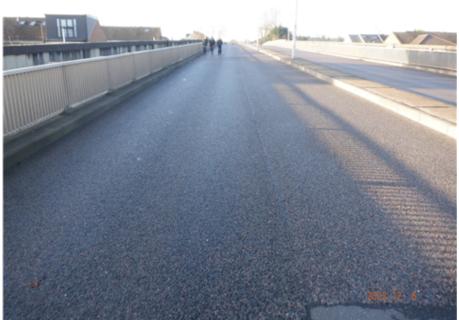
### Photograph #139

General view of Westbound carriageway

Break out the area around the defective surfacing and repair with a suitable mastic asphalt patch repair.

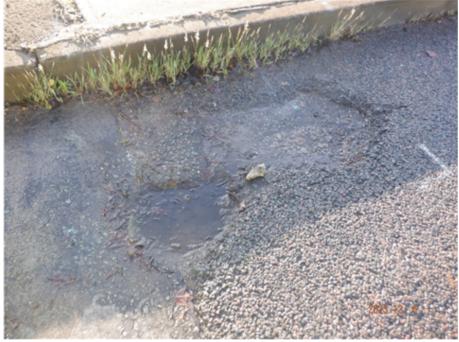
# Photograph #140

View of pothole forming on Eastbound carriageway, measured 750x1400x10mm

Break out the area around the defective surfacing and repair with a suitable mastic asphalt patch repair.

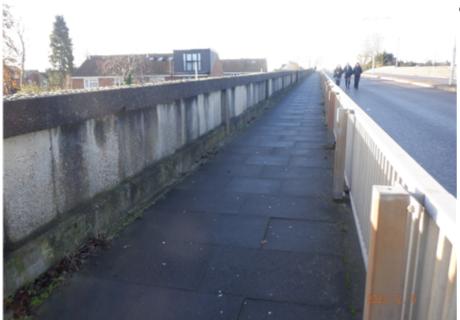
### Photograph #141

General view of South footway

Monitor defect during next schedule inspection

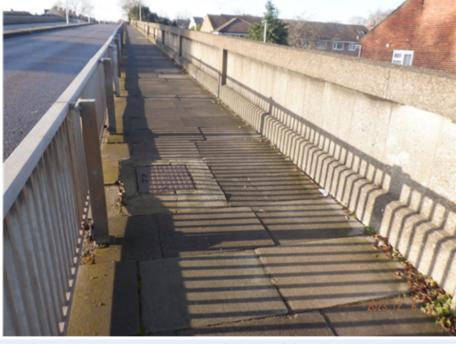
Photograph #142 General view of North footway

Monitor defect during next schedule inspection

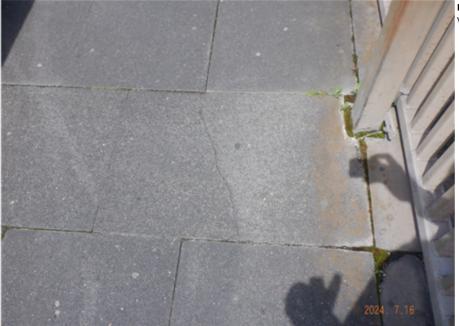
## Photograph #143

View of cracked paving slab at Ch.66m

There was cracked paving slabs on the Southern footway surfacing at  ${\rm Ch.66m}$

Monitor defect during next schedule inspection

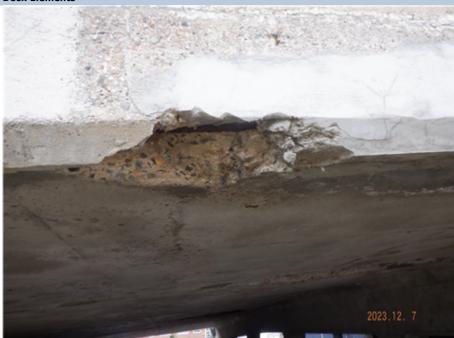
### Photograph #144

View of spalling exposing the reinforcement on the North external face, measured 80x360x80mm 14/11/2023

There were 2No. areas of spalling exposing the reinforcement on the North external face, measuring 80x360x80mm and 60x60x30mm. In addition, multiple areas of deep spalling exposing the corroded reinforcement noted on the deck soffit, measuring 1900x650x55mm, 3800x1900x70mm, 1700x1700x70mm and 300x500x25mm

The reinforcement should clean back to bare metal before an anti-corrosion primer is applied. The areas should be patch repaired with an appropriate cementitious material, ensuring that it is sufficiently 'keyed-in' to the parent concrete.

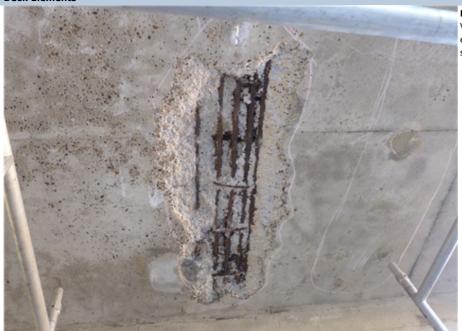
### Photograph #145

View of 1900x650x55mm deep spalling exposing the reinforcement on the deck soffit

There were 2No. areas of spalling exposing the reinforcement on the North external face, measuring 80x360x80mm and 60x60x30mm. In addition, multiple areas of deep spalling exposing the corroded reinforcement noted on the deck soffit, measuring 1900x650x55mm, 3800x1900x70mm, 1700x1700x70mm and 300x500x25mm

The reinforcement should clean back to bare metal before an anti-corrosion primer is applied. The areas should be patch repaired with an appropriate cementitious material, ensuring that it is sufficiently 'keyed-in' to the parent concrete.

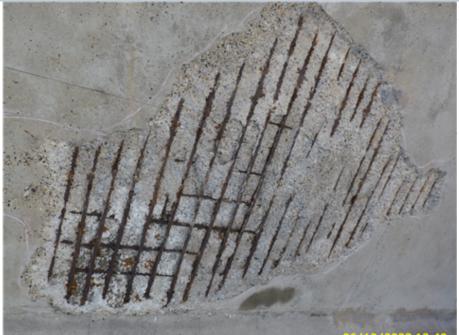
### Photograph #146

View of 3800x1900x70mm deep spalling exposing the reinforcement on the deck soffit

There were 2No. areas of spalling exposing the reinforcement on the North external face, measuring 80x360x80mm and 60x60x30mm. In addition, multiple areas of deep spalling exposing the corroded reinforcement noted on the deck soffit, measuring 1900x650x55mm, 3800x1900x70mm, 1700x1700x70mm and 300x500x25mm

The reinforcement should clean back to bare metal before an anti-corrosion primer is applied. The areas should be patch repaired with an appropriate cementitious material, ensuring that it is sufficiently 'keyed-in' to the parent concrete.

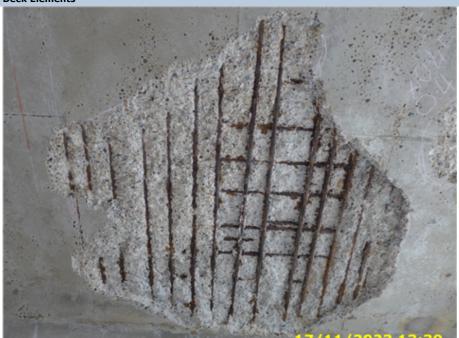
### Photograph #147

View of 1700x1700x70mm deep spalling exposing the reinforcement on the deck soffit

There were 2No. areas of spalling exposing the reinforcement on the North external face, measuring 80x360x80mm and 60x60x30mm. In addition, multiple areas of deep spalling exposing the corroded reinforcement noted on the deck soffit, measuring 1900x650x55mm, 3800x1900x70mm, 1700x1700x70mm and 300x500x25mm

The reinforcement should clean back to bare metal before an anti-corrosion primer is applied. The areas should be patch repaired with an appropriate cementitious material, ensuring that it is sufficiently 'keyed-in' to the parent concrete.

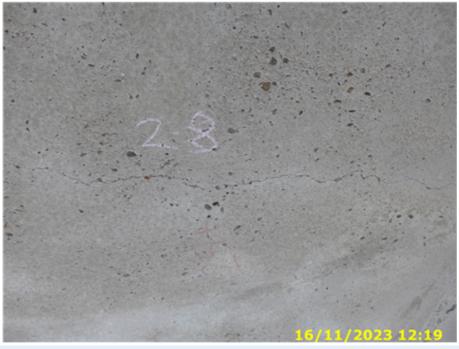
# Photograph #148

View of shrinkage crack up to 2.8m in length on the deck soffit

Minor shrinkage crack up to 2.8m in length noted on the deck soffit.

Monitor defect during next schedule inspection

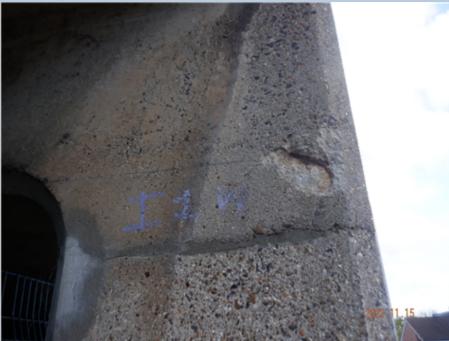
### Photograph #149

View of 100x120x10mm minor spalling exposing the reinforcement on C1 north face and 90x90x5mm shallow spalling on east face

There was an area of 100x120x10mm minor spalling exposing the reinforcement on C1 north face and an area of 90x90x5mm shallow spalling on east face. No visible defects to the other columns

Refer to element #1 for remedial works recommendation

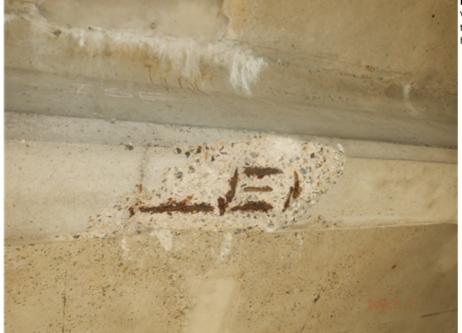
# Photograph #150

View of 400x310x40mm spalling exposing the reinforcement on the underside of cross head between C2 and C3

There were isolated areas of spalling exposing the reinforcement on the underside of cross head between C2 to C5, measuring 400x310x40mm, 460x310x40mm and 100x100x10mm.

Refer to element #1 for remedial works recommendation

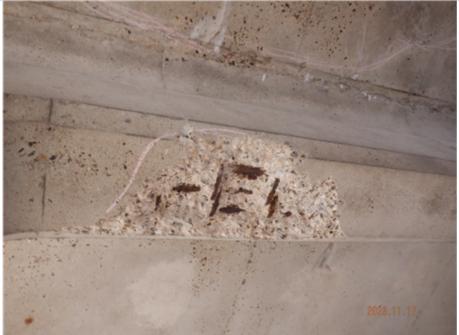
#### Photograph #151

View of 460x310x40mm spalling exposing the reinforcement on the underside of cross head between C3 and C4

There were isolated areas of spalling exposing the reinforcement on the underside of cross head between C2 to C5, measuring 400x310x40mm, 460x310x40mm and 100x100x10mm.

#### Refer to element #1 for remedial works recommendation

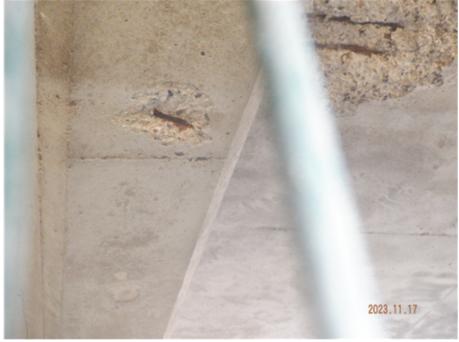
Photograph #152 View of 100x100x10mm spalling exposing the reinforcement on the underside of cross head between C4 and C5

There were isolated areas of spalling exposing the reinforcement on the underside of cross head between C2 to C5, measuring 400x310x40mm, 460x310x40mm and 100x100x10mm.

Refer to element #1 for remedial works recommendation

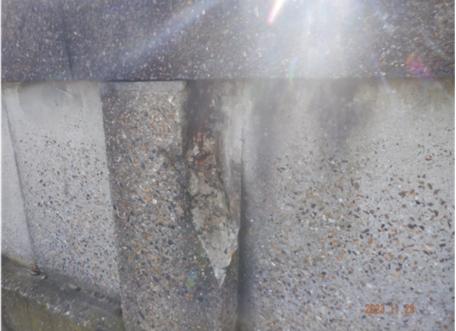
#### Photograph #153

View of spalling exposing the reinforcement on South parapet post, measured 430x70x100mm at Ch.67m

There were multiple areas of spalling exposing the reinforcement on both RC parapet walls, measuring 430x70x100mm at Ch.67m, 55x230x35mm, 50x70x30mm and 50x300x40mm.

Refer to element #1 for remedial works recommendation

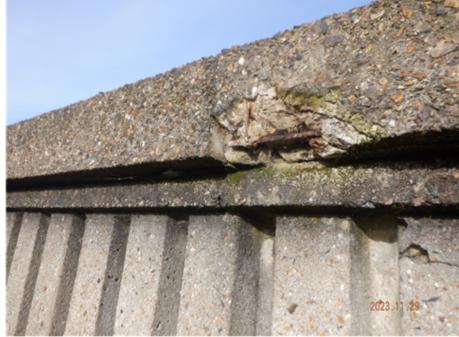
## Photograph #154

View of spalling exposing the reinforcement on South parapet coping, measured 55x230x35mm

There were multiple areas of spalling exposing the reinforcement on both RC parapet walls, measuring 430x70x100mm at Ch.67m, 55x230x35mm, 50x70x30mm and 50x300x40mm.

Refer to element #1 for remedial works recommendation

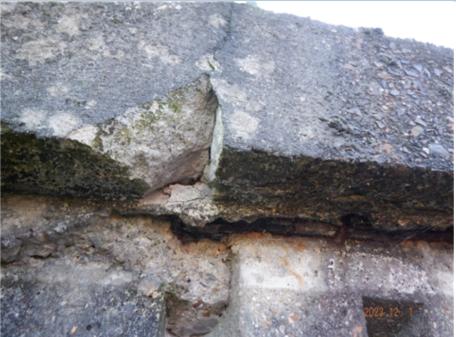
#### Photograph #155

View of spalling on North parapet coping, measured 50x70x30mm

There were multiple areas of spalling exposing the reinforcement on both RC parapet walls, measuring 430x70x100mm at Ch.67m, 55x230x35mm, 50x70x30mm and 50x300x40mm.

Refer to element #1 for remedial works recommendation

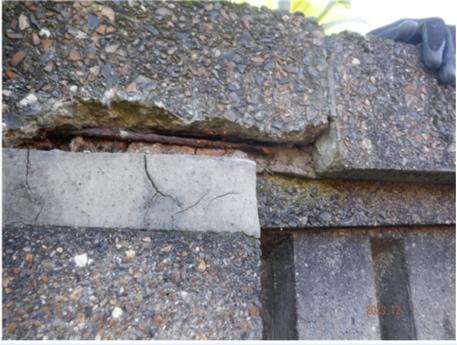
### Photograph #156

View of spalling exposing the reinforcement on North parapet coping, measured 50x300x40mm

There were multiple areas of spalling exposing the reinforcement on both RC parapet walls, measuring 430x70x100mm at Ch.67m, 55x230x35mm, 50x70x30mm and 50x300x40mm.

Refer to element #1 for remedial works recommendation

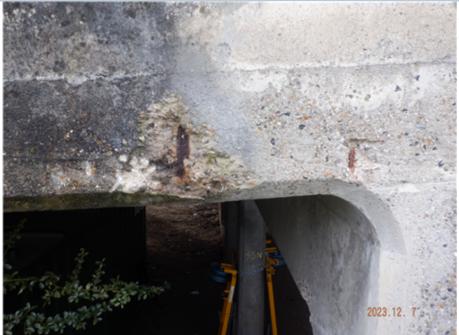
#### Photograph #157

View of spalling exposing the reinforcement on external face at North end, measured 190x210x25mm

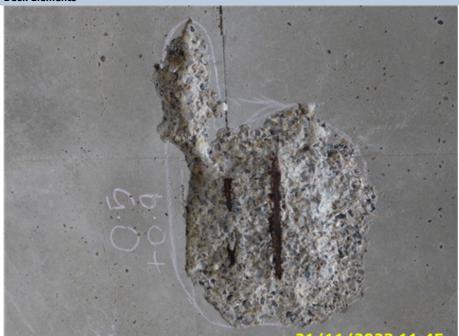
#### Photograph #159

View of 900x500x45mm spalling exposing the reinforcement on the deck soffit

The reinforcement should clean back to bare metal before an anti-corrosion primer is applied. The areas should be patch repaired with an appropriate cementitious material, ensuring that it is sufficiently 'keyed-in' to the parent concrete.

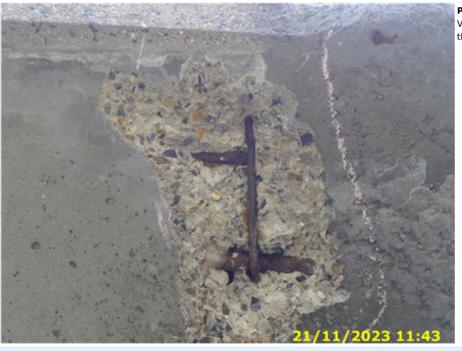
#### Photograph #160

View of 450x250x28mm spalling exposing the reinforcement on the deck soffit

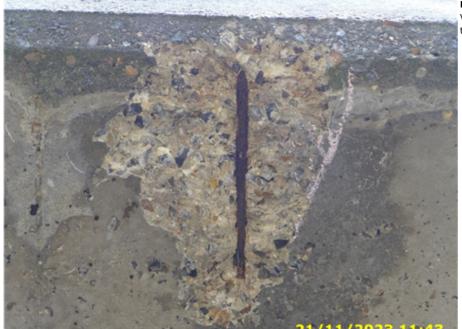
#### Photograph #161

View of 250x350x22mm spalling exposing the reinforcement on the deck soffit

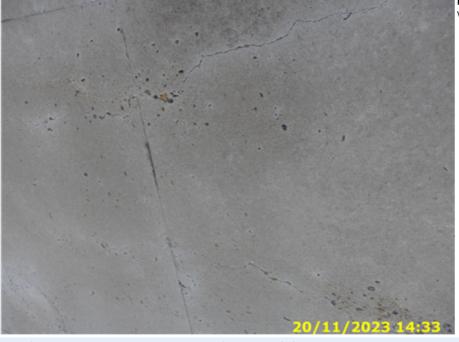
#### Photograph #162

View of shrinkage crack up to 3.1m in length

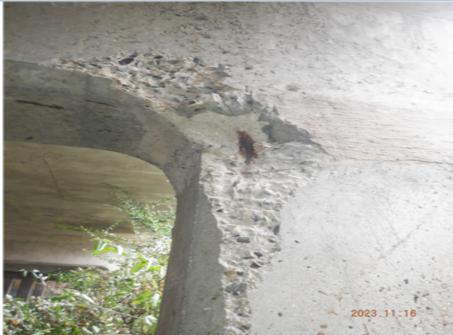
#### Photograph #163

View of 520x180x40mm spalling exposing the reinforcement on C6 east face

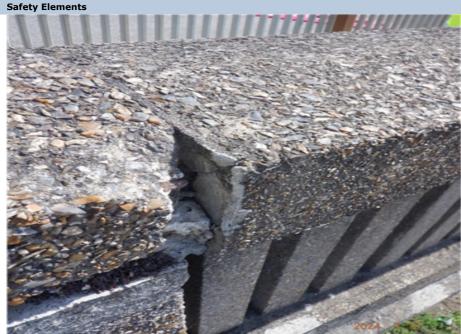
### Photograph #165

View of full height x 50 x 50mm spalling exposing the reinforcement on South parapet coping at Ch.79m

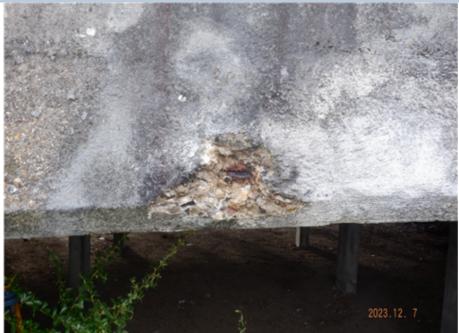
#### Photograph #166

View of spalling exposing the reinforcement on external face at North end, measured 100x150x25mm

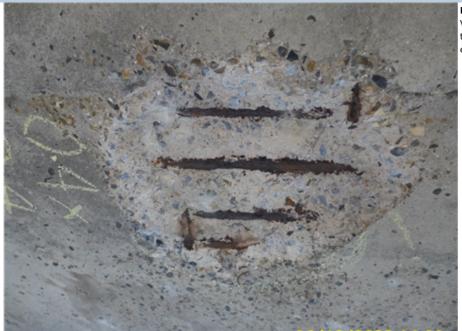
#### Photograph #168

View of 400x400x35mm spalling exposing the reinforcement on the deck soffit at North end

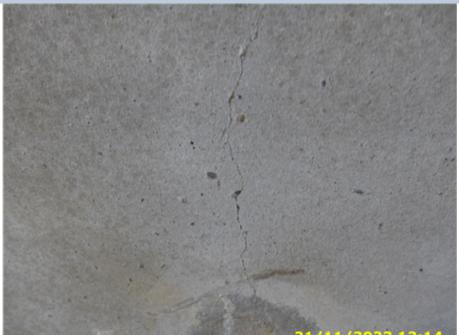
#### Photograph #170

View of shrinkage crack up to 2.8m in length

Monitor defect during next schedule inspection

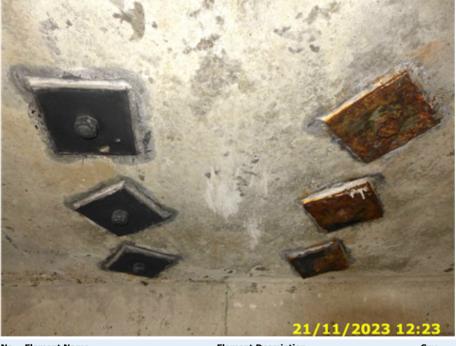
### Photograph #171

View of surface corrosion on the holding down bolts and down bolts and plates

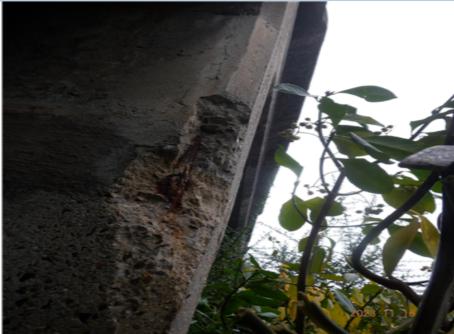
#### Photograph #172

View of 350x180x40mm spalling exposing the reinforcement on C6 east face

There were multiple areas of spalling exposing the reinforcement on C6 east face and north face, measuring 350x180x40mm, 270x110x40mm and 400x350x30mm.

Refer to element #1 for remedial works recommendation

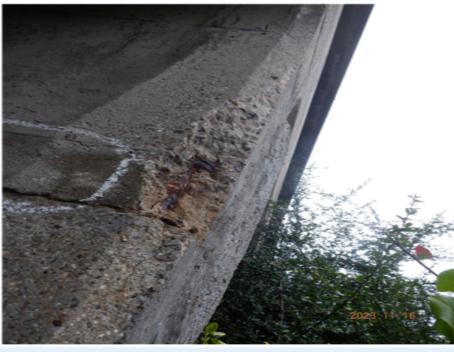
#### Photograph #173

View of 270x110x40mm spalling exposing the reinforcement on C6 north face

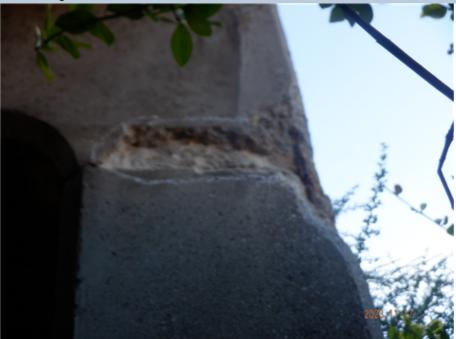
#### Photograph #174

View of 400x350x30mm spalling exposing the reinforcement on C6 east face

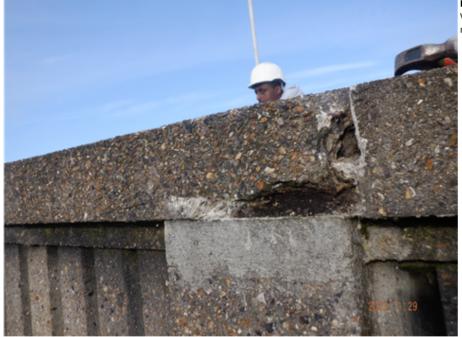
### Photograph #175

View of spalling on South parapet coping, measured 150x300x40mm at Ch.83.7m

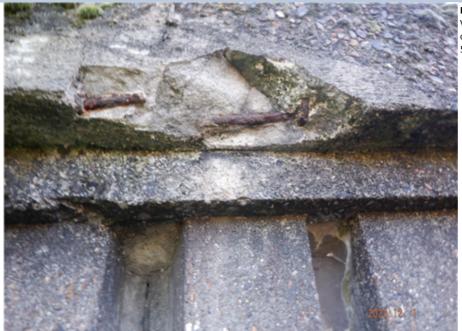
#### Photograph #176

View of spalling exposing the reinforcement on North parapet coping, measured 50x200x30mm

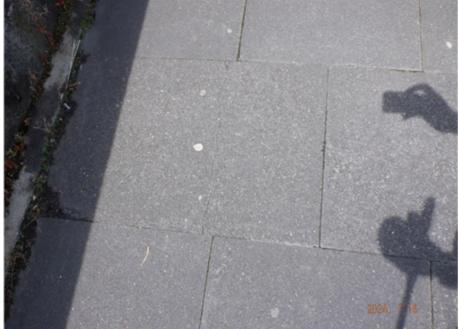
#### Photograph #178

View of cracked paving slab at Ch.87m

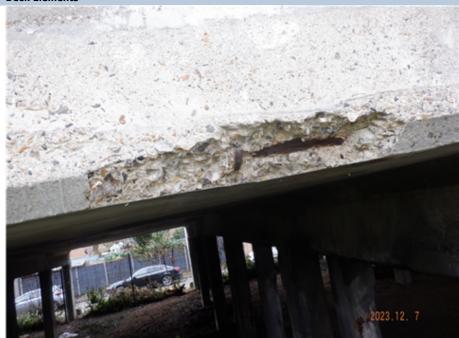
#### Photograph #179

View of 80x400x40mm spalling exposing the reinforcement on external face at North end

There were multiple areas of spalling exposing the reinforcement on external face at North and South end, measuring 80x400x40mm, 50x1000x90mm and 350x200x30mm. Also, same defects noted on the soffit, measured 350x350x40mm, 800x200x40mm, 350x800x55mm, 800x400x50mm and 730x170x35mm

The reinforcement should be clean back to bare metal before an anti-corrosion primer is applied. The areas should be patch repaired with an appropriate cementitious material, ensuring that it is sufficiently 'keyed-in' to the parent concrete.

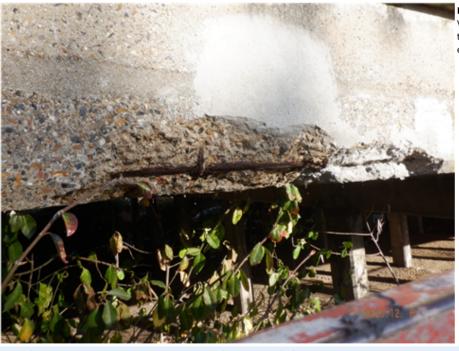
#### Photograph #180

View of 50x1000x90mm spalling exposing the reinforcement on external face at South

There were multiple areas of spalling exposing the reinforcement on external face at North and South end, measuring 80x400x40mm, 50x1000x90mm and 350x200x30mm. Also, same defects noted on the soffit, measured 350x350x40mm, 800x200x40mm, 350x800x55mm, 800x400x50mm and 730x170x35mm

The reinforcement should be clean back to bare metal before an anti-corrosion primer is applied. The areas should be patch repaired with an appropriate cementitious material, ensuring that it is sufficiently 'keyed-in' to the parent concrete.

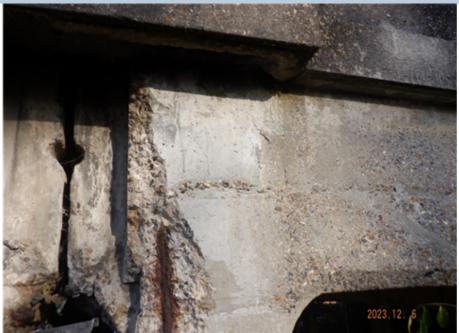
#### Photograph #181

View of 350x200x30mm spalling exposing the reinforcement on external face at South end

There were multiple areas of spalling exposing the reinforcement on external face at North and South end, measuring 80x400x40mm, 50x1000x90mm and 350x200x30mm. Also, same defects noted on the soffit, measured 350x350x40mm, 800x200x40mm, 350x800x55mm, 800x400x50mm and 730x170x35mm

The reinforcement should be clean back to bare metal before an anti-corrosion primer is applied. The areas should be patch repaired with an appropriate cementitious material, ensuring that it is sufficiently 'keyed-in' to the parent concrete.

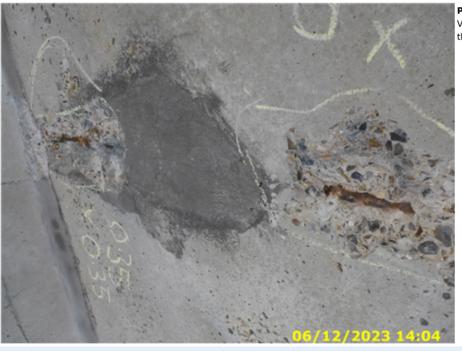
#### Photograph #182

View of 350x350x40mm spalling exposing the reinforcement on the deck soffit

There were multiple areas of spalling exposing the reinforcement on external face at North and South end, measuring 80x400x40mm, 50x1000x90mm and 350x200x30mm. Also, same defects noted on the soffit,

measured 350x350x40mm, 800x200x40mm, 350x800x55mm, 800x400x50mm and 730x170x35mm The reinforcement should be clean back to bare metal before an anti-corrosion primer is applied. The areas should be patch repaired with an appropriate cementitious material, ensuring that it is sufficiently 'keyed-in' to the parent concrete.

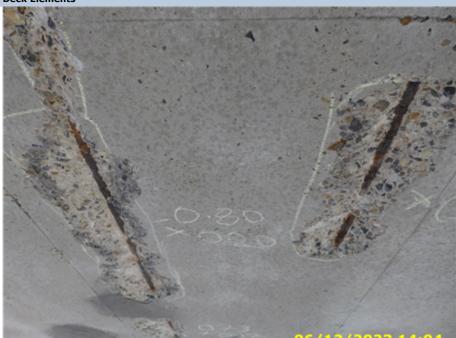
#### Photograph #183

View of 800x200x40mm spalling exposing the reinforcement on the deck soffit

There were multiple areas of spalling exposing the reinforcement on external face at North and South end, measuring 80x400x40mm, 50x1000x90mm and 350x200x30mm. Also, same defects noted on the soffit, measured 350x350x40mm, 800x200x40mm, 350x800x55mm, 800x400x50mm and 730x170x35mm

The reinforcement should be clean back to bare metal before an anti-corrosion primer is applied. The areas should be patch repaired with an appropriate cementitious material, ensuring that it is sufficiently 'keyed-in' to the parent concrete.

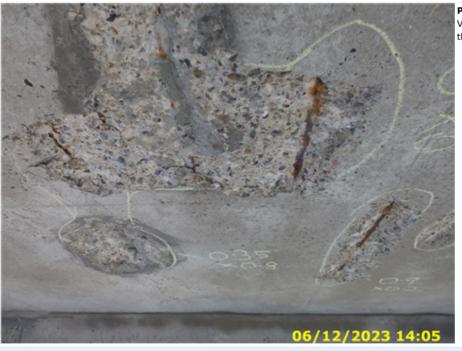
#### Photograph #184

View of 350x800x55mm spalling exposing the reinforcement on the deck soffit

There were multiple areas of spalling exposing the reinforcement on external face at North and South end, measuring 80x400x40mm, 50x1000x90mm and 350x200x30mm. Also, same defects noted on the soffit,

measured 350x350x40mm, 800x200x40mm, 350x800x55mm, 800x400x50mm and 730x170x35mm The reinforcement should be clean back to bare metal before an anti-corrosion primer is applied. The areas should be patch repaired with an appropriate cementitious material, ensuring that it is sufficiently 'keyed-in' to the parent concrete.

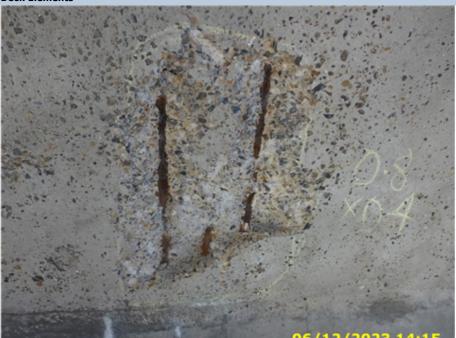
#### Photograph #185

View of 800x400x50mm spalling exposing the reinforcement on the deck soffit

There were multiple areas of spalling exposing the reinforcement on external face at North and South end, measuring 80x400x40mm, 50x1000x90mm and 350x200x30mm. Also, same defects noted on the soffit, measured 350x350x40mm, 800x200x40mm, 350x800x55mm, 800x400x50mm and 730x170x35mm

The reinforcement should be clean back to bare metal before an anti-corrosion primer is applied. The areas should be patch repaired with an appropriate cementitious material, ensuring that it is sufficiently 'keyed-in' to the parent concrete.

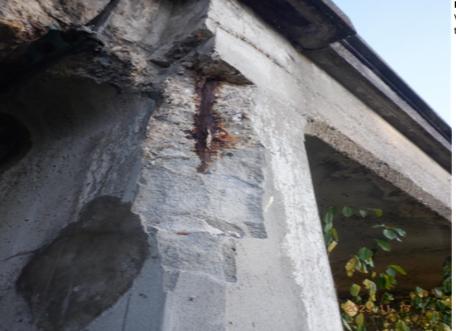
#### Photograph #186

View of 560x160x40mm spalling exposing the reinforcement on top of C1 south face

There were multiple spalling exposing the reinforcement on columns (C1-C4) throughout, measured 560x160x40mm, full height x 370x50mm, 570x190x30mm, 1430x190x30mm and 560x300x30mm.

C1-C3 Refer to element #1 for remedial works recommendation

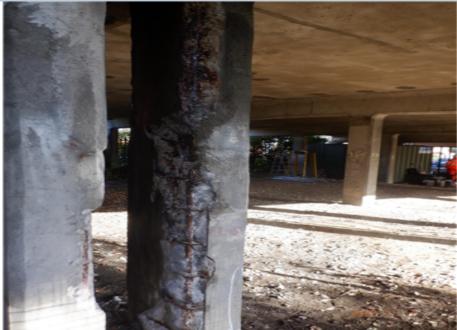
#### Photograph #187

View of full height x 370x50mm spalling exposing the reinforcement on C2 south face extending to west

There were multiple spalling exposing the reinforcement on columns (C1-C4) throughout, measured 560x160x40mm, full height x 370x50mm, 570x190x30mm, 1430x190x30mm and 560x300x30mm.

C1-C3 Refer to element #1 for remedial works recommendation

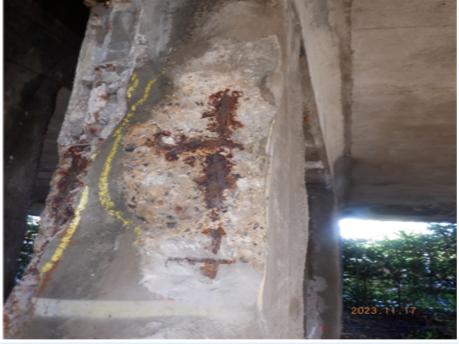
#### Photograph #188

View of 570x190x30mm spalling exposing the reinforcement on C3 south face

There were multiple spalling exposing the reinforcement on columns (C1-C4) throughout, measured 560x160x40mm, full height x 370x50mm, 570x190x30mm, 1430x190x30mm and 560x300x30mm.

C1-C3 Refer to element #1 for remedial works recommendation

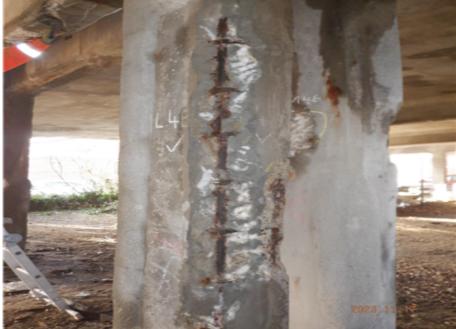
#### Photograph #189

View of 1430x190x30mm spalling exposing the reinforcement on C3 south face

There were multiple spalling exposing the reinforcement on columns (C1-C4) throughout, measured 560x160x40mm, full height x 370x50mm, 570x190x30mm, 1430x190x30mm and 560x300x30mm.

C1-C3 Refer to element #1 for remedial works recommendation

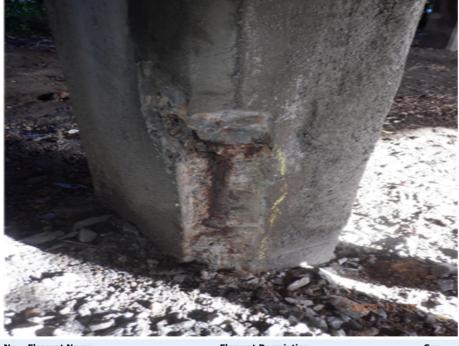
#### Photograph #190

View of 560x300x30mm spalling exposing the reinforcement on bottom of C3 south face

There were multiple spalling exposing the reinforcement on columns (C1-C4) throughout, measured 560x160x40mm, full height x 370x50mm, 570x190x30mm, 1430x190x30mm and 560x300x30mm.

C1-C3 Refer to element #1 for remedial works recommendation

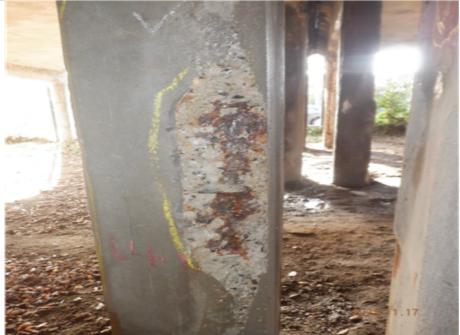
#### Photograph #191

View of 750x140x20mm spalling exposing the reinforcement on C4 north face

There were multiple spalling exposing the reinforcement on columns (C4-C6), measuring 750x140x20mm, 1650x200x40mm, 950x40x20mm, 1150x140x20mm and 1040x240x70mm.

C4-C6 Refer to element #1 for remedial works recommendation

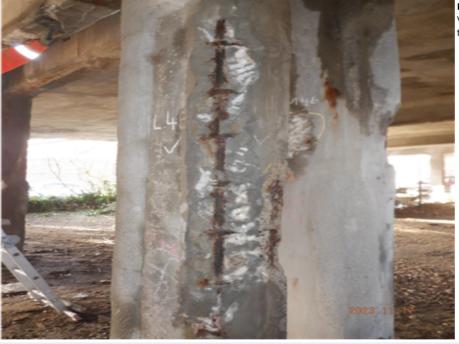
#### Photograph #192

View of 1650x200x40mm spalling exposing the reinforcement on C4 east face

There were multiple spalling exposing the reinforcement on columns (C4-C6), measuring 750x140x20mm, 1650x200x40mm, 950x40x20mm, 1150x140x20mm and 1040x240x70mm.

C4-C6
 Refer to element #1 for remedial works recommendation

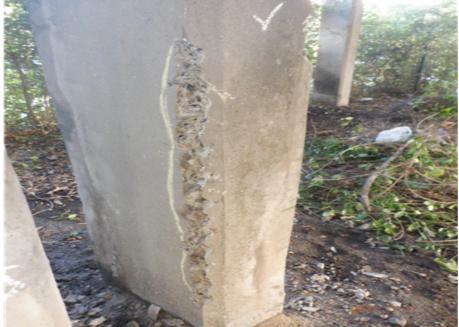
#### Photograph #193

View of 950x40x20mm spalling on C5 west

There were multiple spalling exposing the reinforcement on columns (C4-C6), measuring 750x140x20mm, 1650x200x40mm, 950x40x20mm, 1150x140x20mm and 1040x240x70mm.

Refer to element #1 for remedial works recommendation

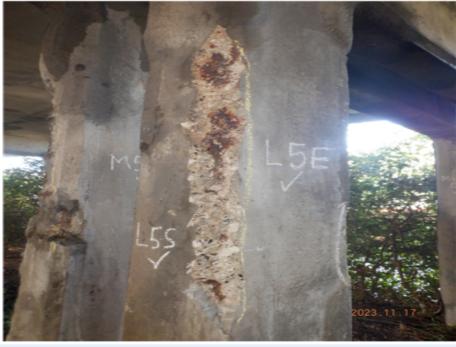
#### Photograph #194

View of 1150x140x20mm spalling exposing the reinforcement on C5 south face

There were multiple spalling exposing the reinforcement on columns (C4-C6), measuring 750x140x20mm,

Refer to element #1 for remedial works recommendation

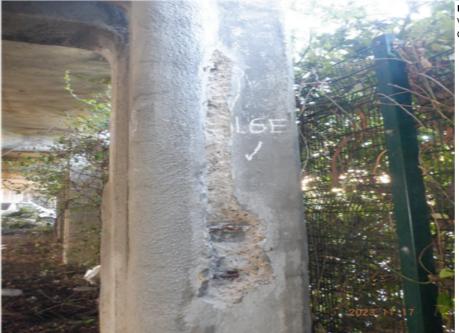
#### Photograph #195

View of 1040x240x70mm deep spalling on C6 east face

There were multiple spalling exposing the reinforcement on columns (C4-C6), measuring 750x140x20mm, 1650x200x40mm, 950x40x20mm, 1150x140x20mm and 1040x240x70mm.

C4-C6 Refer to element #1 for remedial works recommendation

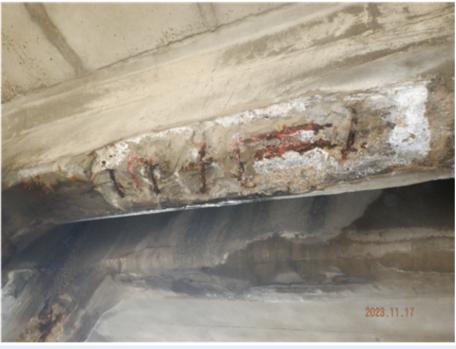
#### Photograph #196

View of 1100x310x40mm spalling exposing the reinforcement on the cross head underside between C2 and C3

There were isolated areas of spalling exposing the reinforcement on the cross head underside between C2-C4, measured 1100x310x40mm, 450x190x40mm and 1050x310x50mm.

Refer to element #1 for remedial works recommendation

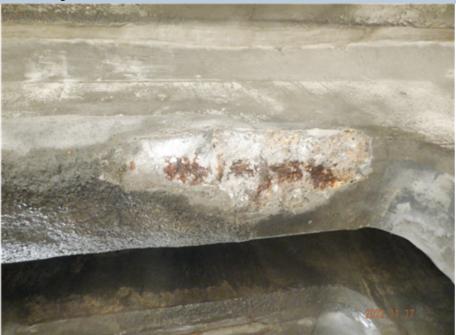
#### Photograph #197

View of 450x190x40mm spalling exposing the reinforcement on the cross head underside between C2 and C3

There were isolated areas of spalling exposing the reinforcement on the cross head underside between C2-C4, measured 1100x310x40mm, 450x190x40mm and 1050x310x50mm.

Refer to element #1 for remedial works recommendation

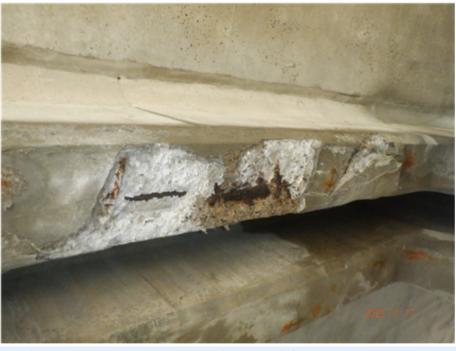
### Photograph #198

View of 1050x310x50mm spalling exposing the reinforcement on the cross head underside between C3 and C4

There were isolated areas of spalling exposing the reinforcement on the cross head underside between C2-C4, measured 1100x310x40mm, 450x190x40mm and 1050x310x50mm.

Refer to element #1 for remedial works recommendation

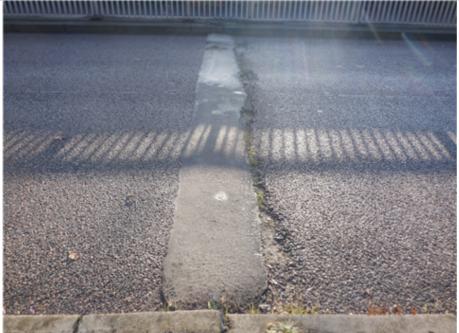
#### Photograph #199

View of moderate loss of road surface adjacent to joint on Westbound

Break out the area of defective carriageway surfacing and repair with a suitable mastic asphalt patch repair

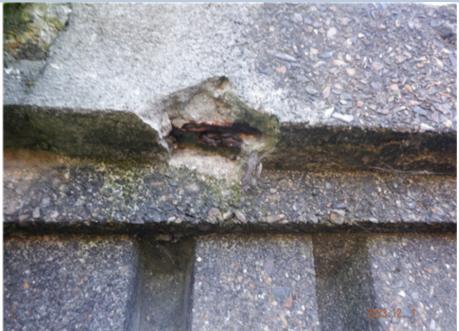
#### Photograph #201

View of isolated spalling exposing the reinforcement on North parapet coping, measured 15x100x10mm

There was an isolated area of spalling exposing the reinforcement on North parapet coping, measuring 15x100x10mm.

Undertake patch repairs with an appropriate cementitious material, ensuring that it is sufficiently 'keyed-in' to the parent concrete.

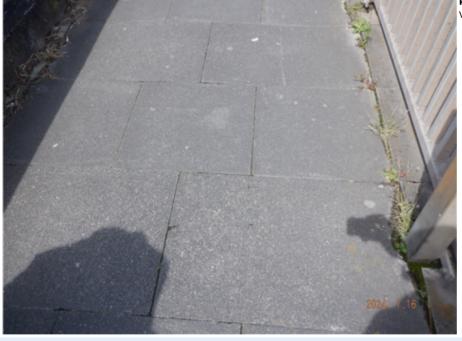
# Photograph #202

View of cracked paving slab at Ch.94m

There was cracked paving slabs on the Southern footway surfacing at Ch.94m

Monitor defect during next schedule inspection

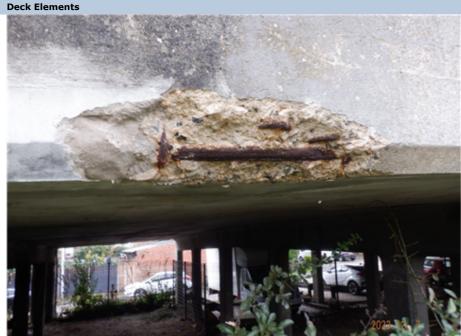
#### Photograph #203

View of 100x450x50mm spalling exposing the reinforcement on external face at North end

There was an area of spalling exposing the reinforcement on external face at North and South end, measuring 100x450x50mm and 160x1360x50mm. Also, same defect noted along the edge of deck soffit at South, measured 350x300x35mm and 700x300x35mm.

The reinforcement should be clean back to bare metal before an anti-corrosion primer is applied. The areas should be patch repaired with an appropriate cementitious material, ensuring that it is sufficiently 'keyed-in' to the parent concrete.

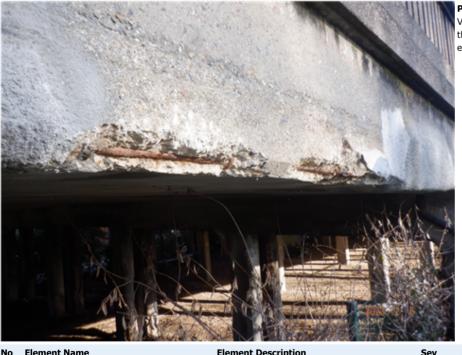
#### Photograph #204

View of 160x1360x50mm spalling exposing the reinforcement on external face at South end

There was an area of spalling exposing the reinforcement on external face at North and South end, measuring 100x450x50mm and 160x1360x50mm. Also, same defect noted along the edge of deck soffit at South, measured 350x300x35mm and 700x300x35mm.

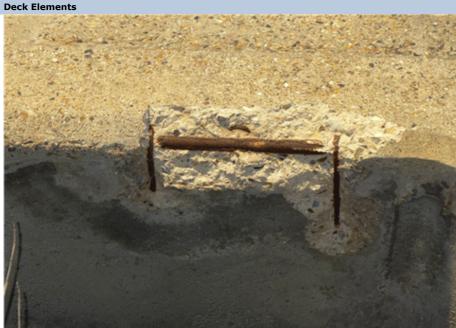
#### Photograph #205

View of 350x300x35mm spalling exposing the reinforcement on the edge of deck soffit at South

The reinforcement should be clean back to bare metal before an anti-corrosion primer is applied. The areas should be patch repaired with an appropriate cementitious material, ensuring that it is sufficiently 'keyed-in' to the parent concrete.

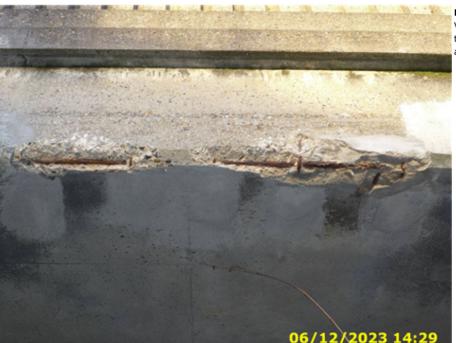
#### Photograph #206

View of 700x300x35mm spalling exposing the reinforcement on the edge of deck soffit at South

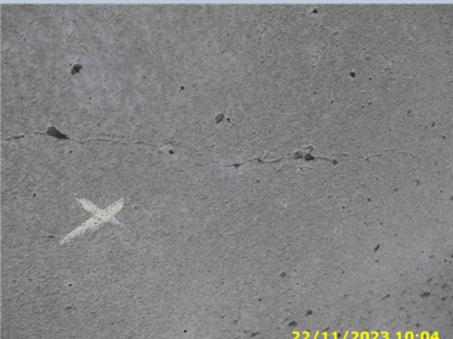
#### Photograph #207

View of shrinkage crack up to 3.5m on the deck soffit

Minor shrinkage crack up to 3.5 m in length noted on the deck soffit.

Monitor defect during next schedule inspection

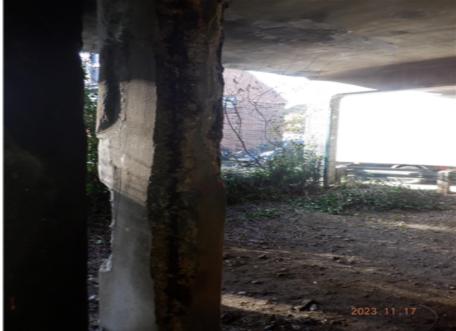
#### Photograph #209

View of full height x200x40mm spalling exposing the reinforcement on C2 north face

There were multiple spalling exposing the reinforcement on columns (C2-C3) throughout, measured 1400x200x40mm, full height x200x40mm, 700x200x55mm, 1250x250x40mm and 570x190x40mm.

C1-C3 Refer to element #1 for remedial works recommendation

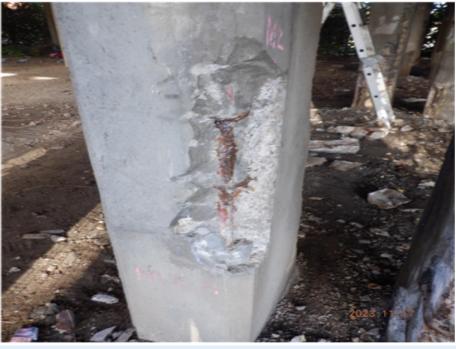
#### Photograph #210

View of 700x200x55mm spalling exposing the reinforcement on C2 east face

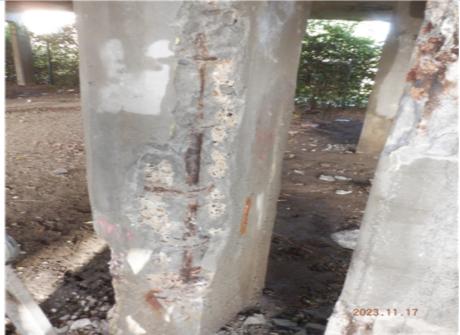
#### Photograph #211

View of 1250x250x40mm spalling exposing the reinforcement on C3 south face

There were multiple spalling exposing the reinforcement on columns (C2-C3) throughout, measured 1400x200x40mm, full height x200x40mm, 700x200x55mm, 1250x250x40mm and 570x190x40mm.

C1-C3 Refer to element #1 for remedial works recommendation

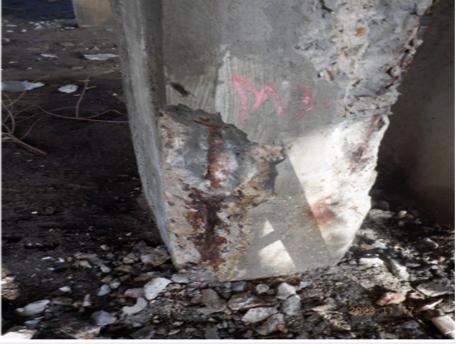
## Photograph #212

View of 570x190x40mm spalling exposing the reinforcement at bottom of C3 south face

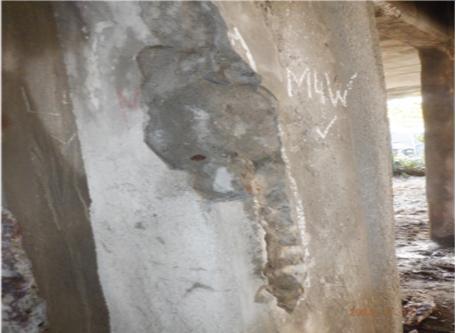
#### Photograph #213

View of 730x180x30mm spalling on C4 west

There were multiple areas of spalling exposing the reinforcement on columns (C4-C5) throughout, measuring 730x180x30mm, 700x200x50mm, 1500x310x50mm and 1600x210x40mm.

Refer to element #1 for remedial works recommendation

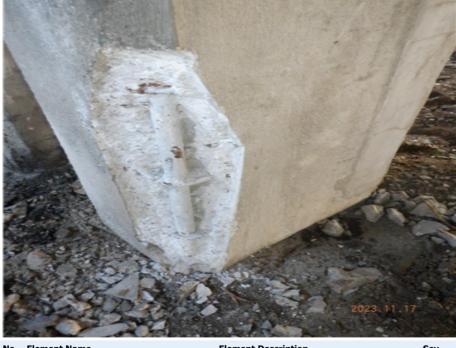
#### Photograph #214

View of 700x200x50mm spalling exposing the reinforcement on C5 north face

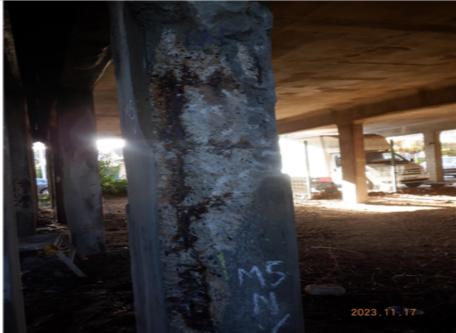
#### Photograph #215

View of 1500x310x50mm spalling exposing the reinforcement on C5 north face

There were multiple areas of spalling exposing the reinforcement on columns (C4-C5) throughout, measuring 730x180x30mm, 700x200x50mm, 1500x310x50mm and 1600x210x40mm.

Refer to element #1 for remedial works recommendation

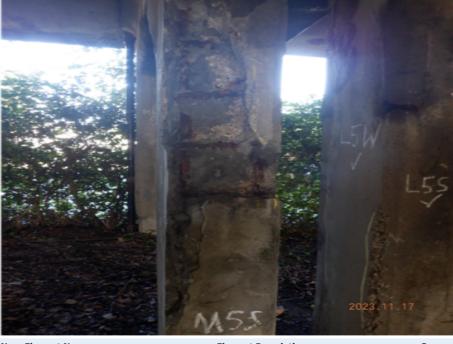
#### Photograph #216

View of 1600x210x40mm spalling exposing the reinforcement on C5 south face

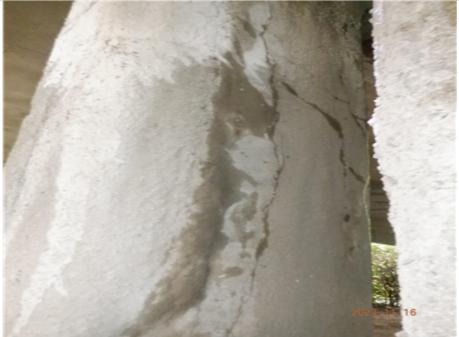
## Photograph #217

View of 1200x1mm vertical crack on C2

Monitor defect during next schedule inspection

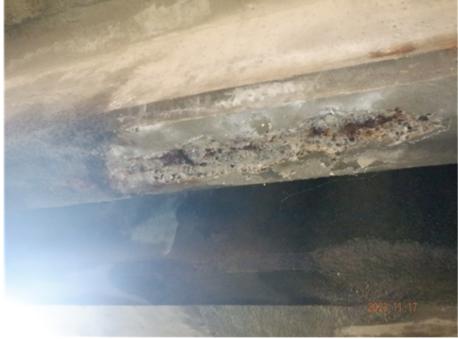
#### Photograph #218

View of 700x100x50mm spalling exposing the reinforcement on the cross head underside between C5 and C6

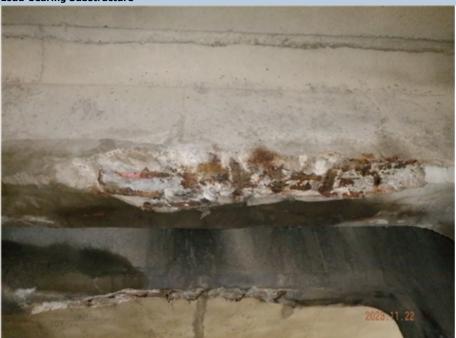
#### Photograph #219

View of 1100x170x50mm spalling exposing the reinforcement on the cross head underside between C2 and C3

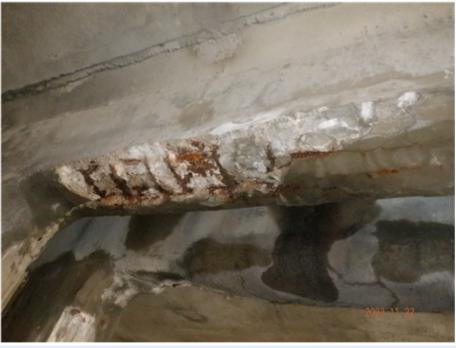
#### Photograph #220

There were multiple areas of spalling exposing the reinforcement on the cross head underside between C2 to C6, measuring 700x100x50mm, 1100x170x50mm, 1200x260x50mm and 1000x300x50mm

View of 1200x260x50mm spalling exposing the reinforcement on the cross head underside between C2 and C3

Refer to element #1 for remedial works recommendation

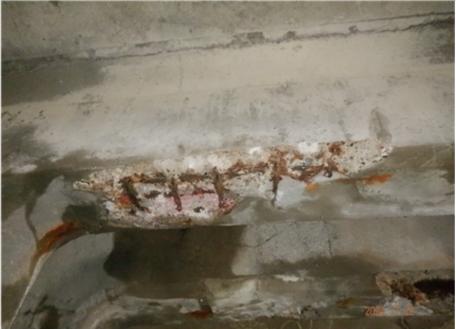
### Photograph #221

View of 1000x300x50mm spalling exposing the reinforcement on the cross head underside between C3 and C4

There were multiple areas of spalling exposing the reinforcement on the cross head underside between C2 to C6, measuring 700x100x50mm, 1100x170x50mm, 1200x260x50mm and 1000x300x50mm

Refer to element #1 for remedial works recommendation

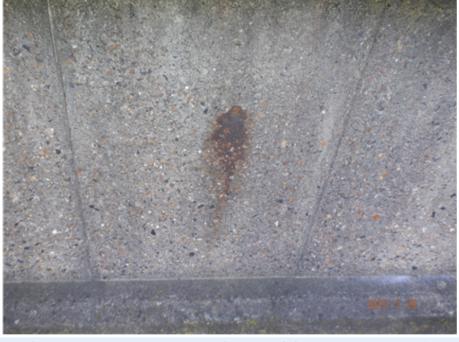
Photograph #222 View of iron pyrite staining on RC parapet wall

There was minor iron pyrite staining on RC parapet wall.

Monitor defect during next schedule inspection

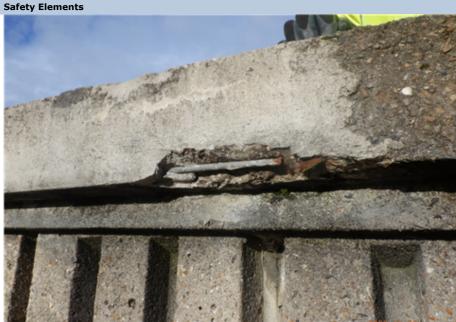
### Photograph #223

View of spalling exposing the reinforcement on South parapet coping, measured 50x190x30mm

There was an isolated area of spalling exposing the reinforcement on South parapet coping and North external face, measuring 50x190x30mm and 50x300x25mm.

Refer to element #1 for remedial works recommendation

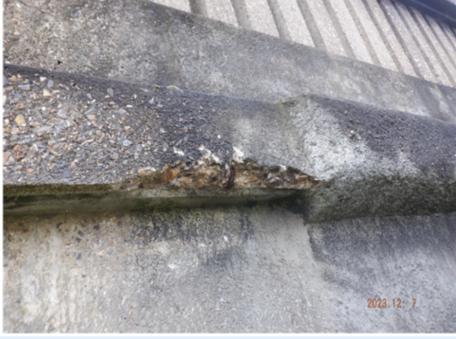
## Photograph #224

View of spalling exposing the reinforcement on external face at North parapet, measured 50x300x25mm

There was an isolated area of spalling exposing the reinforcement on South parapet coping and North external face, measuring 50x190x30mm and 50x300x25mm.

Refer to element #1 for remedial works recommendation

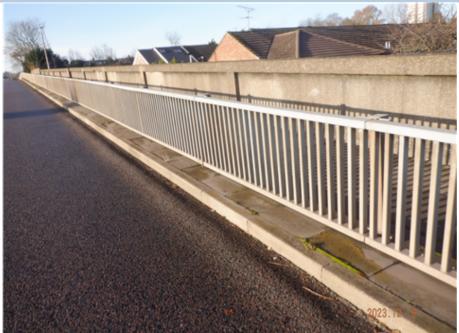
## Photograph #225

General view of North steel parapet between span #11 to span #15

Overall, both South and North steel parapets appears in good condition. No visible defects noted

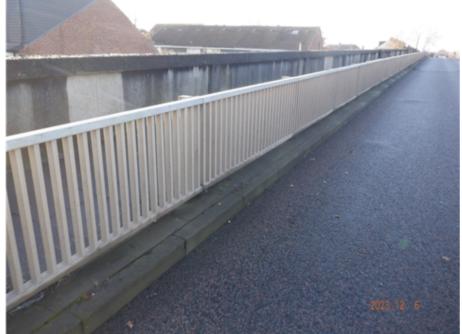
## Photograph #226

There was minor moss growth and dirty staining on the RC parapet coping and wall. Refer to span #11 photograph #226

There was minor moss growth and dirty staining on the Northern RC parapet coping and wall. Refer to span #11 photograph #226

General view of South steel parapet between span #11 to span #15

Overall, both South and North steel parapets appears in good condition. No visible defects noted

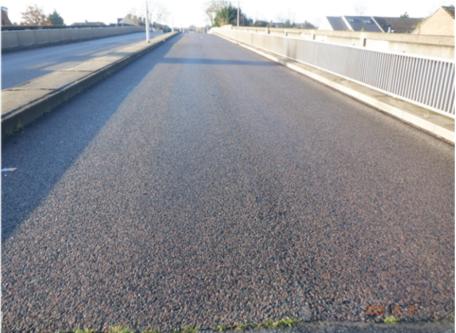
## Photograph #227

General view of Eastbound carriageway surfacing between span #11 to span #15

Overall, both Eastbound and Westbound carriageway surfacing appears in good condition. No visible defects noted

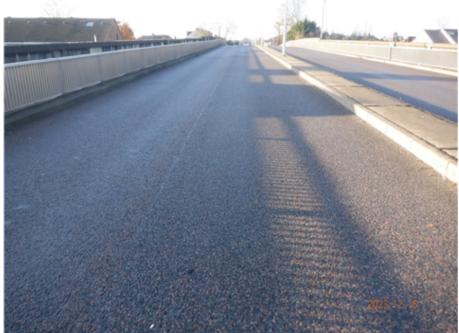
## Photograph #228

General view of Westbound carriageway surfacing between span #11 to span #15

Overall, both Eastbound and Westbound carriageway surfacing appears in good condition. No visible defects noted
