# **Principal Inspection Report**

Structure Name: Broadmead Road Viaduct

**Identifier:** B4

**Inspection Date:** 14/11/2023

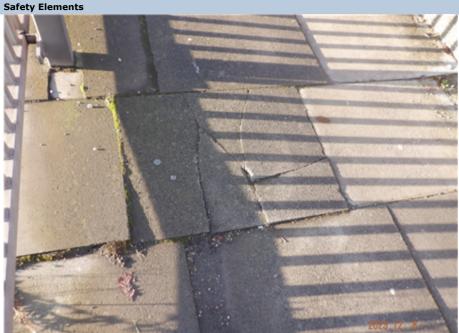
## Photograph #229

View of cracked paving slab on North footway

There were uneven paving slabs slabs which over time will lead to trip hazards on the North footway.

Re-bed the uneven paving slabs on North footway.

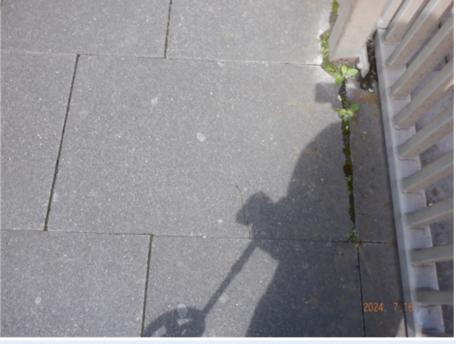
## Photograph #230

View of cracked paving slab at Ch.103m

CommentRemedial WorksThere was cracked paving slabs on the Southern footway[none]

Monitor defect during next schedule inspection

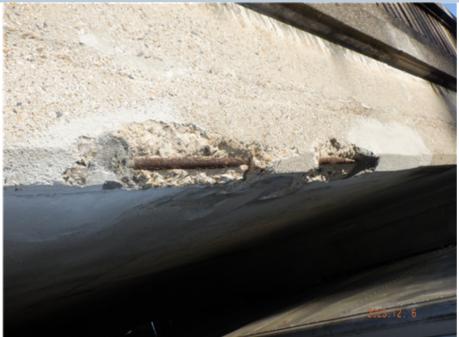
### Photograph #231

View of 130x1000x50mm spalling exposing the reinforcement on external face at South

There was an isolated area of spalling exposing the reinforcement on external face at South, measured 130x1000x50mm.

The reinforcement should be clean back to bare metal before an anti-corrosion primer is applied. The areas should be patch repaired with an appropriate cementitious material, ensuring that it is sufficiently 'keyed-in' to the parent concrete.

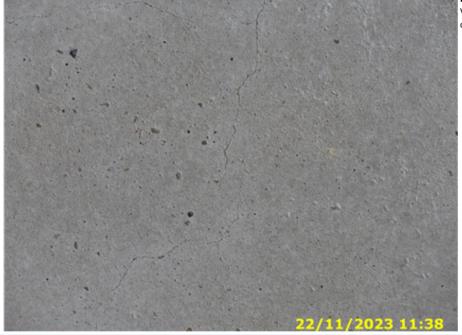
## Photograph #232

View of minor shrinkage crack up to 0.9m on the deck soffit

Minor shrinkage crack up to 0.9m in length noted on the deck soffit.

Monitor defect during next schedule inspection

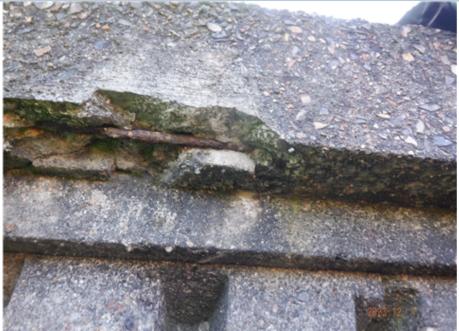
### Photograph #233

View of isolated area of spalling exposing the reinforcement on North parapet coping, measured 40x200x20mm

Multiple areas of spalling exposing the reinforcement on North parapet coping and external face, measured 40x200x20mm, 140x400x45mm and 160x100x20mm.

Refer to element #1 for remedial works recommendation

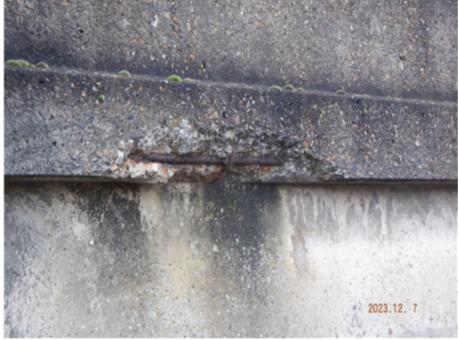
## Photograph #234

View of spalling exposing the reinforcement on external face at North parapet, measured 140x400x45mm

Multiple areas of spalling exposing the reinforcement on North parapet coping and external face, measured 40x200x20mm, 140x400x45mm and 160x100x20mm.

Refer to element #1 for remedial works recommendation

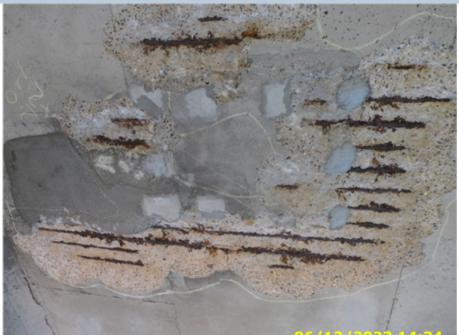
### Photograph #235

View of 2200x2000x55mm spalling exposing the reinforcement on the deck soffit around mid-span

There were multiple spalling areas on the deck soffit and along the edge at South end, measuring 2200x2000x55mm, 300x300x35mm and 450x350x35mm.

The reinforcement should be clean back to bare metal before an anti-corrosion primer is applied. The areas should be patch repaired with an appropriate cementitious material, ensuring that it is sufficiently 'keyed-in' to the parent concrete.

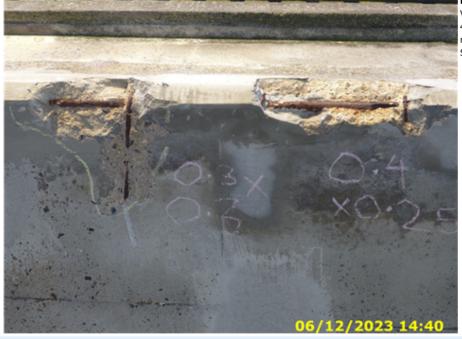
# Photograph #236

View of 300x300x35mm and 450x350x35mm spalling exposing the reinforcement on the edge of deck soffit at South end

There were multiple spalling areas on the deck soffit and along the edge at South end, measuring 2200x2000x55mm, 300x300x35mm and 450x350x35mm.

The reinforcement should be clean back to bare metal before an anti-corrosion primer is applied. The areas should be patch repaired with an appropriate cementitious material, ensuring that it is sufficiently 'keyed-in' to the parent concrete.

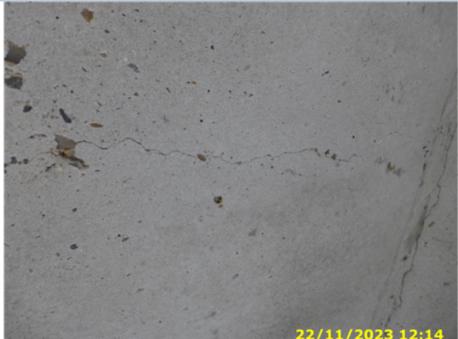
## Photograph #237

Minor shrinkage crack up to 1.95m in length on the deck soffit

Minor shrinkage crack up to 1.95m in length noted on the deck soffit.

Monitor defect during next schedule inspection

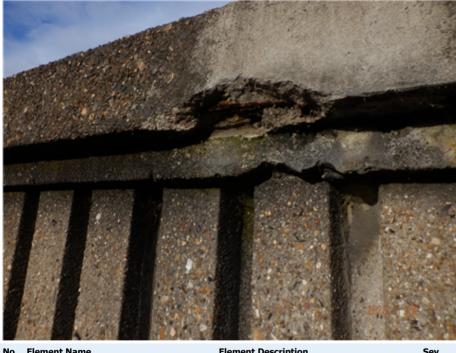
## Photograph #238

View of spalling exposing the reinforcement on South parapet coping, measured 40x170x40mm

Multiple spalling exposing the reinforcement on on both parapet coping and external face of North parapet, measured 40x170x40mm, 50x350x50mm and 100x100x20mm. Also, spalling on South parapet at Ch.104m, measured 50x150x20mm noted.

For remedial works recommendation refer to element #1

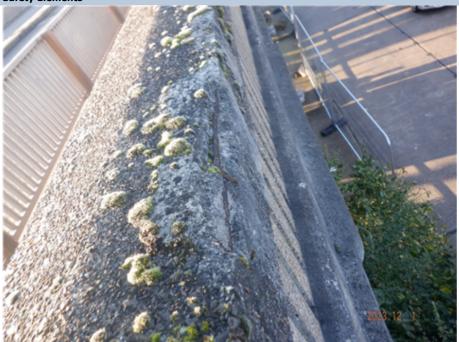
## Photograph #239

View of failed repair exposing the reinforcement on North parapet coping, measured 50x350x50mm

Multiple spalling exposing the reinforcement on on both parapet coping and external face of North parapet, measured 40x170x40mm, 50x350x50mm and 100x100x20mm. Also, spalling on South parapet at Ch.104m, measured 50x150x20mm noted

# For remedial works recommendation refer to element #1

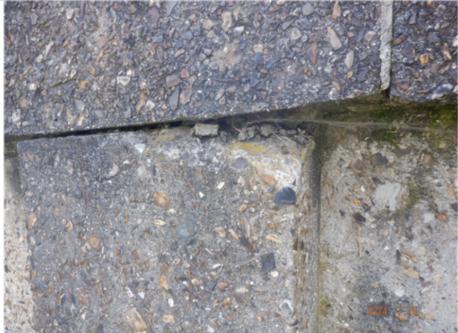
## Photograph #241

View of spalling on South parapet at Ch.104m, measured 50x150x20mm

Multiple spalling exposing the reinforcement on on both parapet coping and external face of North parapet, measured 40x170x40mm, 50x350x50mm and 100x100x20mm. Also, spalling on South parapet at Ch.104m, measured 50x150x20mm noted.

For remedial works recommendation refer to element #1

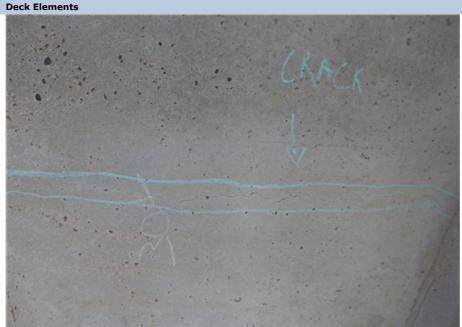
## Photograph #242

Minor of 1mm shrinkage crack up to 1.2m in length on the deck soffit

Minor shrinkage crack up to 1.2m in length noted on the deck soffit.

Minor areas of spalling also noted

Monitor defect during next schedule inspection

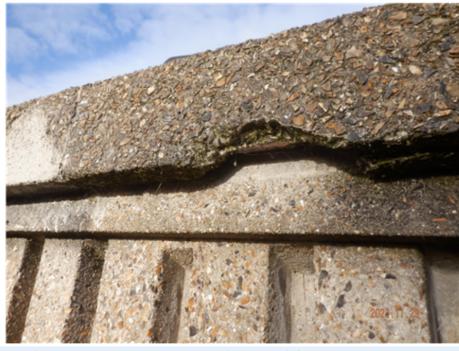
## Photograph #243

View of spalling exposing the reinforcement on South parapet coping, measured 50x190x50mm

There were multiple spalling exposing the reinforcement on both parapet coping and external face of North and South parapet, measured 50x190x50mm, 70x700x70mm, 200x500x20mm, 100x100x20mm and

an anti-corrosion primer is applied. The areas should be patch repaired with an appropriate cementitious material, ensuring that it is sufficiently 'keyed-in' to the parent concrete.

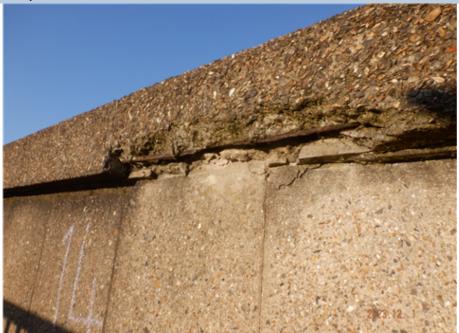
#### Photograph #244

View of spalling exposing the reinforcement on North parapet coping, measured 70x700x70mm at Ch.113m

There were multiple spalling exposing the reinforcement on both parapet coping and external face of North and South parapet, measured 50x190x50mm, 70x700x70mm, 200x500x20mm, 100x100x20mm and 110x90x20mm.

The reinforcement should be clean back to bare metal before an anti-corrosion primer is applied. The areas should be patch repaired with an appropriate cementitious material, ensuring that it is sufficiently 'keyed-in' to the parent concrete.

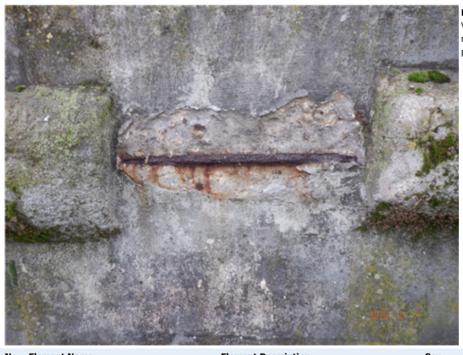
## Photograph #245

View of spalling spalling exposing the reinforcement on external face of North parapet, measured 200x500x20mm

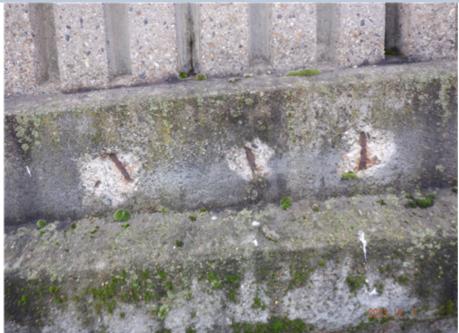
### Photograph #246

View of multiple spalling spalling exposing the reinforcement on external face of North parapet, measured 100x100x20mm

The reinforcement should be clean back to bare metal before an anti-corrosion primer is applied. The areas should be patch repaired with an appropriate cementitious material, ensuring that it is sufficiently 'keyed-in' to the parent concrete.

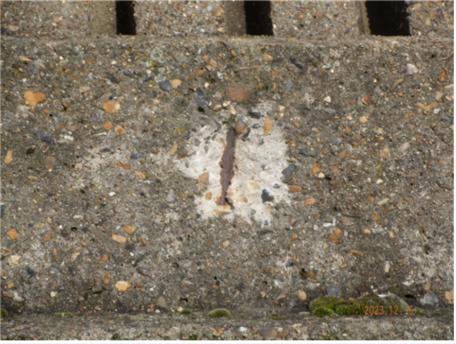
## Photograph #247

View of 110x90x20mm spalling exposing the reinforcement on external face at South

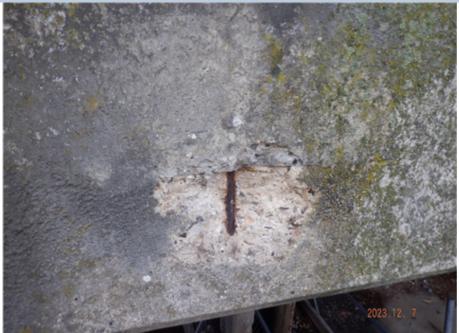
## Photograph #248

View of spalling spalling exposing the reinforcement on external face at North, measured 150x200x25mm

The reinforcement should be clean back to bare metal before an anti-corrosion primer is applied. The areas should be patch repaired with an appropriate cementitious material, ensuring that it is sufficiently 'keyed-in' to the parent concrete.

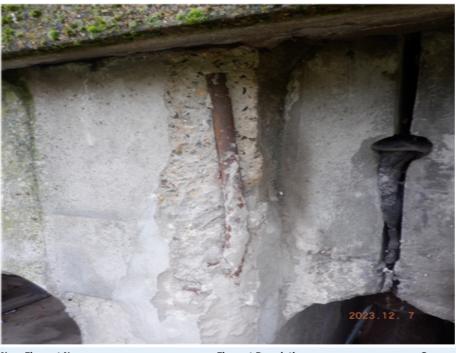
## Photograph #249

View of spalling spalling exposing the reinforcement on external face at North, measured 800x150x50mm

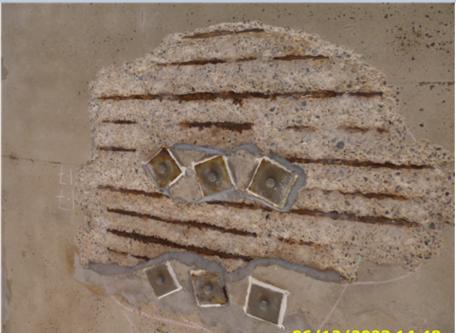
### Photograph #250

View of 1700x1700x40mm spalling exposing the reinforcement on the deck soffit

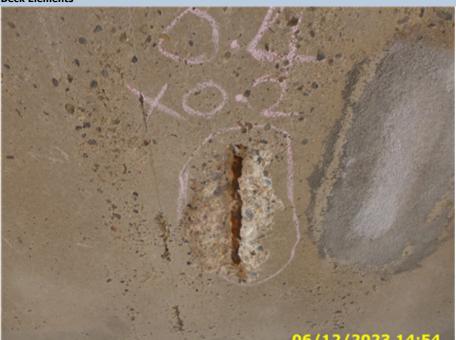
### Photograph #252

View of 400x200x15mm spalling exposing the reinforcement on the deck soffit

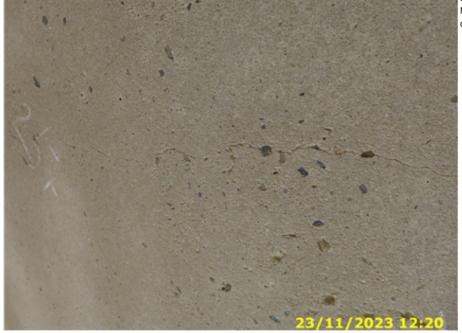
## Photograph #253

Minor shrinkage crack up to 2.6m in length on the deck soffit.

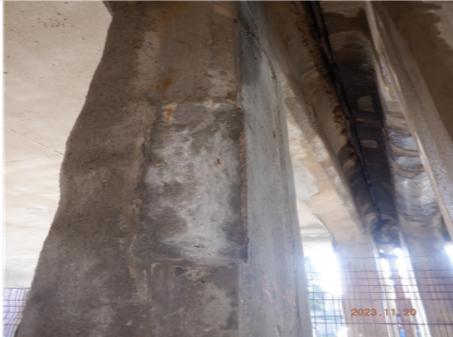
## Photograph #254 View of 470x150x30mm spalling on C3

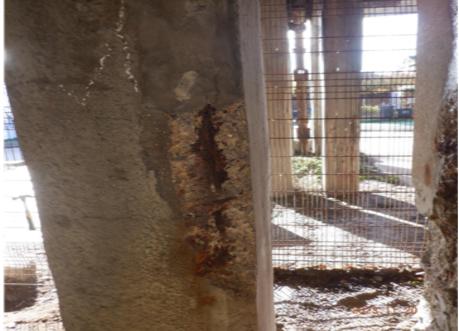
## Photograph #255

View of 880x200x40mm spalling exposing the reinforcement on C3 north face

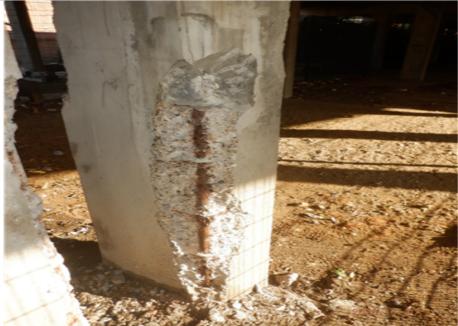
## Photograph #256

View of 1200x200x40mm spalling exposing the reinforcement on C3 south face extending to west

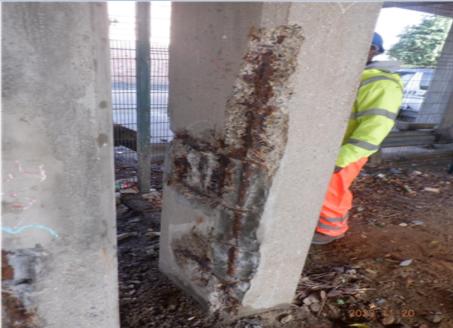
### Photograph #257

View of 1470x530x35mm spalling exposing the reinforcement on C4 south face extending to west

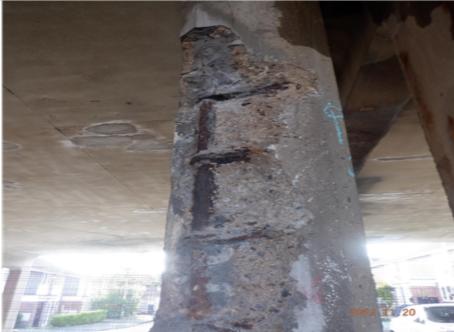
### Photograph #258

View of 1000x250x50mm spalling exposing the reinforcement on C4 north face

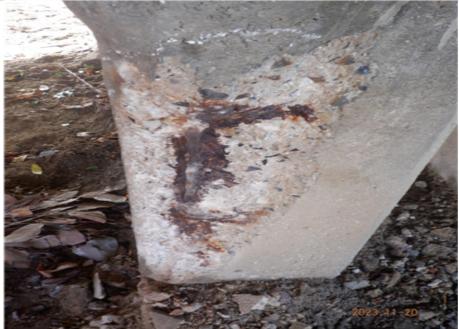
## Photograph #259

Seepage staining on cross heads and columns at East of span. Refer to photograph #259

View of 550x180x30mm spalling exposing the reinforcement on C4 south face

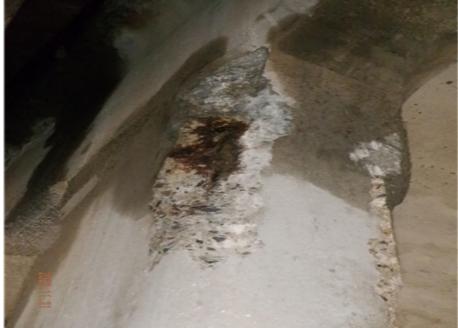
## Photograph #260

View of 650x100x30mm spalling exposing the reinforcement on C4 south face at top

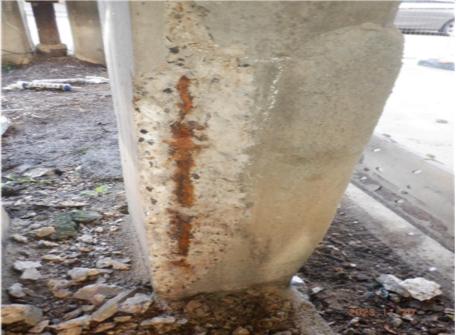
### Photograph #261

View of 850x180x40mm spalling exposing the reinforcement on C5 south face

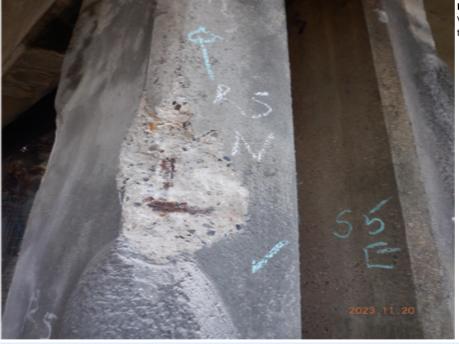
## Photograph #262

There were multiple areas of spalling exposing the reinforcement on column (C5) throughout, measuring 850x180x40mm, 400x190x40mm, 600x120x40mm and 1000x330x40mm.

View of 400x190x40mm spalling exposing the reinforcement on C5 north face

Refer to element #1 for remedial works recommendation

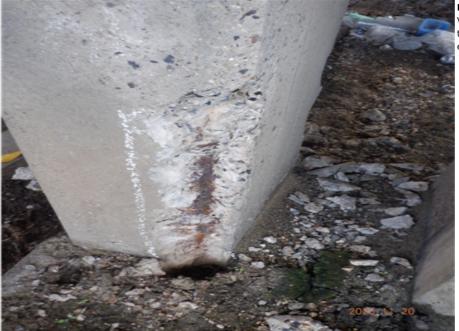
### Photograph #263

View of 600x120x40mm spalling exposing the reinforcement on C5 north face extending to west

There were multiple areas of spalling exposing the reinforcement on column (C5) throughout, measuring 850x180x40mm, 400x190x40mm, 600x120x40mm and 1000x330x40mm.

C5-C6 Refer to element #1 for remedial works recommendation

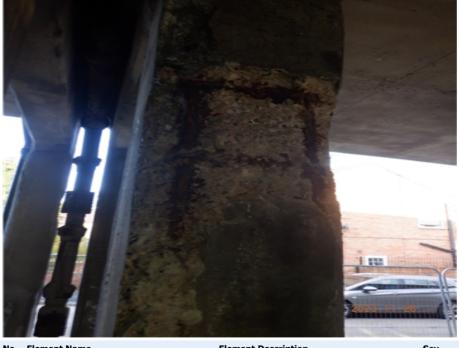
## Photograph #264

View of 1000x330x40mm spalling exposing the reinforcement on C5 south face extending to west

There were multiple areas of spalling exposing the reinforcement on column (C5) throughout, measuring 850x180x40mm, 400x190x40mm, 600x120x40mm and 1000x330x40mm.

C5-C6 Refer to element #1 for remedial works recommendation

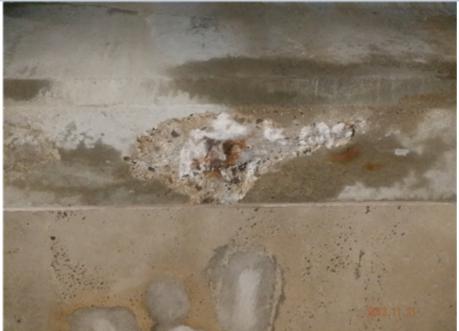
### Photograph #265

View of 400x270x40mm isolated area of spalling exposing the reinforcement on the cross head underside between C3 and C4

There was an isolated area of spalling exposing the reinforcement on the cross head underside between C3 and C4.

Refer to element #1 for remedial works recommendation

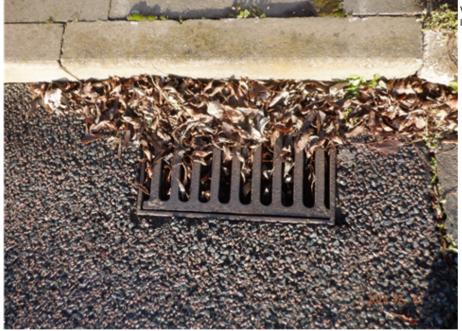
## Photograph #266

View of fully blocked with debris and fallen leaves on the Eastbound carriageway gully

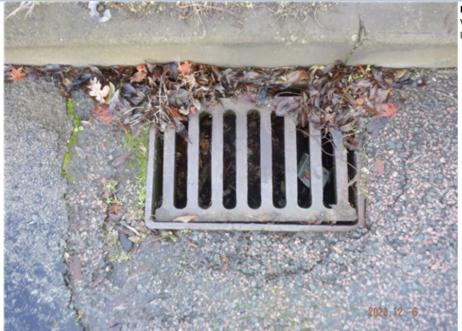
### Photograph #267

View of fully blocked with debris and fallen leaves on the Westbound carriageway gully

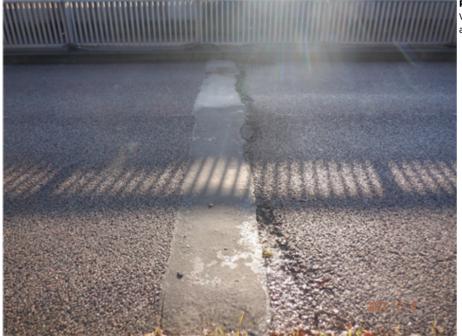
## Photograph #268

View of moderate loss of road surface adjacent to joint on Westbound

Break out the area of defective carriageway surfacing and repair with a suitable mastic asphalt patch repair on both expansion joint at North and South

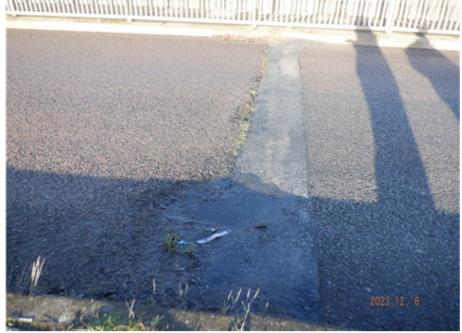
View of tracking and flow of binder of Eastbound carriageway joint

Longstanding tracking and flow of binder noted on Eastbound carriageway joint leading to extensive leakage onto the elements below

Replace the existing expansion joint on Eastbound carriageway

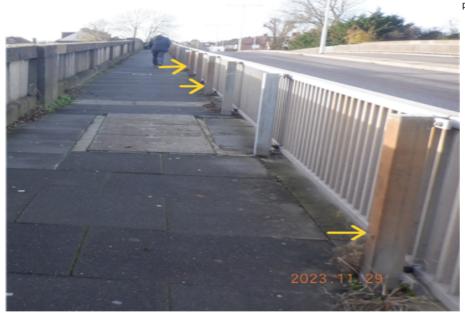
## Photograph #270

View of surface corrosion on South parapet

There was minor surface corrosion on the steel parapet post.

Monitor defect during next schedule inspection

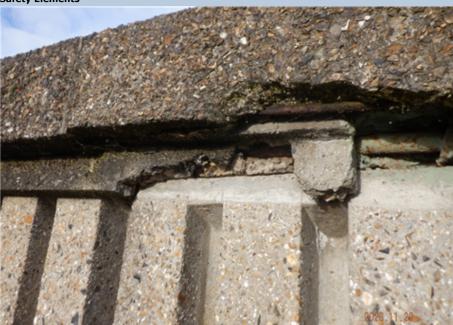
### Photograph #271

View of spalling exposing the reinforcement on South parapet coping, measured 40x280x50mm

There were areas of spalling exposing the reinforcement on both parapet copings, measuring 40x280x50mm, 90x40x20mm at Ch.122m on South and 90x300x40mmon North.

Refer to element #1 for remedial works recommendation

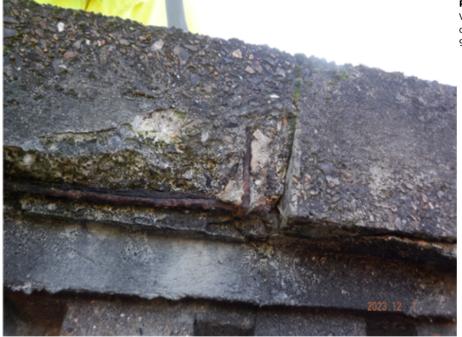
## Photograph #272

View of spalling exposing the reinforcement on North parapet coping, measured 90x300x40mm

There were areas of spalling exposing the reinforcement on both parapet copings, measuring 40x280x50mm, 90x40x20mm at Ch.122m on South and 90x300x40mm on North.

Refer to element #1 for remedial works recommendation

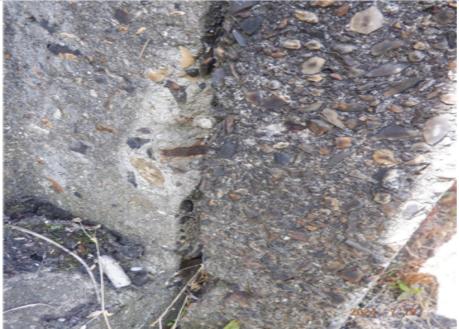
## Photograph #273

View of spalling exposing the reinforcement on South parapet, measured 90x40x20mm at Ch.122m

There were areas of spalling exposing the reinforcement on both parapet copings, measuring 40x280x50mm, 90x40x20mm at Ch.122m on South and 90x300x40mm on North.

Refer to element #1 for remedial works recommendation

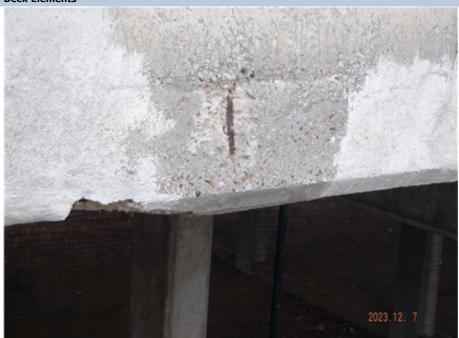
#### Photograph #274

View of spalling exposing the reinforcement on external face at North end, measured 150x140x15mm

There were areas of spalling exposing the reinforcement on the deck soffit and external face at North, measuring 50x300x50mm, 150x140x15mm and 400x600x30mm.

The reinforcement should be clean back to bare metal before an anti-corrosion primer is applied. The areas should be patch repaired with an appropriate cementitious material, ensuring that it is sufficiently 'keyed-in' to the parent concrete.

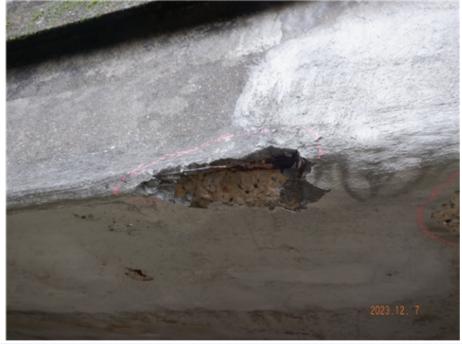
## Photograph #275

View of spalling exposing the reinforcement on the deck soffit at North, measured 50x300x50mm

There were areas of spalling exposing the reinforcement on the deck soffit and external face at North, measuring 50x300x50mm, 150x140x15mm and 400x600x30mm.

The reinforcement should be clean back to bare metal before an anti-corrosion primer is applied. The areas should be patch repaired with an appropriate cementitious material, ensuring that it is sufficiently 'keyed-in' to the parent concrete.

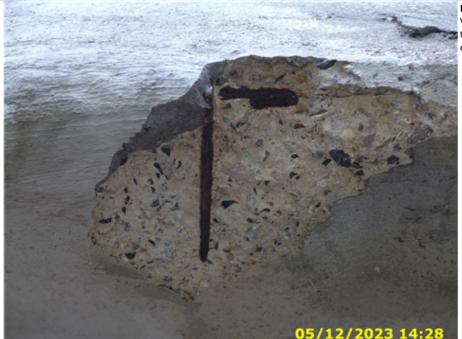
### Photograph #276

View of 400x600x30mm spalling exposing the reinforcement on the deck soffit at North

There were areas of spalling exposing the reinforcement on the deck soffit and external face at North, measuring 50x300x50mm, 150x140x15mm and 400x600x30mm.

The reinforcement should be clean back to bare metal before an anti-corrosion primer is applied. The areas should be patch repaired with an appropriate cementitious material, ensuring that it is sufficiently 'keyed-in' to the parent concrete.

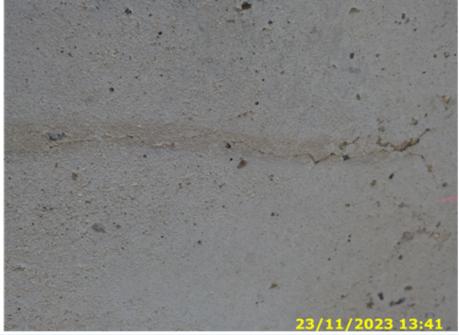
## Photograph #277

Minor shrinkage crack up to 1.3m in length noted on the deck soffit.

Monitor defect during next schedule inspection

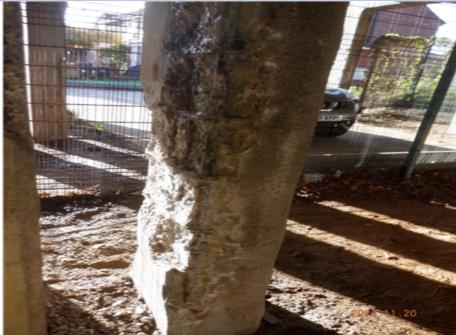
## Photograph #278

View of 1880x530x50mm spalling exposing the reinforcement on C2 north face extending to east

There were multiple areas of spalling exposing the reinforcement on column (C2-6) throughout, measuring 880x530x50mm, 740x180x50mm, 1700x200x40mm, 1340x170x50mm, 1000x170x40mm and 1000x160x30mm.

Refer to element #1 for remedial works recommendation

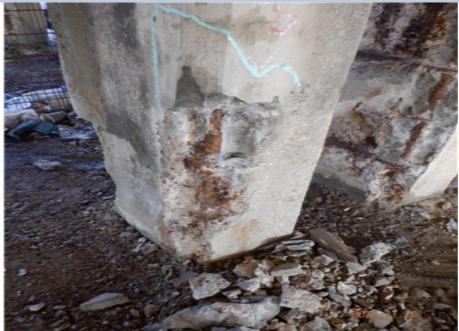
## Photograph #279

View of 740x180x50mm spalling exposing the reinforcement on C4 south face

There were multiple areas of spalling exposing the reinforcement on column (C2-6) throughout, measuring 880x530x50mm, 740x180x50mm, 1700x200x40mm, 1340x170x50mm, 1000x170x40mm and 1000x160x30mm.

Refer to element #1 for remedial works recommendation

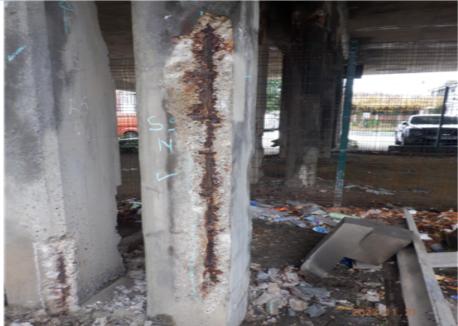
## Photograph #280

View of 1700x200x50mm spalling exposing the reinforcement on C5 north face

There were multiple areas of spalling exposing the reinforcement on column (C2-6) throughout, measuring 880x530x50mm, 740x180x50mm, 1700x200x40mm, 1340x170x50mm, 1000x170x40mm and 1000x160x30mm.

Refer to element #1 for remedial works recommendation

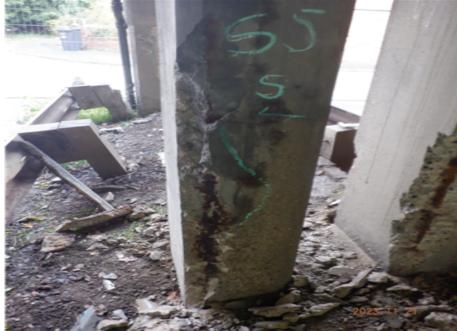
#### Photograph #281

View of 1340x170x50mm spalling exposing the reinforcement on C5 south face

There were multiple areas of spalling exposing the reinforcement on column (C2-6) throughout, measuring 880x530x50mm, 740x180x50mm, 1700x200x40mm, 1340x170x50mm, 1000x170x40mm and

Refer to element #1 for remedial works recommendation

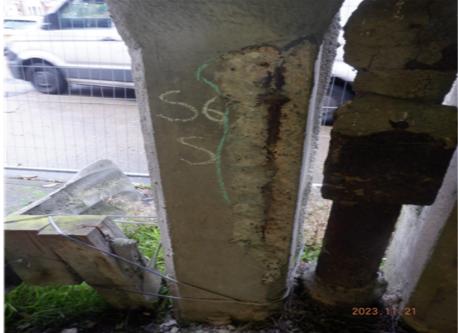
#### Photograph #282

View of 1000x170x40mm spalling exposing the reinforcement on C6 south face

There were multiple areas of spalling exposing the reinforcement on column (C2-6) throughout, measuring 880x530x50mm, 740x180x50mm, 1700x200x40mm, 1340x170x50mm, 1000x170x40mm and 1000x160x30mm.

C2-C6 Refer to element #1 for remedial works recommendation

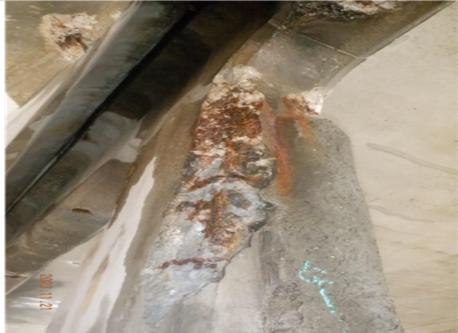
#### Photograph #283

View of 1000x160x30mm spalling exposing the reinforcement on C4 north face

There were multiple areas of spalling exposing the reinforcement on column (C2-6) throughout, measuring 880x530x50mm, 740x180x50mm, 1700x200x40mm, 1340x170x50mm, 1000x170x40mm and 1000x160x30mm.

Refer to element #1 for remedial works recommendation

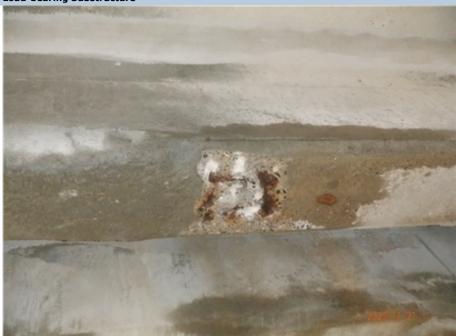
#### Photograph #285

View of 210x310x20mm spalling exposing the reinforcement on the cross head underside between C3 and C4

There were isolated areas of spalling exposing the reinforcement on the cross head underside between C3-C5. Note: Columns on East of span. No defects on cross heads at West of span throughout

Refer to element #1 for remedial works recommendation

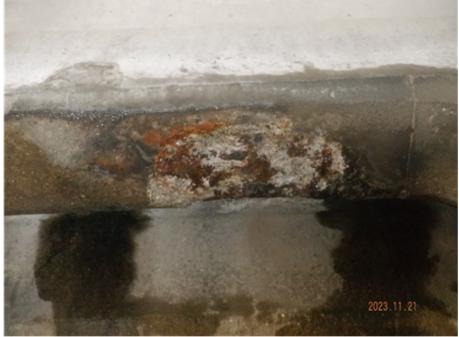
#### Photograph #286

View of 400x290x30mm spalling exposing the reinforcement on the cross head underside between C4 and C5

There were isolated areas of spalling exposing the reinforcement on the cross head underside between C3-C5. Note: Columns on East of span. No defects on cross heads at West of span throughout

Refer to element #1 for remedial works recommendation

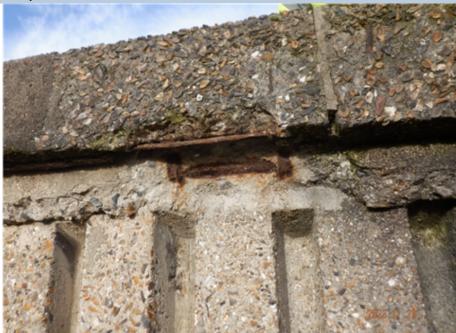
#### Photograph #287

View of spalling exposing the reinforcement on South parapet, measured 30x250x30mm

There were multiple spalling on both parapet, worse measured 30x250x30mm, 200x370x50mm, 120x70x50mm at Ch.122.6m and 180x130x50mm on the base of North parapet at Ch.124m.

Refer to element #1 for remedial works recommendation

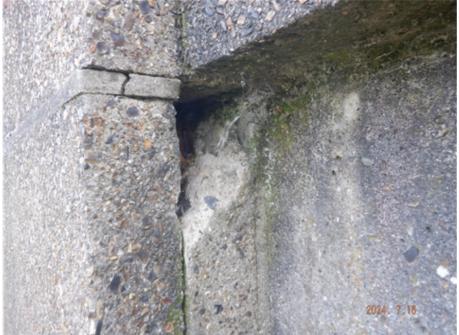
#### Photograph #289

View of spalling on South, measured 120x70x50mm at Ch.122.6m

Refer to element #1 for remedial works recommendation

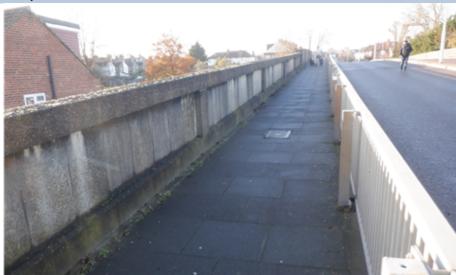
#### Photograph #295

General view of South footway surfacing. Note: Minor vegetation growth at interface with parapet

Monitor defect during next schedule inspection

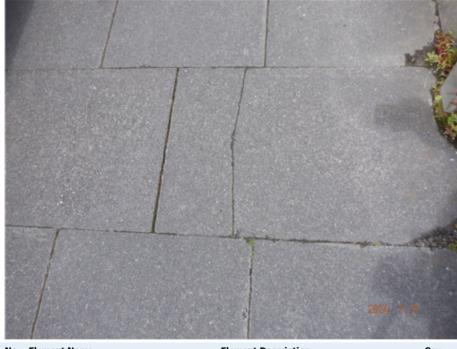
## Photograph #296

View of cracked paving slab at Ch.131m

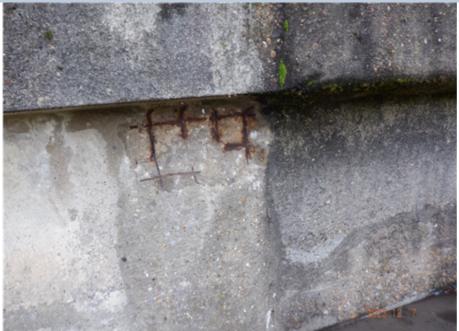
#### Photograph #297

View of spalling exposing the reinforcement on external face at North, measured 140x230x5mm

The reinforcement should be clean back to bare metal before an anti-corrosion primer is applied. The areas should be patch repaired with an appropriate cementitious material, ensuring that it is sufficiently 'keyed-in' to the parent concrete.

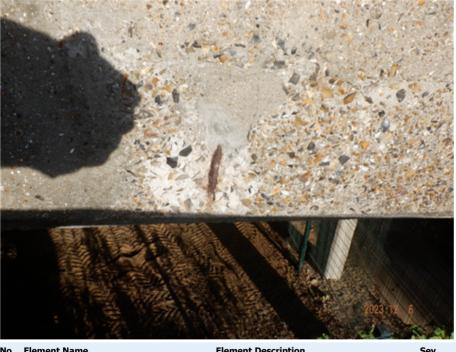
#### Photograph #298

View of 90x70x20mm spalling exposing the reinforcement on external face at South end

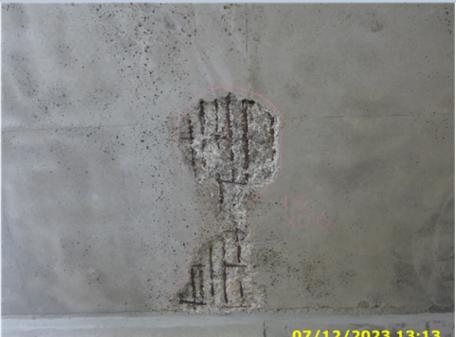
#### Photograph #299

View of 1500x600x50mm spalling exposing the reinforcement on the deck soffit

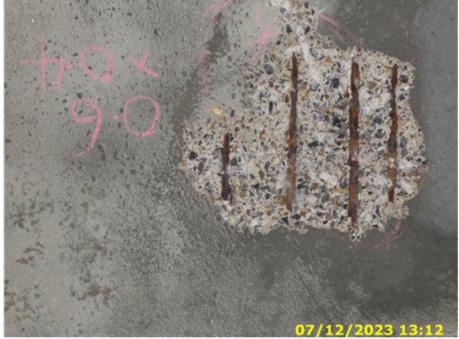
#### Photograph #300

View of 600x400x35mm spalling exposing the reinforcement on the deck soffit

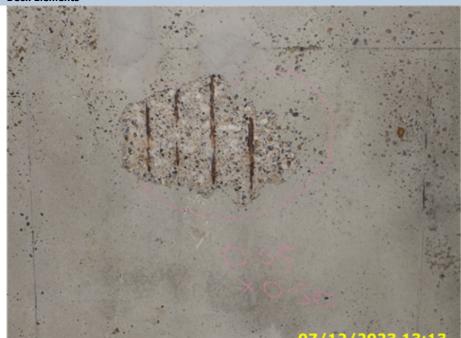
#### Photograph #301

View of 600x500x30mm spalling exposing the reinforcement on the deck soffit

The reinforcement should be clean back to bare metal before an anti-corrosion primer is applied. The areas should be patch repaired with an appropriate cementitious material, ensuring that it is sufficiently 'keyed-in' to the parent concrete.

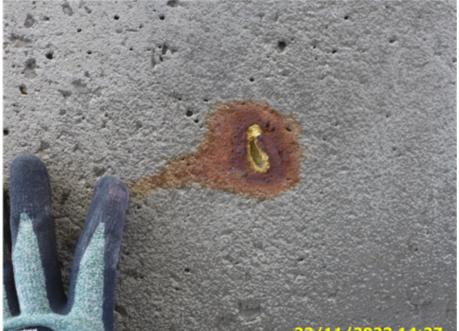
#### Photograph #303

View of minor iron pyrite staining

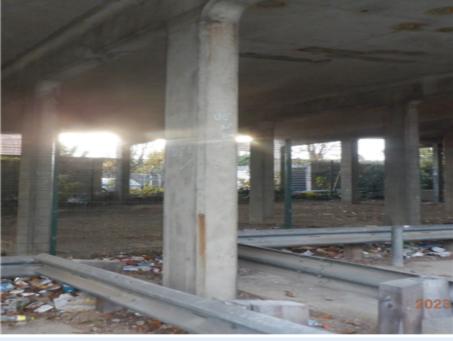
#### Photograph #304

View of minor iron pyrite staining on C5

Comment **Remedial Works** Minor iron pyrite staining noted on C5 north face.

Monitor defect during next schedule inspection

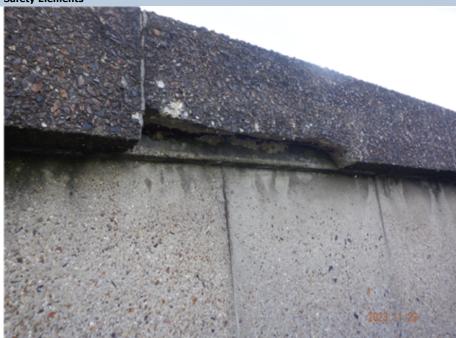
#### Photograph #305

View of spalling exposing the reinforcement on South parapet coping, measured 50x450x60mm at Ch.133.7m 14/11/2023

There were multiple areas of spalling exposing the reinforcement on both parapet coping and external faces, measuring 50x450x60mm at Ch.133.7m, 170x50x20mm at Ch.131m, 100x300x20mm and 150x140x20mm.

The reinforcement should be clean back to bare metal before an anti-corrosion primer is applied. The areas should be patch repaired with an appropriate cementitious material, ensuring that it is sufficiently 'keyed-in' to the parent concrete.

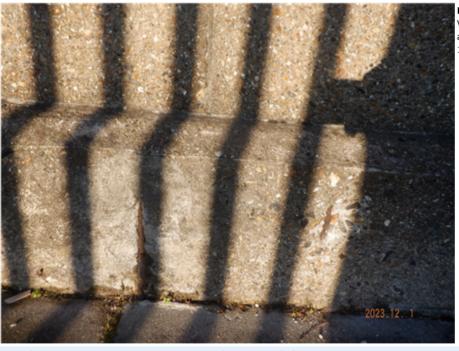
#### Photograph #306

View of spalling exposing the reinforcement at base of North parapet, measured 170x50x20mm at Ch.131m

There were multiple areas of spalling exposing the reinforcement on both parapet coping and external faces, measuring 50x450x60mm at Ch.133.7m, 170x50x20mm at Ch.131m, 100x300x20mm and 150x140x20mm.

The reinforcement should be clean back to bare metal before an anti-corrosion primer is applied. The areas should be patch repaired with an appropriate cementitious material, ensuring that it is sufficiently 'keyed-in' to the parent concrete.

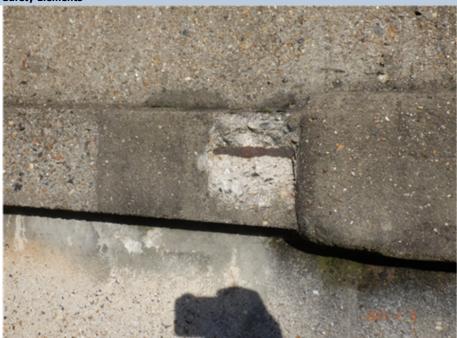
#### Photograph #307

View of 150x140x20mm spalling exposing the reinforcement on external face at South end

There were multiple areas of spalling exposing the reinforcement on both parapet coping and external faces, measuring 50x450x60mm at Ch.133.7m, 170x50x20mm at Ch.131m, 100x300x20mm and 150x140x20mm.

The reinforcement should be clean back to bare metal before an anti-corrosion primer is applied. The areas should be patch repaired with an appropriate cementitious material, ensuring that it is sufficiently 'keyed-in' to the parent concrete.

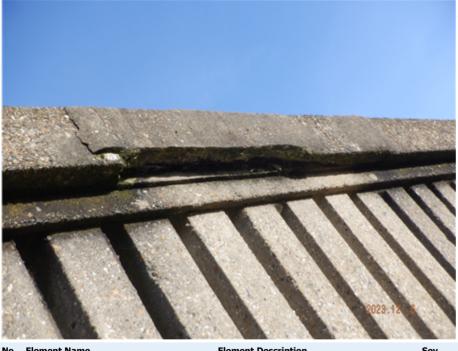
#### Photograph #308

View of spalling exposing the reinforcement on South parapet coping, measured 100x300x20mm

There were multiple areas of spalling exposing the reinforcement on both parapet coping and external faces, measuring 50x450x60mm at Ch.133.7m, 170x50x20mm at Ch.131m, 100x300x20mm and 150x140x20mm.

The reinforcement should be clean back to bare metal before an anti-corrosion primer is applied. The areas should be patch repaired with an appropriate cementitious material, ensuring that it is sufficiently 'keyed-in' to the parent concrete.

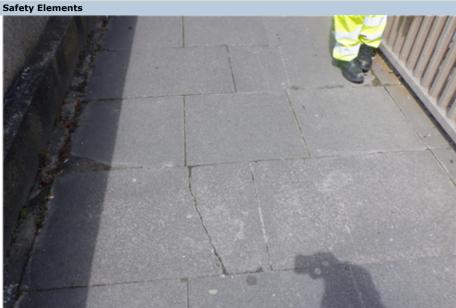
#### Photograph #309

View of cracked paving slab at Ch.137m

There were multiple cracked paving slabs on the Southern footway surfacing at Ch.137m

Monitor defect during next schedule inspection

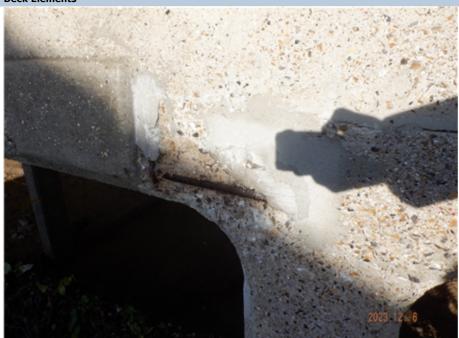
#### Photograph #310

View of 100x300x25mm spalling exposing the reinforcement on external face at South

There was an area of 100x300x25mm spalling exposing the reinforcement on external face at South end end. 150x150x15mm spalling on the deck soffit also noted.

The reinforcement should be clean back to bare metal before an anti-corrosion primer is applied. The areas should be patch repaired with an appropriate cementitious material, ensuring that it is sufficiently 'keyed-in' to the parent concrete.

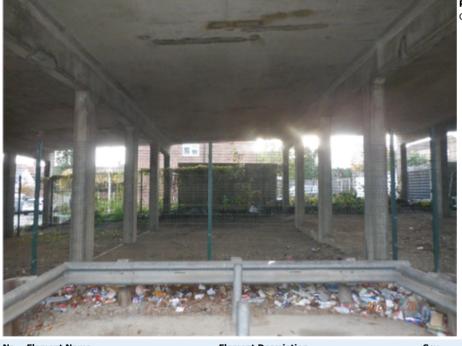
#### Photograph #311 General view of underside

## There was an area of 100x300x25mm spalling exposing

the reinforcement on external face at South end end. 150x150x15mm spalling on the deck soffit also noted.

The reinforcement should be clean back to bare metal before an anti-corrosion primer is applied. The areas should be patch repaired with an appropriate cementitious material, ensuring that it is sufficiently 'keyed-in' to the parent concrete.

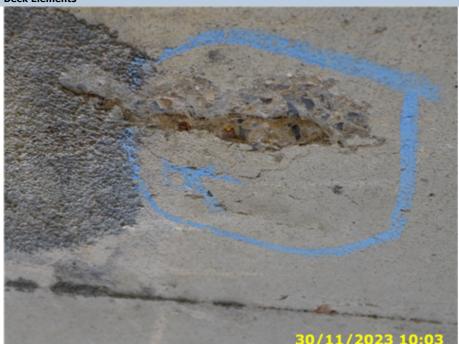
#### Photograph #312

View of 150x150x15mm spalling on the deck soffit

There was an area of 100x300x25mm spalling exposing the reinforcement on external face at South end end. 150x150x15mm spalling on the deck soffit also noted.

The reinforcement should be clean back to bare metal before an anti-corrosion primer is applied. The areas should be patch repaired with an appropriate cementitious material, ensuring that it is sufficiently 'keyed-in' to the parent concrete.

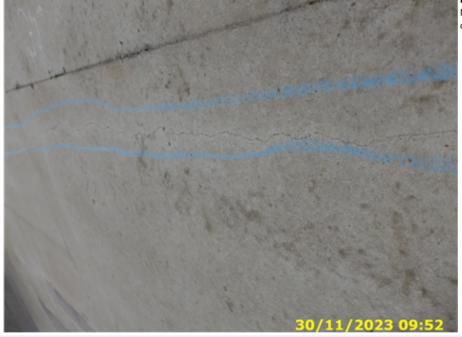
## Photograph #313

Minor shrinkage crack up to 3.6m in length on the deck soffit.

Minor shrinkage crack up to 3.6m in length noted on the deck soffit.

Monitor defect during next schedule inspection

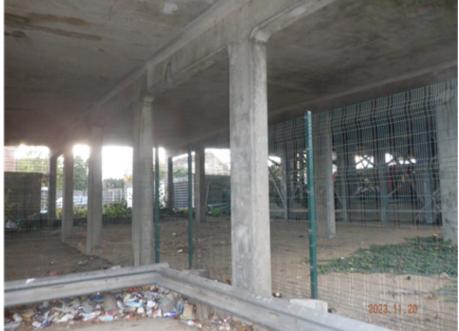
Photograph #314 General view of all columns

Overall, all columns were in good condition throughout.

No visible defects noted

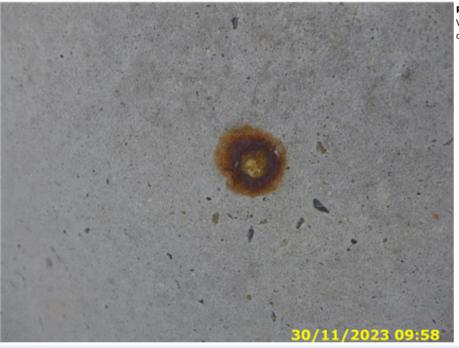
### Photograph #315

View of minor iron pyrite staining on the deck soffit

Minor iron pyrite staining on the deck soffit. [none]

Monitor defect during next schedule inspection

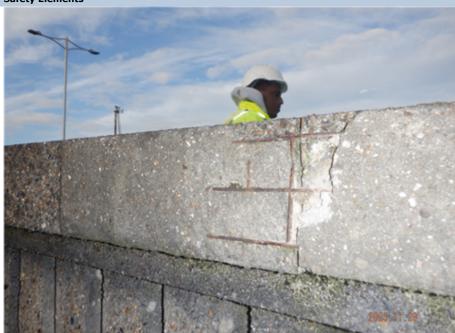
#### Photograph #316

View of spalling exposing the reinforcement on South parapet coping external face, measured 180x180x15mm 14/11/2023

There were multiple areas of spalling exposing the reinforcement on South parapet coping external face, measuring 180x180x15mm, 35x300x40mm, 50x300x25mm at Ch.137.8m and 100x90x20mm on external face of North parapet.

Refer to element #1 for remedial works recommendation

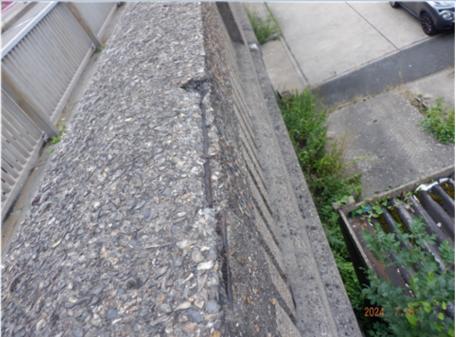
#### Photograph #318

View of spalling exposing the reinforcement on South parapet coping external face, measured 50x300x25mm at Ch.141.2m 14/11/2023

There were multiple areas of spalling exposing the reinforcement on South parapet coping external face, measuring 180x180x15mm, 35x300x40mm, 50x300x25mm at Ch.137.8m and 100x90x20mm on external face of North parapet.

Refer to element #1 for remedial works recommendation

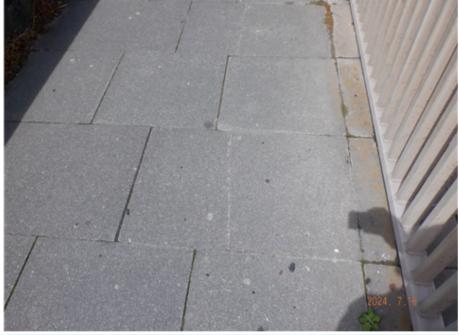
## Photograph #319

View of cracked paving slab at Ch.142m

There was cracked paving slabs on the Southern footway surfacing at  $\mbox{Ch.}142\mbox{m}$

Monitor defect during next schedule inspection

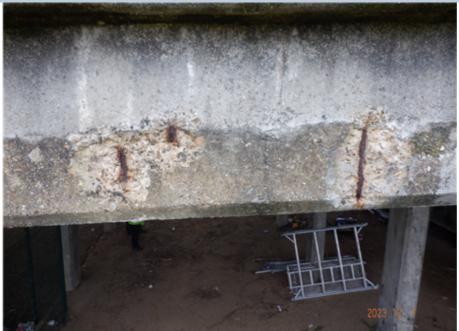
#### Photograph #320

View of spalling exposing the reinforcement on external face at North end, measured 240x200x20mm

There was 2No. areas of spalling exposing the reinforcement on external face at North end, measuring 200x140x20mm and 240x200x20mm. Also, multiple spalling areas noted on the deck soffit and along the edge, measuring 1900x2800x70mm, 800x400x40mm and 1900x350x35mm.

Refer to element #1 for remedial works recommendation

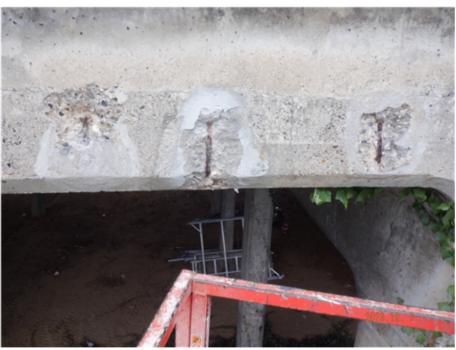
#### Photograph #321

View of spalling exposing the reinforcement on external face at North end, measured 200x140x20mm

There was 2No. areas of spalling exposing the reinforcement on external face at North end, measuring 200x140x20mm and 240x200x20mm. Also, multiple spalling areas noted on the deck soffit and along the edge, measuring 1900x2800x70mm, 800x400x40mm and 1900x350x35mm.

Refer to element #1 for remedial works recommendation

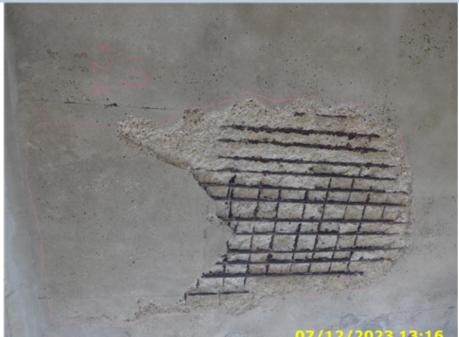
#### Photograph #322

View of 1900x2800x70mm spalling exposing the reinforcement on the deck soffit

There was 2No. areas of spalling exposing the reinforcement on external face at North end, measuring 200x140x20mm and 240x200x20mm. Also, multiple spalling areas noted on the deck soffit and along the edge, measuring 1900x2800x70mm, 800x400x40mm and 1900x350x35mm.

Refer to element #1 for remedial works recommendation

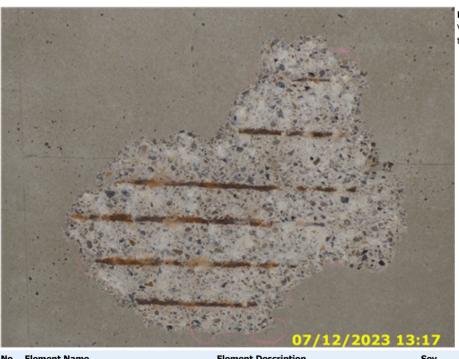
#### Photograph #323

View of 800x600x40mm spalling exposing the reinforcement on the deck soffit

There was 2No. areas of spalling exposing the reinforcement on external face at North end, measuring 200x140x20mm and 240x200x20mm. Also, multiple spalling areas noted on the deck soffit and along the edge, measuring 1900x2800x70mm, 800x400x40mm and 1900x350x35mm.

Refer to element #1 for remedial works recommendation

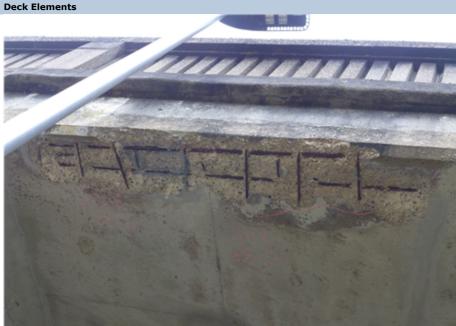
#### Photograph #324

View of 1900x350x35mm spalling exposing the reinforcement along the edge of deck soffit at North end

There was 2No. areas of spalling exposing the reinforcement on external face at North end, measuring 200x140x20mm and 240x200x20mm. Also, multiple spalling areas noted on the deck soffit and along the edge, measuring 1900x2800x70mm, 800x400x40mm and 1900x350x35mm.

Refer to element #1 for remedial works recommendation

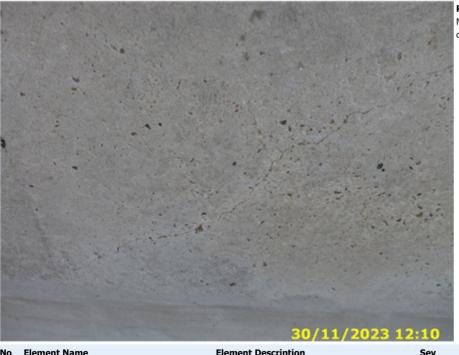
#### Photograph #325

Minor shrinkage crack up to 0.8m in length on the deck soffit.

Comment **Remedial Works** Minor shrinkage crack up to 0.8m and 1.5m in length on [none]

Monitor defect during next schedule inspection

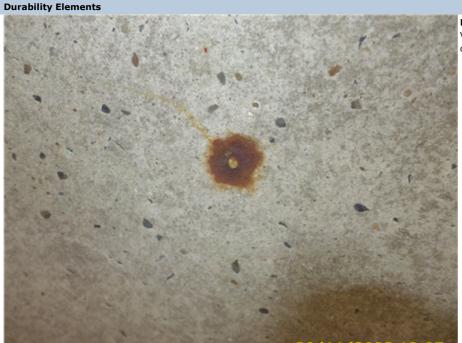
#### Photograph #326

View of minor iron pyrite staining on the

Minor iron pyrite staining on the deck soffit. [none]

Monitor defect during next schedule inspection

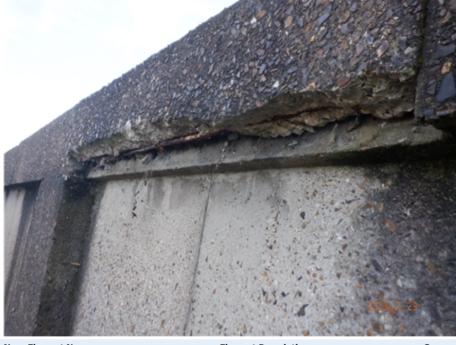
#### Photograph #327

View of spalling exposing the reinforcement on South parapet coping, measured 50x920x55mm at Ch.141.2m

Spalling exposing the reinforcement on South parapet coping and external face at North, measuring 50x920x55mm at Ch.141.2m, 30x200x80mm at Ch.145m on South parapet and 200x1000x30mm on North.

The reinforcement should be clean back to bare metal before an anti-corrosion primer is applied. The areas should be patch repaired with an appropriate cementitious material, ensuring that it is sufficiently 'keyed-in' to the parent concrete.

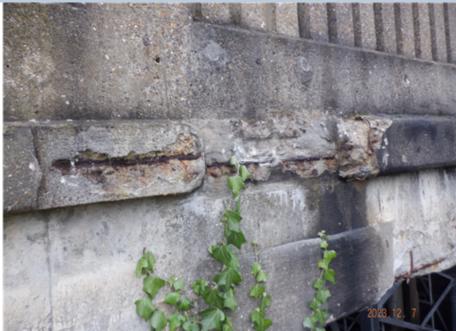
#### Photograph #328

View of spalling exposing the reinforcement on external face at North, measured 200x1000x30mm

Spalling exposing the reinforcement on South parapet coping and external face at North, measuring 50x920x55mm at Ch.141.2m, 30x200x80mm at Ch.145m on South parapet and 200x1000x30mm on North.

The reinforcement should be clean back to bare metal before an anti-corrosion primer is applied. The areas should be patch repaired with an appropriate cementitious material, ensuring that it is sufficiently 'keyed-in' to the parent concrete.

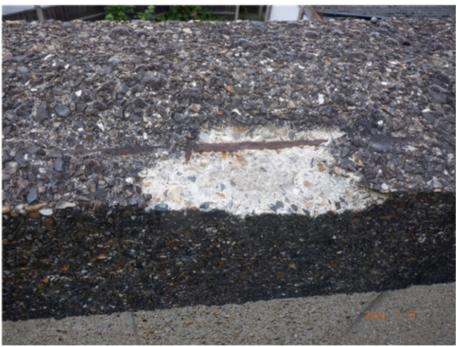
#### Photograph #329

View of spalling exposing the reinforcement on South parapet coping, measured 30x200x80mm at Ch.145m

Spalling exposing the reinforcement on South parapet coping and external face at North, measuring 50x920x55mm at Ch.141.2m, 30x200x80mm at Ch.145m on South parapet and 200x1000x30mm on North.

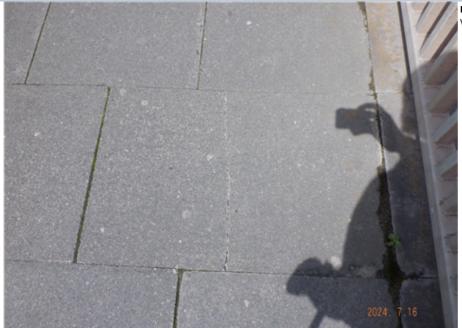
#### Photograph #330

View of cracked paving slab at Ch.150m

There were multiple cracked paving slabs on the Southern footway surfacing at Ch.149m and Ch.150m [none]

Monitor defect during next schedule inspection

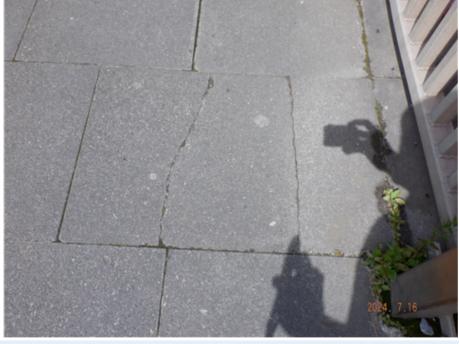
## Photograph #331

View of cracked paving slab at Ch.149m

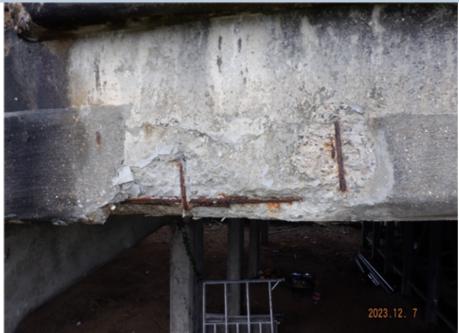
#### Photograph #332

View of spalling exposing the reinforcement on external face at North end, measured 250x700x50mm

The reinforcement should be clean back to bare metal before an anti-corrosion primer is applied. The areas should be patch repaired with an appropriate cementitious material, ensuring that it is sufficiently 'keyed-in' to the parent concrete.

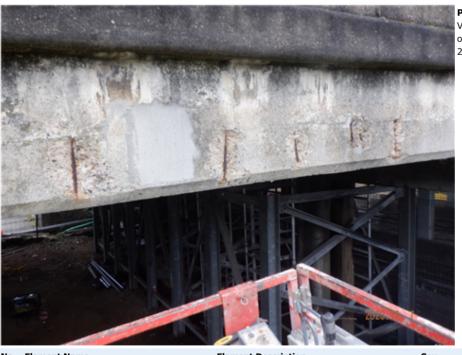
#### Photograph #333

View of spalling exposing the reinforcement on external face at North end, measured 200x200x20mm

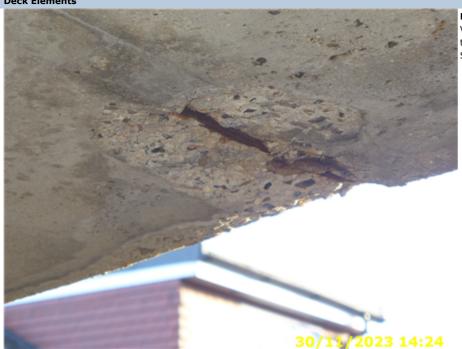
#### Photograph #334

View of 350x250x30mm spalling exposing the reinforcement on the deck soffit at South

The reinforcement should be clean back to bare metal before an anti-corrosion primer is applied. The areas should be patch repaired with an appropriate cementitious material, ensuring that it is sufficiently 'keyed-in' to the parent concrete.
