# **Principal Inspection Report**

Structure Name: Broadmead Road Viaduct

**Identifier:** B4

**Inspection Date:** 14/11/2023

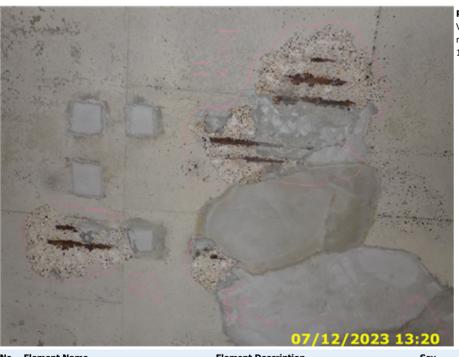
#### Photograph #335

View of multiple spalling exposing the reinforcement on the deck soffit, measured 1100x900x45mm and 300x450x45mm

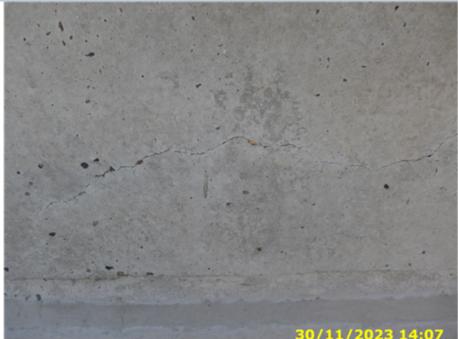
#### Photograph #336

Minor shrinkage crack up to 1.2m in length on the deck soffit.

Monitor defect during next schedule inspection

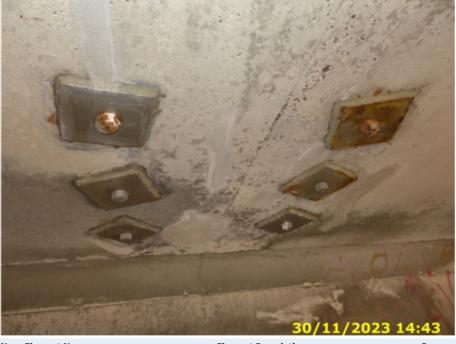
### Photograph #337

View of minor surface corrosion on the holding down bolts and plate

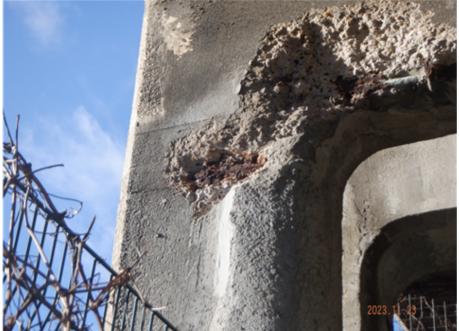
#### Photograph #338

View of 300x400x30mm spalling exposing the reinforcement on C1 east face extending to cross head

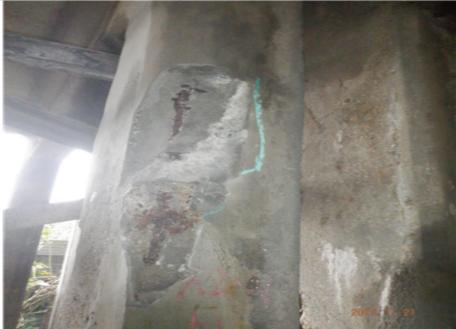
#### Photograph #339

View of 700x250x50mm spalling exposing the reinforcement on C2 east face

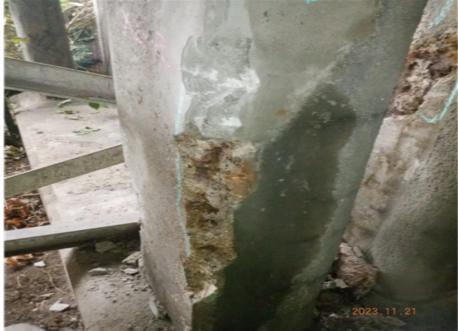
#### Photograph #340

View of 900x150x40mm spalling exposing the reinforcement on C2 east face

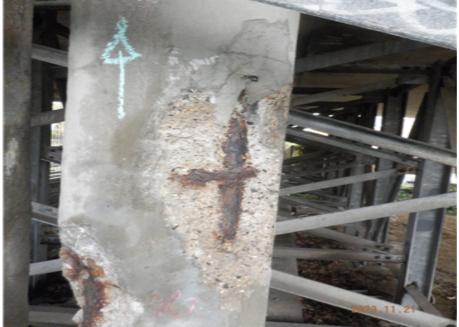
#### Photograph #341

View of 500x200x40mm spalling exposing the reinforcement on C1 south face

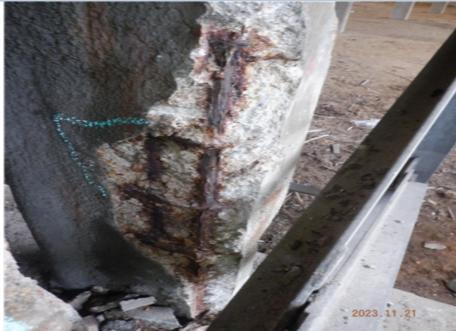
#### Photograph #342

View of 1300x300x50mm spalling exposing the reinforcement on C2 west face

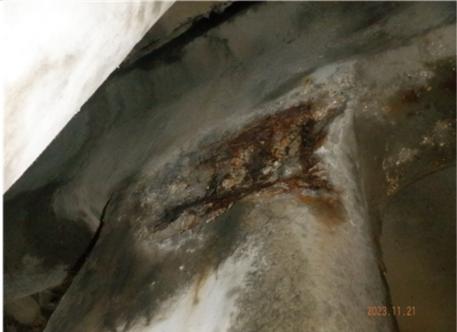
#### Photograph #343

View of 400x400x25mm spalling exposing the reinforcement on C3 west face

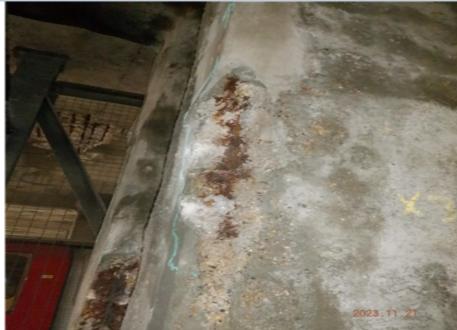
# Photograph #344

View of 590x150x40mm spalling exposing the reinforcement on C3 south face

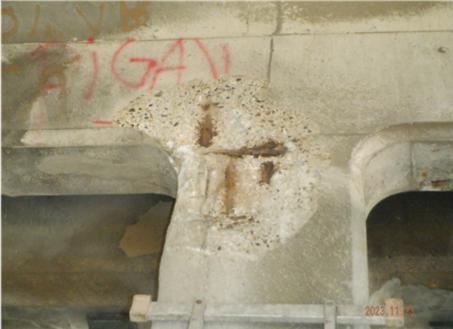
View of 620x290x50mm spalling exposing the reinforcement on C4 east face

There were multiple areas of severe spalling exposing the reinforcement on column (C4-6) throughout, measuring 620x290x50mm, 1100x150x30mm, 950x100x40mm, 1200x150x40mm, 350x170x35mm, 900x130x30mm and 900x130x30mm.

C4-C6 Refer to element #1 for remedial works recommendation

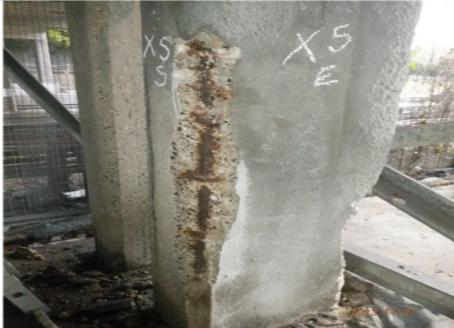
View of 1100x150x30mm spalling exposing the reinforcement on C5 south face

There were multiple areas of severe spalling exposing the reinforcement on column (C4-6) throughout, measuring 620x290x50mm, 1100x150x30mm, 950x100x40mm, 1200x150x40mm, 350x170x35mm,

Refer to element #1 for remedial works recommendation

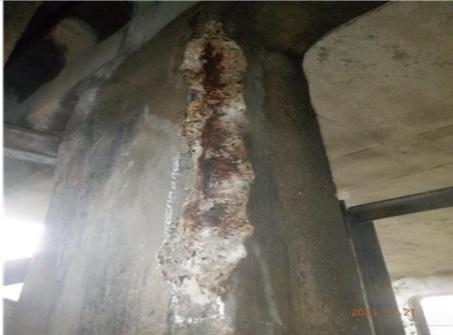
View of 950x100x40mm spalling exposing the reinforcement on C5 south face

There were multiple areas of severe spalling exposing the reinforcement on column (C4-6) throughout, measuring 620x290x50mm, 1100x150x30mm, 950x100x40mm, 1200x150x40mm, 350x170x35mm, 900x130x30mm and 900x130x30mm.

Refer to element #1 for remedial works recommendation

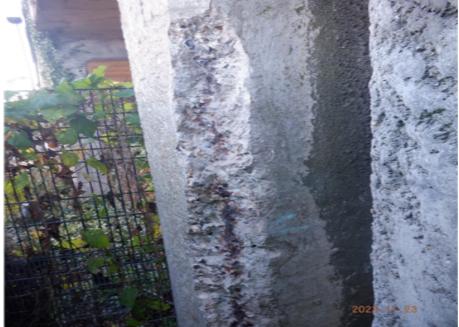
View of 1200x150x40mm spalling exposing the reinforcement on C6 north face

There were multiple areas of severe spalling exposing the reinforcement on column (C4-6) throughout, measuring 620x290x50mm, 1100x150x30mm, 950x100x40mm, 1200x150x40mm, 350x170x35mm, 900x130x30mm and 900x130x30mm.

C4-C6 Refer to element #1 for remedial works recommendation

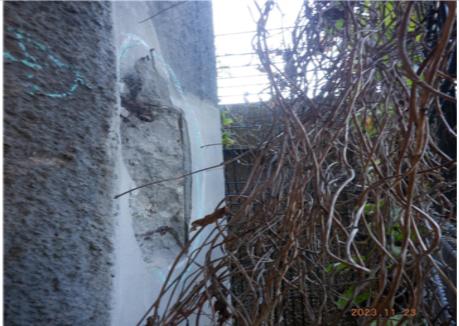
View of 350x170x35mm spalling exposing the reinforcement on C6 east face

There were multiple areas of severe spalling exposing the reinforcement on column (C4-6) throughout, measuring 620x290x50mm, 1100x150x30mm, 950x100x40mm, 1200x150x40mm, 350x170x35mm, 900x130x30mm and 900x130x30mm.

C4-C6 Refer to element #1 for remedial works recommendation

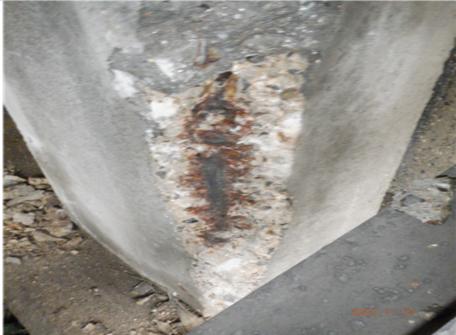
View of 900x130x30mm spalling exposing the reinforcement on C5 north face

There were multiple areas of severe spalling exposing the reinforcement on column (C4-6) throughout, measuring 620x290x50mm, 1100x150x30mm, 950x100x40mm, 1200x150x40mm, 350x170x35mm, 900x130x30mm and 900x130x30mm.

C4-C6 Refer to element #1 for remedial works recommendation

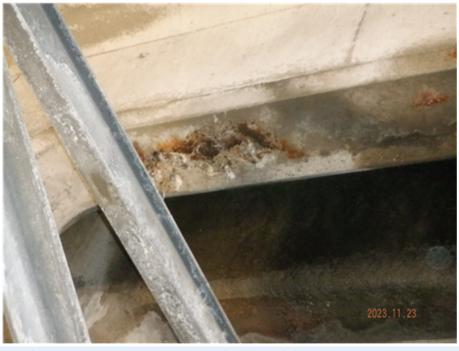
View of 480x170x30mm spalling exposing the reinforcement on the cross head underside between C4 and C5

There were multiple areas of severe spalling exposing the reinforcement on the cross heads between C1-C5, measuring 480x170x30mm, full width x 310x40mm, 1000x250x35mm and 480x330x25mm.

Refer to element #1 for remedial works recommendation

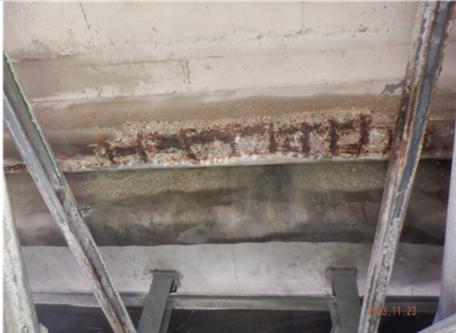
View of full width x 310x40mm spalling exposing the reinforcement on the cross head underside between C2 and C3

There were multiple areas of severe spalling exposing the reinforcement on the cross heads between C1-C5, measuring 480x170x30mm, full width x 310x40mm, 1000x250x35mm and 480x330x25mm.

Refer to element #1 for remedial works recommendation

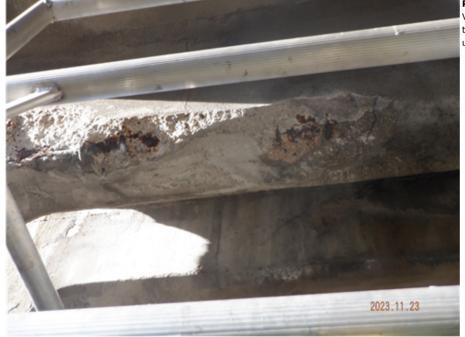
View of 1000x250x35mm spalling exposing the reinforcement on the cross head underside between C1 and C2

There were multiple areas of severe spalling exposing the reinforcement on the cross heads between C1-C5, measuring 480x170x30mm, full width x 310x40mm, 1000x250x35mm and 480x330x25mm.

Refer to element #1 for remedial works recommendation

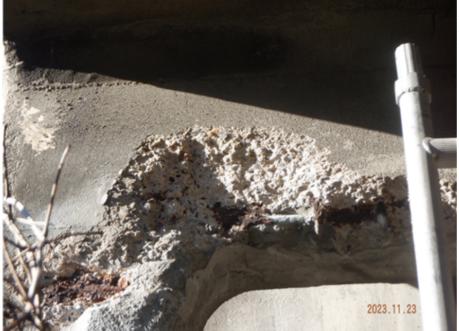
View of 480x330x25mm spalling exposing the reinforcement on the cross head east face between C1 and C2

There were multiple areas of severe spalling exposing the reinforcement on the cross heads between C1-C5, measuring 480x170x30mm, full width x 310x40mm, 1000x250x35mm and 480x330x25mm.

### Refer to element #1 for remedial works recommendation

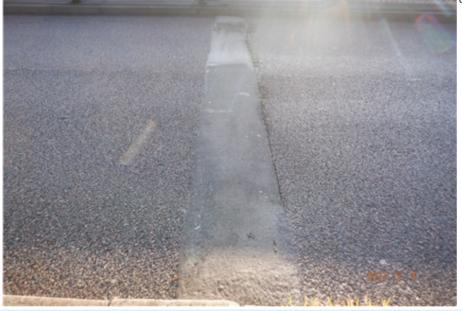
View of typical tracking and flow of binder on Westbound carriageway joint

Longstanding tracking and flow of binder noted on Eastbound carriageway joint leading to extensive leakage onto the elements below

Replace the existing expansion joints on Westbound carriageway

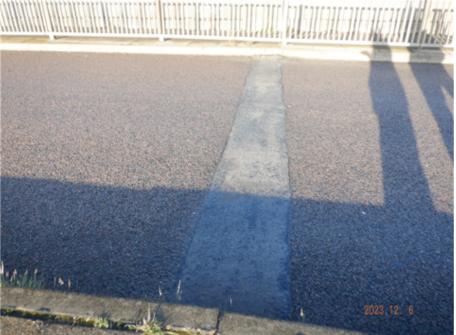
General view of asphalt plug joint on Eastbound carriageway surfacing in good condition

Longstanding tracking and flow of binder noted on Eastbound carriageway joint leading to extensive leakage onto the elements below

Replace the existing expansion joints on Westbound carriageway

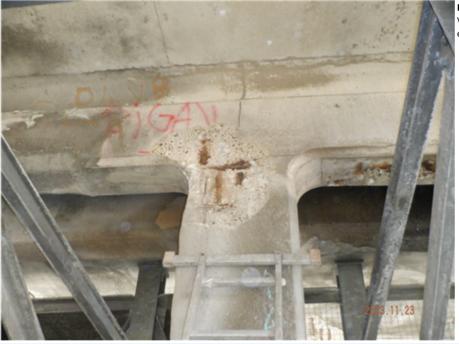
View of non-offensive graffiti on cross head east face between C3 and C4

Non-offensive graffiti noted on east face between C3 and
 Remove graffiti f

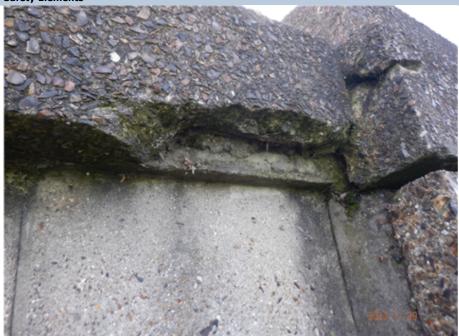
View of spalling exposing the reinforcement on South parapet coping, measured 90x340x50mm

There were multiple spalling exposing the reinforcement on South parapet coping, post, internal and external face, measured 90x340x50mm, 50x160x90mm, 150x180x15mm and 160x170x130mm at Ch.152m. Also, 100x50x30mm minor spalling noted on North parapet post at Ch.155m

The reinforcement should be clean back to bare metal before an anti-corrosion primer is applied. The areas should be patch repaired with an appropriate cementitious material, ensuring that it is sufficiently 'keyed-in' to the parent concrete.

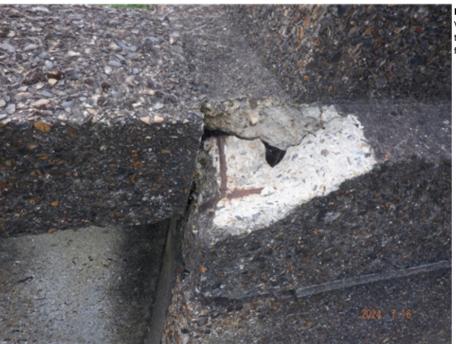
View of 160x170x130mm spalling exposing the reinforcement on South parapet internal face at Ch.152m

There were multiple spalling exposing the reinforcement on South parapet coping, post, internal and external face, measured 90x340x50mm, 50x160x90mm, 150x180x15mm and 160x170x130mm at Ch.152m. Also, 100x50x30mm minor spalling noted on North parapet post at Ch.155m

The reinforcement should be clean back to bare metal before an anti-corrosion primer is applied. The areas should be patch repaired with an appropriate cementitious material, ensuring that it is sufficiently 'keyed-in' to the parent concrete.

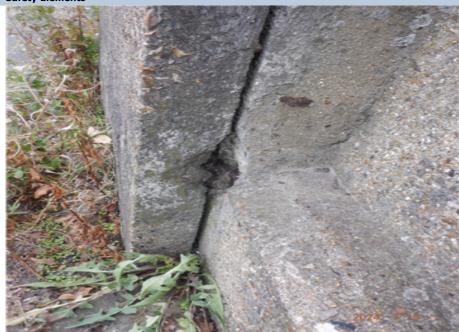
View of minor spalling on North parapet post, measured 100x50x30mm at Ch.155m

There were multiple spalling exposing the reinforcement on South parapet coping, post, internal and external face, measured 90x340x50mm, 50x160x90mm, 150x180x15mm and 160x170x130mm at Ch.152m. Also, 100x50x30mm minor spalling noted on North parapet post at Ch.155m

The reinforcement should be clean back to bare metal before an anti-corrosion primer is applied. The areas should be patch repaired with an appropriate cementitious material, ensuring that it is sufficiently 'keyed-in' to the parent concrete.

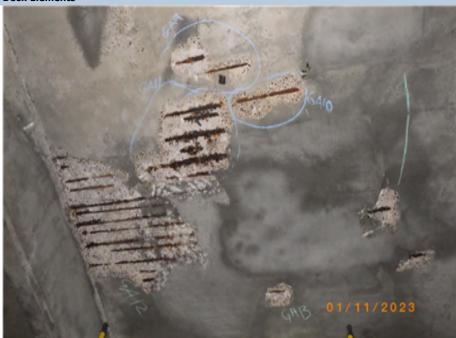
View of multiple spalling exposing the reinforcement on the deck soffit, measured 700x350x25mm, 600x300x30mm, 900x900x30mm and 1700x1300x40mm

There were multiple areas of spalling exposing the reinforcement on the deck soffit throughout, the worse areas measured 700x350x25mm, 600x300x30mm, 900x900x30mm, 1700x1300x40mm, 300x350x40mm, 650x600x50mm, 300x250x30mm, 2620x2600x50mm, 700x400x30mm, 1000x600x40mm, 1000x700x40mm and 650x450x30mm

The reinforcement should be clean back to bare metal before an anti-corrosion primer is applied. The areas should be patch repaired with an appropriate cementitious material, ensuring that it is sufficiently 'keyed-in' to the parent concrete.

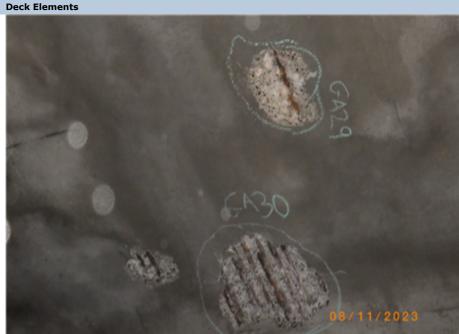
View of multiple spalling exposing the reinforcement on the deck soffit, measured 300x350x40mm, 650x600x50mm and 300x250x30mm

There were multiple areas of spalling exposing the reinforcement on the deck soffit throughout, the worse areas measured 700x350x25mm, 600x300x30mm, 900x900x30mm, 1700x1300x40mm, 300x350x40mm, 650x600x50mm, 300x250x30mm, 2620x2600x50mm, 700x400x30mm, 1000x600x40mm, 1000x700x40mm and 650x450x30mm

The reinforcement should be clean back to bare metal before an anti-corrosion primer is applied. The areas should be patch repaired with an appropriate cementitious material, ensuring that it is sufficiently 'keyed-in' to the parent concrete.

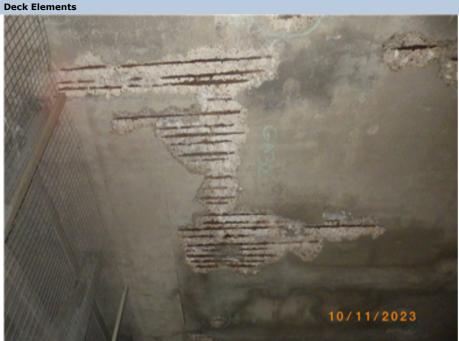
View of spalling exposing the reinforcement on the deck soffit, measured 2620x2600x50mm

There were multiple areas of spalling exposing the reinforcement on the deck soffit throughout, the worse areas measured 700x350x25mm, 600x300x30mm, 900x900x30mm, 1700x1300x40mm, 300x350x40mm, 650x600x50mm, 300x250x30mm, 2620x2600x50mm, 700x400x30mm, 1000x600x40mm, 1000x700x40mm and 650x450x30mm

The reinforcement should be clean back to bare metal before an anti-corrosion primer is applied. The areas should be patch repaired with an appropriate cementitious material, ensuring that it is sufficiently 'keyed-in' to the parent concrete.

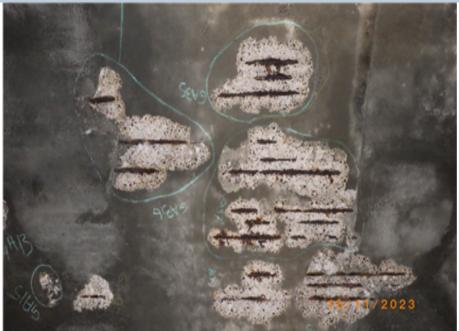
View of multiple spalling exposing the reinforcement on the deck soffit, measured 700x400x30mm, 1000x600x40mm, 1000x700x40mm and 650x450x30mm

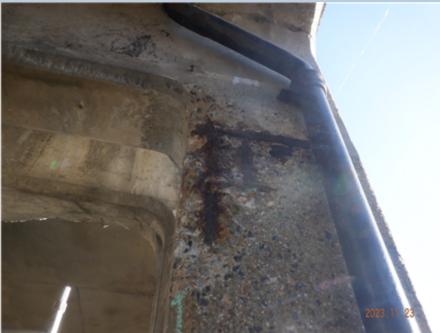
View of 600mm x full width x 45mm spalling exposing the reinforcement on C1 west face

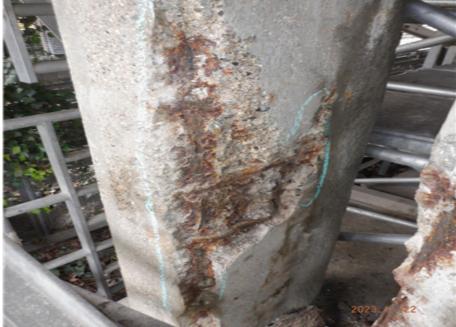
View of 1560x360x50mm spalling exposing the reinforcement on C2 east face

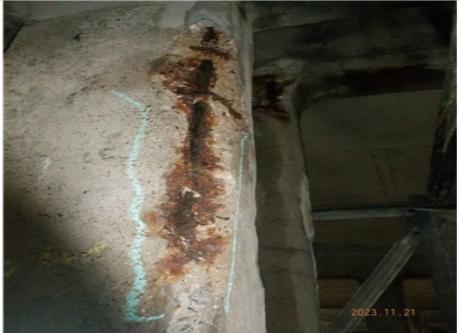
View of 1100x200x50mm spalling exposing the reinforcement on C3 south face

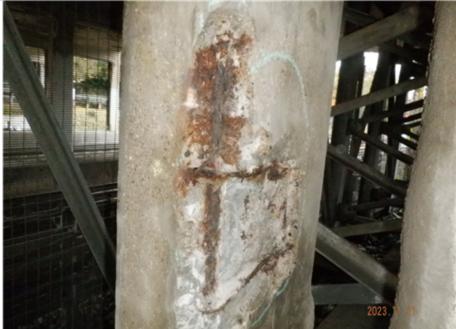
View of 760x370x40mm spalling exposing the reinforcement on C3 east face

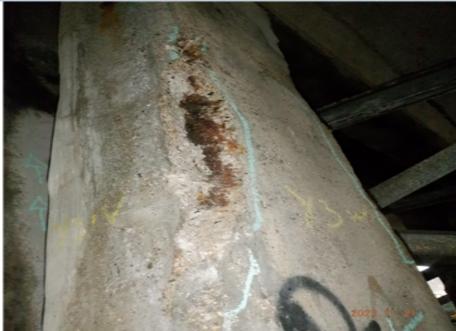
View of 660x100x50mm spalling exposing the reinforcement on C3 west face

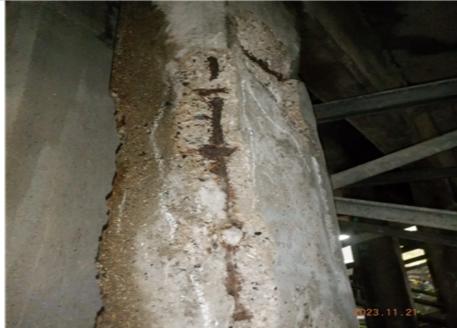
View of 1600x150x30mm spalling exposing the reinforcement on C4 north face

There were multiple areas of severe spalling exposing the reinforcement on column (C4-6) throughout, measuring 1600x150x30mm,  $550mm \times full$  width  $\times 45mm$ , 730x100x30mm,  $1800mm \times full$  width  $\times 60mm$ , 700x100x25mm and 1000x150x35mm

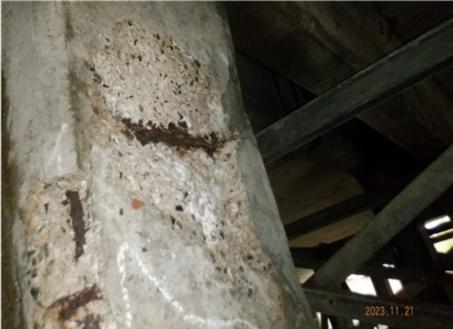
View of 550mm x full width x 45mm spalling exposing the reinforcement on C4 west face

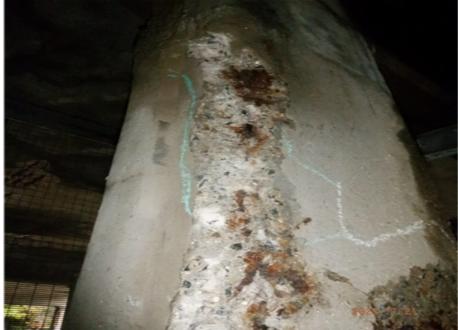
View of 730x100x30mm spalling exposing the reinforcement on C4 south face

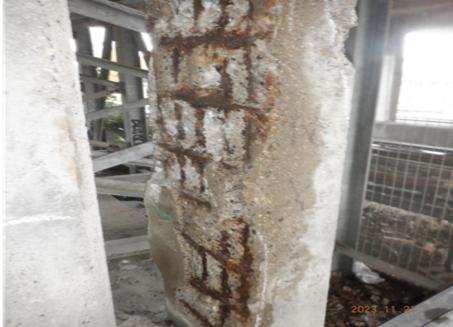
View of 1800mm x full width x 60mm spalling exposing the reinforcement on C4 east face

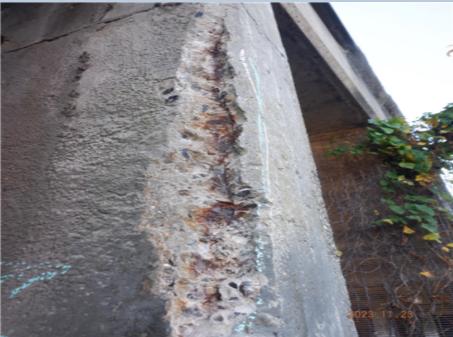
View of 700x100x25mm spalling exposing the reinforcement on C6 north face

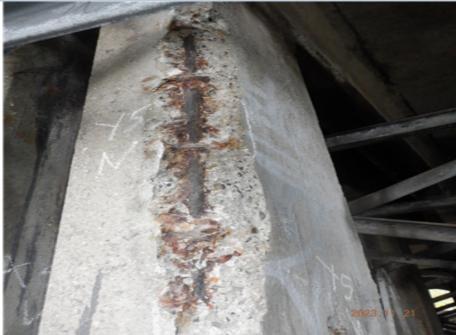
View of 1000x150x35mm spalling exposing the reinforcement on C6 north face

C4-C6 Refer to element #1 for remedial works recommendation

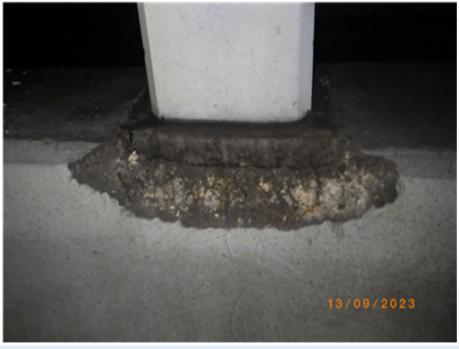
View of spalling along the edge of column support, measured approximately 520x130x25mm

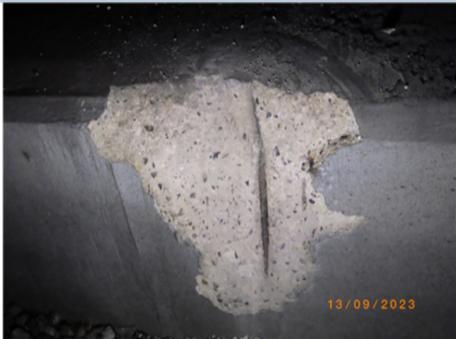
View of spalling exposing the reinforcement on the column support, measured 500mm  $\times$  full height  $\times$  30mm

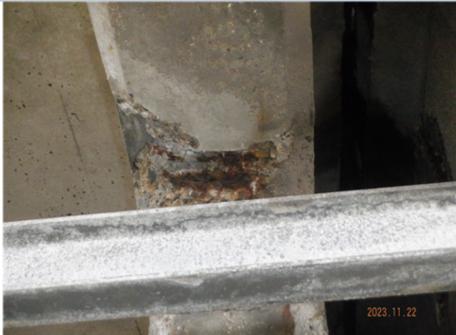
View of 300x300x30mm spalling exposing the reinforcement on the cross head between C1 and C2

The reinforcement should be clean back to bare metal before an anti-corrosion primer is applied. The areas should be patch repaired with an appropriate cementitious material, ensuring that it is sufficiently 'keyed-in' to the parent concrete.

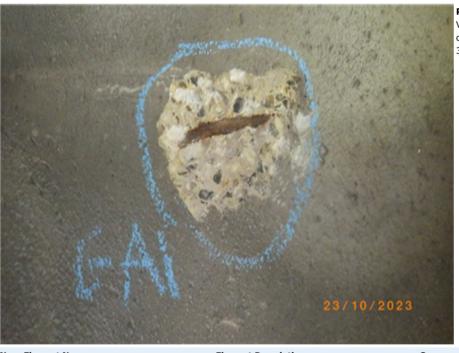
View of spalling exposing the reinforcement on the Eastern face, measured 350x200x30mm

There were multiple spalling exposing the reinforcement on the Eastern face of cross head, measured 350x200x30mm, 500x400x30mm, 400x300x40mm and 350x200x40mm

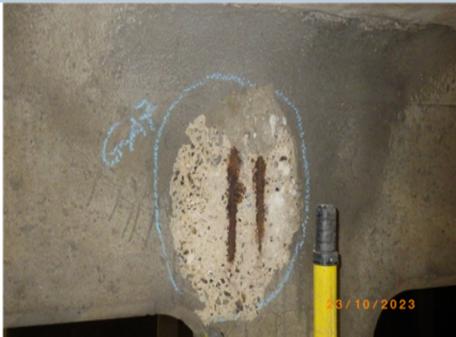
View of spalling exposing the reinforcement on the Eastern face, measured 500x400x30mm

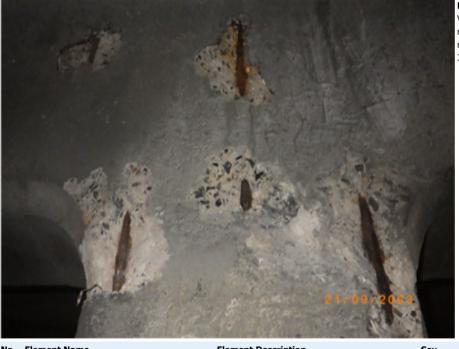
View of 4No. spalling exposing the reinforcement on the Eastern face, worse measured 400x300x40mm and 350x200x40mm

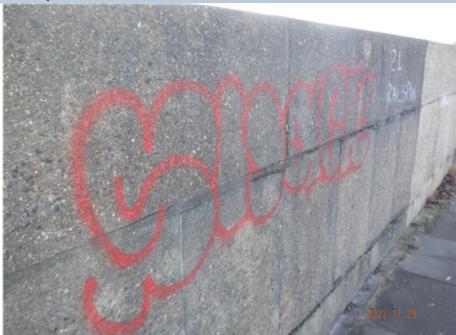
View of isolated area of non-offensive graffiti on South RC parapet wall at Ch.159.3m

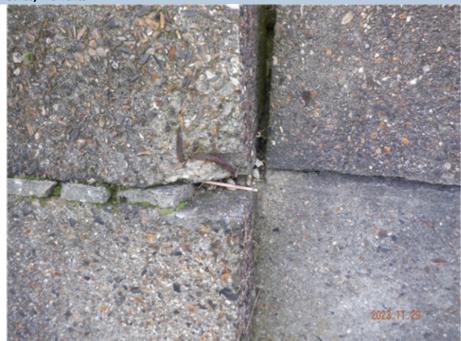
View of minor spalling on South RC parapet wall, measured 100x100x50mm, at Ch.153.7m

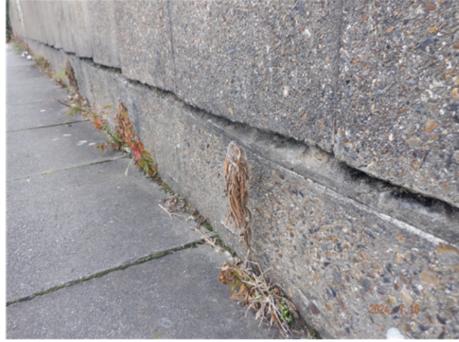
View of joint mortar loss along the base of Northern RC wall at Ch.156m to 164m

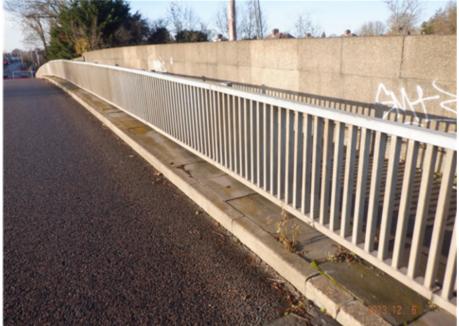
### Photograph #387

General view of North steel parapet

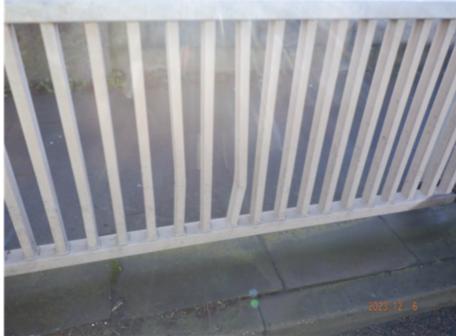
# Photograph #388

View of impact damage to South parapet vertical infill at East end

Isolated area of minor impact damage noted on the South parapet vertical infill at East end

Repair/ replace damaged parapet infill

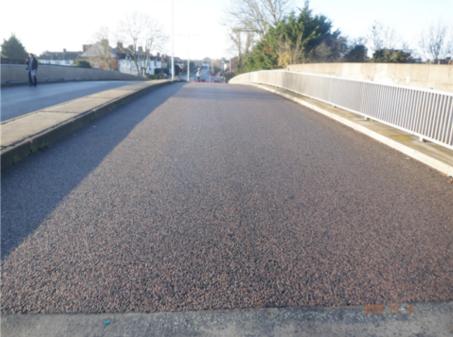
# Photograph #389

View of Eastbound carriageway surfacing

Overall, both Eastbound and Westbound carriageway surfacing appears in good condition. No visible defects noted.

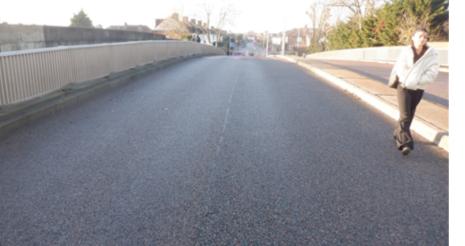
# Photograph #390

View of Westbound carriageway surfacing

Overall, both Eastbound and Westbound carriageway surfacing appears in good condition. No visible defects noted.

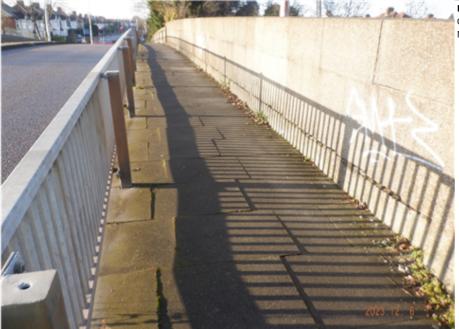
# Photograph #391

General view of North footway surfacing. Note: Uneven paving slabs

Monitor defect during next schedule inspection

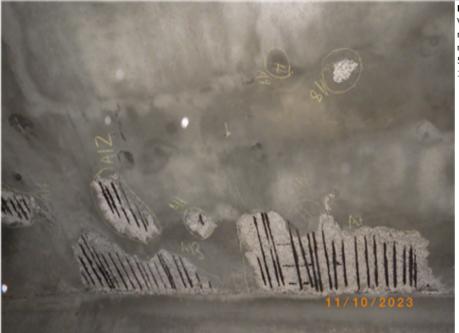
### Photograph #392

View of multiple spalling exposing the reinforcement on the deck soffit, worse measured 3060x1400x70mm, 500x300x45mm, 300x250x40mm, 1600x900x50mm and 2400x1120x60mm

There were multiple areas of spalling exposing the severely corroded reinforcement on the deck soffit throughout, worse areas measured 3060x1400x70mm, 500x300x45mm, 300x250x40mm, 1600x900x50mm, 2400x1120x60mm, 1200x600x45mm, 1400x1300x45mm and 1500x800x45mm.

The reinforcement should be clean back to bare metal before an anti-corrosion primer is applied. The areas should be patch repaired with an appropriate cementitious material, ensuring that it is sufficiently 'keyed-in' to the parent concrete.

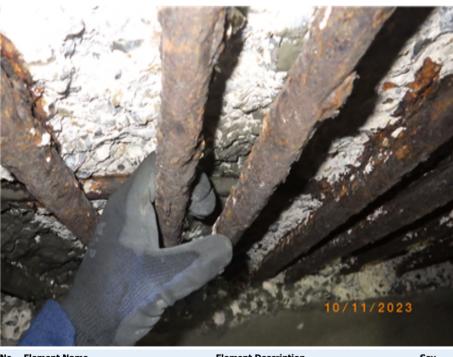
# Photograph #393

Closed up view of the above defect showing severe corrosion on the main bar

There were multiple areas of spalling exposing the severely corroded reinforcement on the deck soffit throughout, worse areas measured 3060x1400x70mm, 500x300x45mm, 300x250x40mm, 1600x900x50mm, 2400x1120x60mm, 1200x600x45mm, 1400x1300x45mm and 1500x800x45mm.

The reinforcement should be clean back to bare metal before an anti-corrosion primer is applied. The areas should be patch repaired with an appropriate cementitious material, ensuring that it is sufficiently 'keyed-in' to the parent concrete.

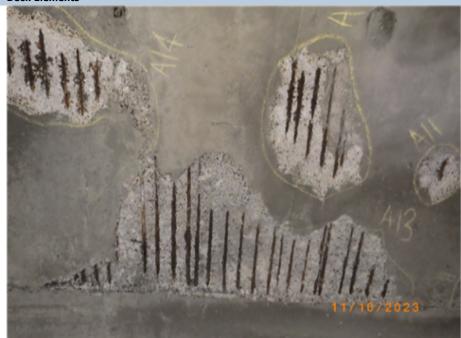
# Photograph #394

View of 1200x600x45mm spalling exposing the reinforcement on the deck soffit

There were multiple areas of spalling exposing the severely corroded reinforcement on the deck soffit throughout, worse areas measured 3060x1400x70mm, 500x300x45mm, 300x250x40mm, 1600x900x50mm, 2400x1120x60mm, 1200x600x45mm, 1400x1300x45mm and 1500x800x45mm.

The reinforcement should be clean back to bare metal before an anti-corrosion primer is applied. The areas should be patch repaired with an appropriate cementitious material, ensuring that it is sufficiently 'keyed-in' to the parent concrete.

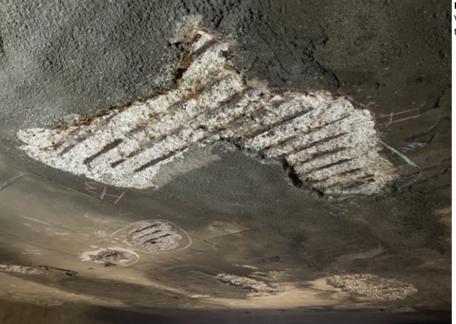
# Photograph #395

View of 1400x1300x45mm spalling exposing the reinforcement on the deck soffit

There were multiple areas of spalling exposing the severely corroded reinforcement on the deck soffit throughout, worse areas measured 3060x1400x70mm, 500x300x45mm, 300x250x40mm, 1600x900x50mm, 2400x1120x60mm, 1200x600x45mm, 1400x1300x45mm **Remedial Works**

The reinforcement should be clean back to bare metal before an anti-corrosion primer is applied. The areas should be patch repaired with an appropriate cementitious material, ensuring that it is sufficiently 'keyed-in' to the parent concrete.

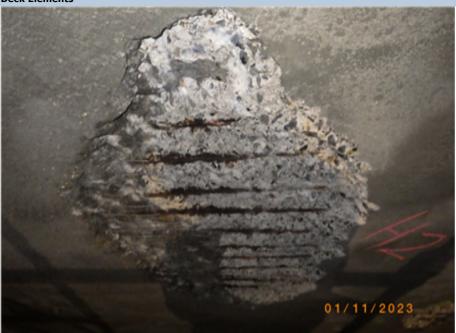
# Photograph #396

View of 1500x800x45mm spalling exposing the reinforcement on the deck soffit

There were multiple areas of spalling exposing the severely corroded reinforcement on the deck soffit throughout, worse areas measured 3060x1400x70mm, 500x300x45mm, 300x250x40mm, 1600x900x50mm, 2400x1120x60mm, 1200x600x45mm, 1400x1300x45mm and 1500x800x45mm.

The reinforcement should be clean back to bare metal before an anti-corrosion primer is applied. The areas should be patch repaired with an appropriate cementitious material, ensuring that it is sufficiently 'keyed-in' to the parent concrete.

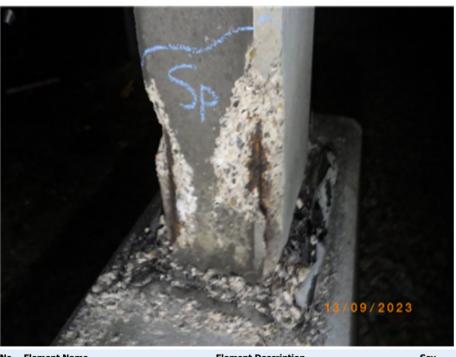
# Photograph #397

View of 2No. spalling exposing the reinforcement at bottom of C6 south face, measured 400x250x20mm

There were multiple areas of spalling exposing the corroded reinforcement at the bottom and the top of  ${\sf C6}$ south face and on the column concrete plinth/ upstand throughout, measuring 2No. of 400x250x20mm, 600x200x20mm, 670x90x15mm and 500x450x15mm. Refer to element #1 for remedial works recommendation

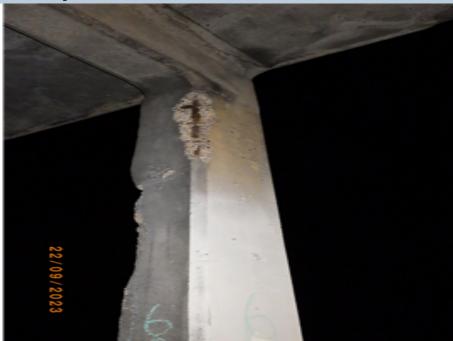
# Photograph #398

View of 2No. spalling exposing the reinforcement at top of C6 south face, measured 600x200x20mm

There were multiple areas of spalling exposing the corroded reinforcement at the bottom and the top of C6 south face and on the column concrete plinth/ upstand throughout, measuring 2No. of 400x250x20mm, 600x200x20mm, 670x90x15mm and 500x450x15mm.

# Refer to element #1 for remedial works recommendation

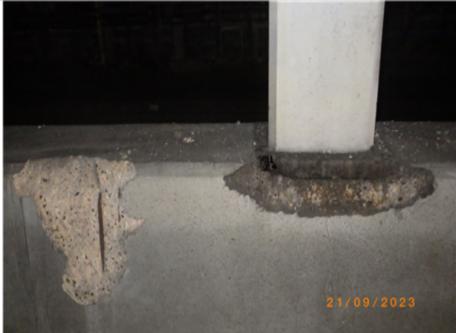
# Photograph #400

View of spalling exposing the reinforcement on the concrete plinth/upstand, measured 500x450x15mm

There were multiple areas of spalling exposing the corroded reinforcement at the bottom and the top of C6 south face and on the column concrete plinth/ upstand throughout, measuring 2No. of 400x250x20mm, 600x200x20mm, 670x90x15mm and 500x450x15mm.

# Refer to element #1 for remedial works recommendation

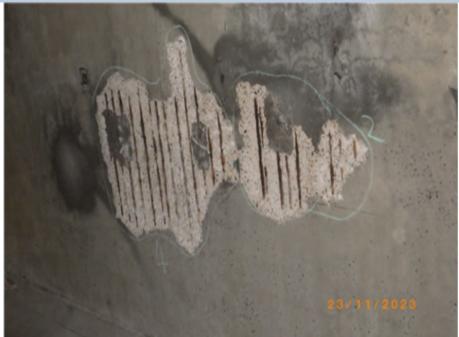
View of multiple spalling exposing the reinforcement on the deck soffit, measured 1000x700x45mm and 1500x1300x60mm

There were multiple areas of spalling exposing the corroded reinforcement on the deck soffit throughout, the worst areas measured 1000x700x45mm, 1500x1300x60mm, 900x800x50mm, 650x750x50mm, 750x650x50mm, 350x300x40mm, 800x800x40mm, 800x800x50mm and 1100x800x40mm.

The reinforcement should be clean back to bare metal before an anti-corrosion primer is applied. The areas should be patch repaired with an appropriate cementitious material, ensuring that it is sufficiently 'keyed-in' to the parent concrete.

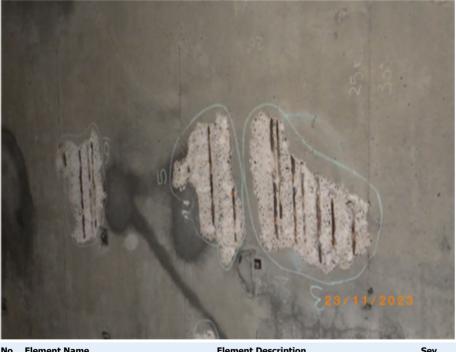
# Photograph #403

View of multiple spalling exposing the reinforcement on the deck soffit, measured 900x800x50mm, 650x750x50mm and 750x650x50mm

There were multiple areas of spalling exposing the corroded reinforcement on the deck soffit throughout, the worst areas measured 1000x700x45mm, 1500x1300x60mm, 900x800x50mm, 650x750x50mm, 750x650x50mm, 350x300x40mm, 800x800x40mm, 800x800x50mm and 1100x800x40mm.

The reinforcement should be clean back to bare metal before an anti-corrosion primer is applied. The areas should be patch repaired with an appropriate cementitious material, ensuring that it is sufficiently 'keyed-in' to the parent concrete.

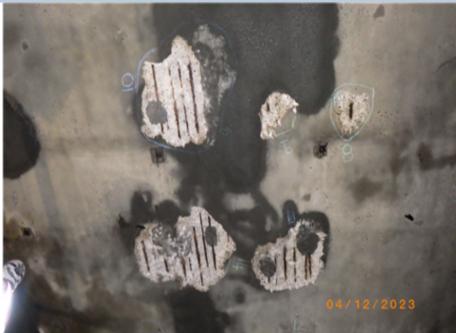
# Photograph #404

View of multiple spalling exposing the reinforcement on the deck soffit, measured 350x300x40mm, 800x800x40mm, 800x800x50mm and 1100x800x40mm

There were multiple areas of spalling exposing the corroded reinforcement on the deck soffit throughout, the worst areas measured 1000x700x45mm, 1500x1300x60mm, 900x800x50mm, 650x750x50mm, 750x650x50mm, 350x300x40mm, 800x800x40mm, 800x800x50mm and 1100x800x40mm.

The reinforcement should be clean back to bare metal before an anti-corrosion primer is applied. The areas should be patch repaired with an appropriate cementitious material, ensuring that it is sufficiently 'keyed-in' to the parent concrete.

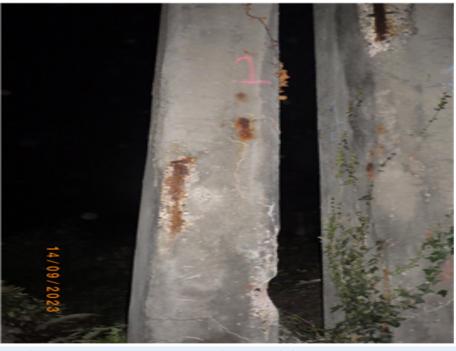
# Photograph #405

View of 700x80x45mm spalling exposing the reinforcement on C1 north face

There were multiple areas of spalling exposing the reinforcement on all columns throughout, the worst areas measured on C1-C3 North and South face, 700x80x45mm, 1200x200x45mm, 870x170x35mm, 1400x200x40mm, 700x200x30mm and 1000x150x30mm **Remedial Works**

Refer to element #1 for remedial works recommendation

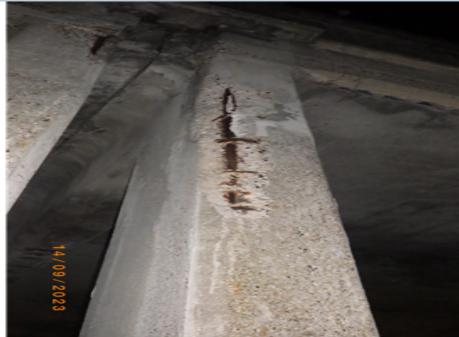
# Photograph #406

View of 1200x200x45mm spalling exposing the reinforcement on C2 south face

There were multiple areas of spalling exposing the reinforcement on all columns throughout, the worst areas measured on C1-C3 North and South face, 700x80x45mm, 1200x200x45mm, 870x170x35mm, 1400x200x40mm, 700x200x30mm and 1000x150x30mm

Refer to element #1 for remedial works recommendation

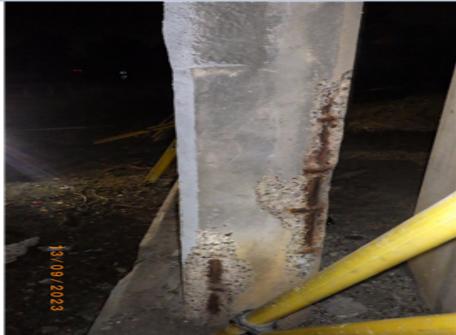
# Photograph #408 View of 700x200x30mm and 1000x150x30mm spalling exposing the reinforcement on C3 north face

There were multiple areas of spalling exposing the reinforcement on all columns throughout, the worst areas measured on C1-C3 North and South face, 700x80x45mm, 1200x200x45mm, 870x170x35mm, 1400x200x40mm, 700x200x30mm and 1000x150x30mm

# Refer to element #1 for remedial works recommendation

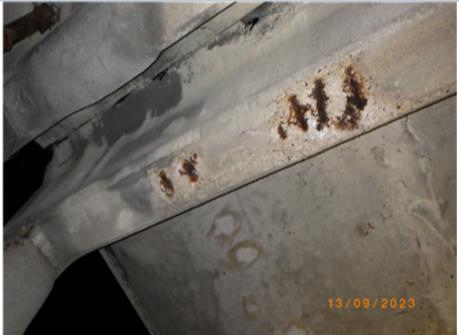
# Photograph #410

View of multiple spalling exposing the reinforcement on the cross head underside between C5 and C6, measured 800x300x40mm and 300x300x20mm

There were multiple areas of spalling exposing the reinforcement on the cross head underside throughout the whole length, the worst areas measured 450x280x40mm, 800x300x40mm and 300x300x20mm between C4-C6.

Refer to element #1 for remedial works recommendation

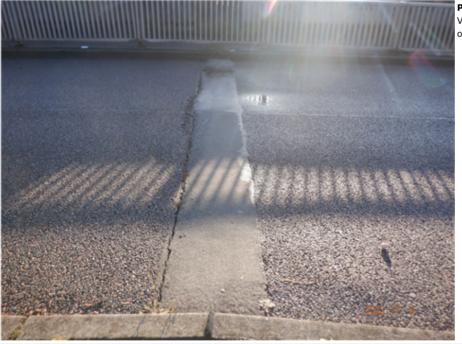
# Photograph #411

View of loss of road surface adjacent to joint on Eastbound

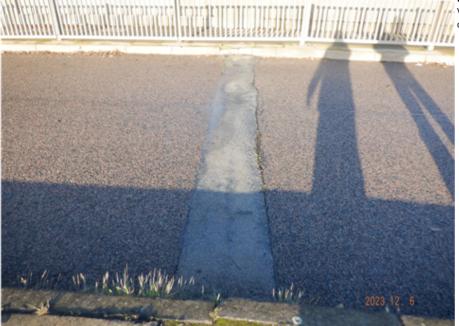
# Photograph #412

View of typical tracking and flow of binder on Westbound carriageway joint

Replace the existing expansion joints on Westbound carriageway

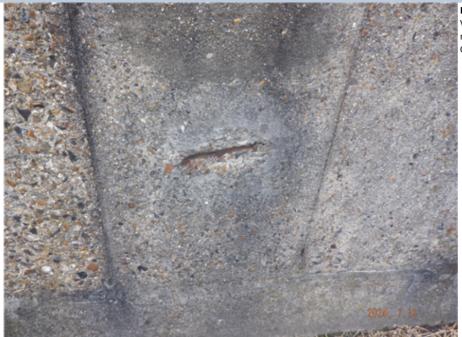
# Photograph #414

View of 50x150x75mm spalling exposing the reinforcement on South RC parapet wall at Ch.171m

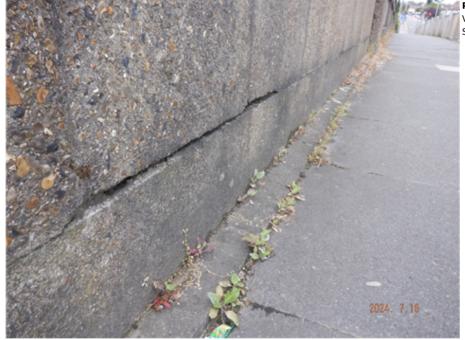
# Photograph #415

View of joint mortar loss along the bottom of South RC parapet wall at Ch.175.7m

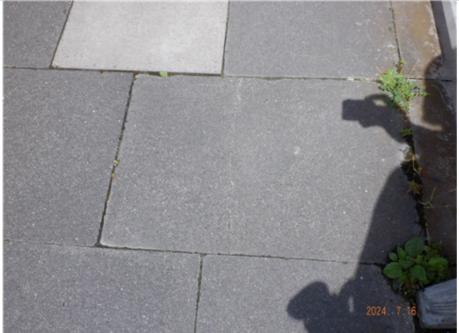
# Photograph #416

View of cracked paving slab at Ch.181m

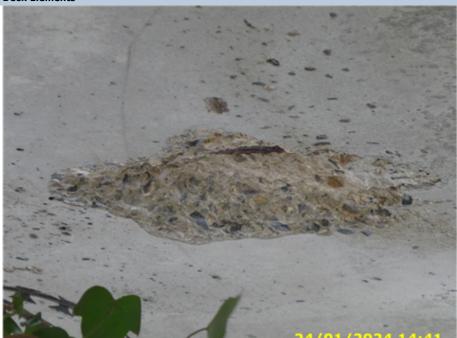
# Photograph #417

View of 400x300x35mm spalling exposing the reinforcement on the deck soffit

The reinforcement should clean back to bare metal before an anti-corrosion primer is applied. The areas should be patch repaired with an appropriate cementitious material, ensuring that it is sufficiently 'keyed-in' to the parent concrete.

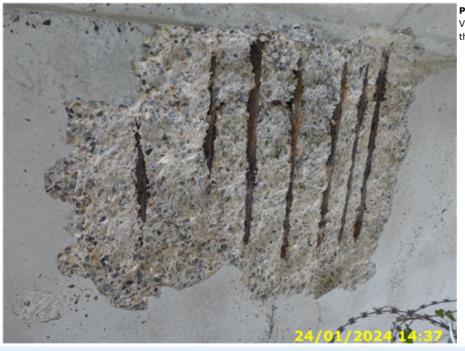
# Photograph #418

View of 1000x800x40mm spalling exposing the reinforcement on the deck soffit

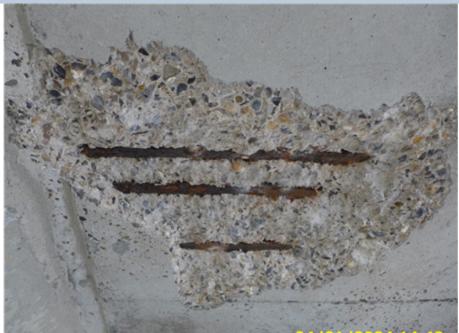
# Photograph #419

View of 600x500x40mm spalling exposing the reinforcement on the deck soffit

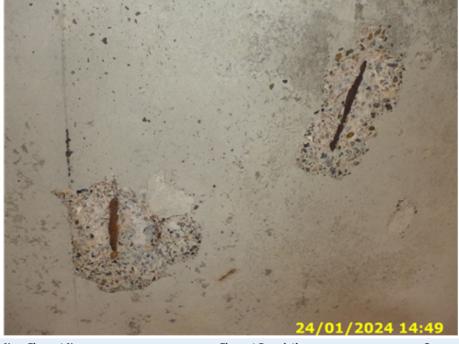
# Photograph #420

View of 300x300x35mm and 500x20x35mm spalling exposing the reinforcement on the deck soffit

The reinforcement should clean back to bare metal before an anti-corrosion primer is applied. The areas should be patch repaired with an appropriate cementitious material, ensuring that it is sufficiently 'keyed-in' to the parent concrete.

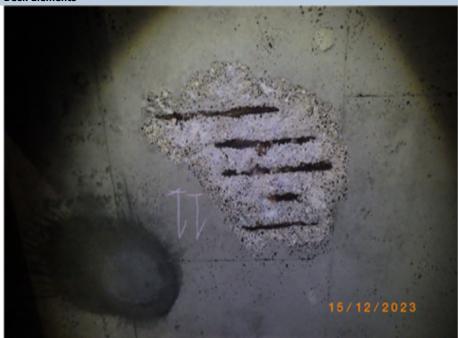
# Photograph #421

View of 1070x800x45mm spalling exposing the reinforcement on the deck soffit

The reinforcement should clean back to bare metal before an anti-corrosion primer is applied. The areas should be patch repaired with an appropriate cementitious material, ensuring that it is sufficiently 'keyed-in' to the parent concrete.

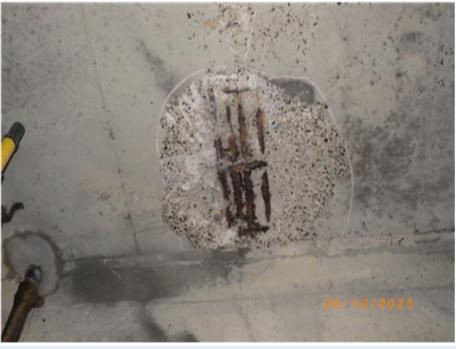
# Photograph #422

View of 950x900x45mm spalling exposing the reinforcement on the deck soffit

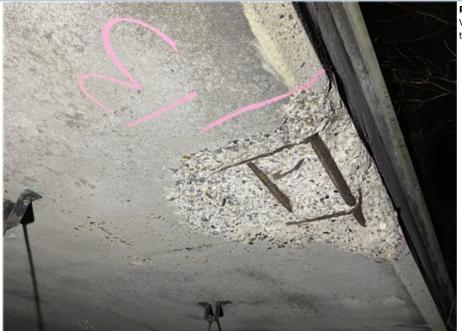
# Photograph #423

View of 600x570x45mm spalling exposing the reinforcement on the deck soffit

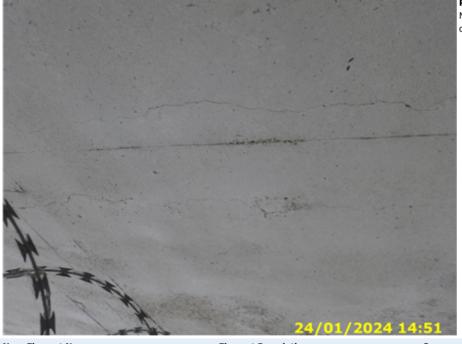
# Photograph #424

Minor shrinkage crack up to 3.5m in length on the deck soffit.

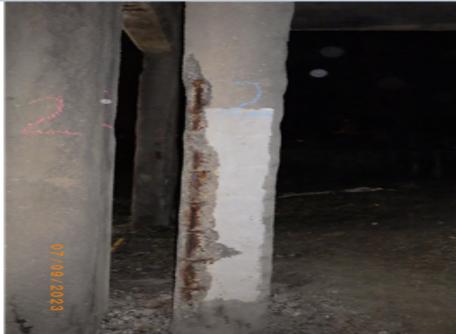
# Photograph #425

View of 1900x120x30mm spalling exposing the reinforcement on C2 north face extending to west face

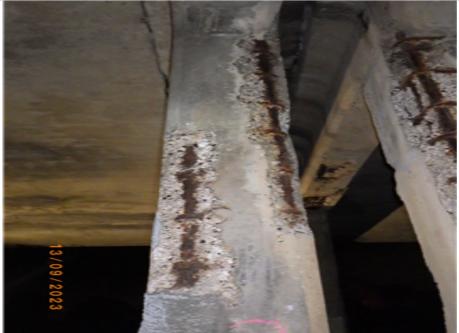
# Photograph #427

View of multiple spalling exposing the reinforcement on C3 south face extending to east face, measured 1200x150x50mm and 1200x250x50mm

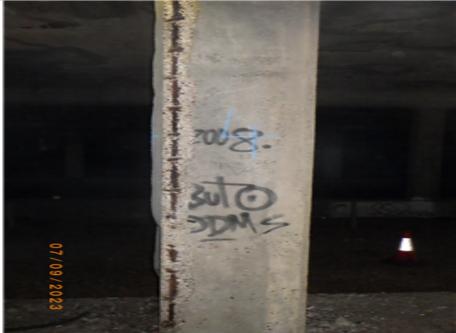
# Photograph #429

View of 3400x80x35mm spalling exposing the reinforcement on C4 north face extending to west face

There were multiple areas of spalling exposing the reinforcement on all columns throughout, the worst areas measured on C2-C4, 1900x120x30mm, 3560x300x40mm, 1200x150x50mm, 1200x250x50mm, 3200x400x25mm and 3400x80x35mm.

Refer to element #1 for remedial works recommendation

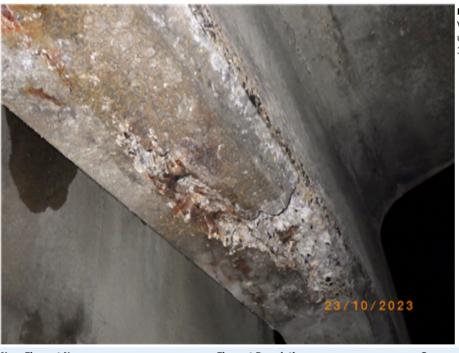
# Photograph #430

View of spalling exposing on the cross head underside between C1 and C2, measured 300x485x15mm

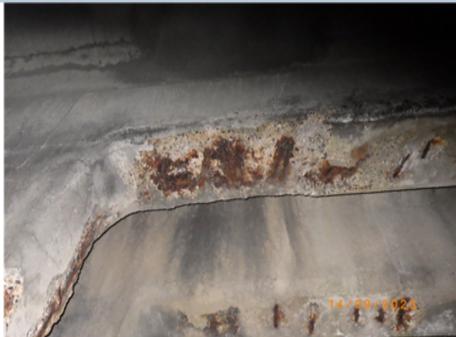
# Photograph #431

View of full width x1100x20mm spalling exposing the reinforcement on the cross head underside between C1 and C2

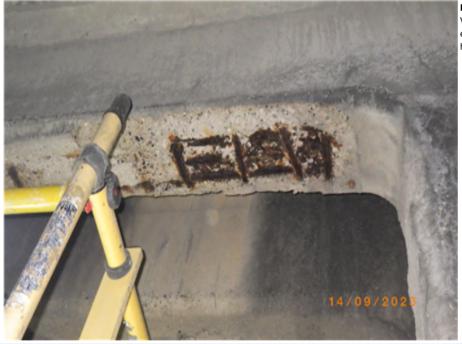
# Photograph #432

View of full width x700x20mm spalling exposing the reinforcement on the cross head underside between C2 and C3

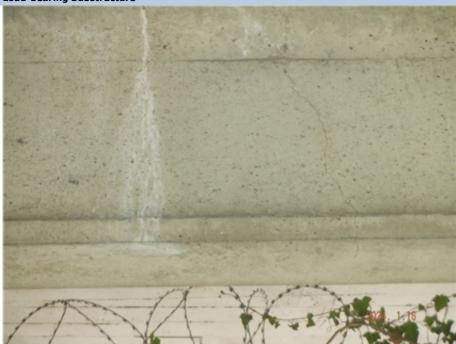
# Photograph #433

View of full height 1mm shrinkage crack on cross head between C2 and C3. Note: Crack associated with leachate

Minor full height shrinkage noted on cross heads between C2 and C3. Note: Crack associated with leachate. All other cross heads were in good condition Monitor defect during next schedule inspection

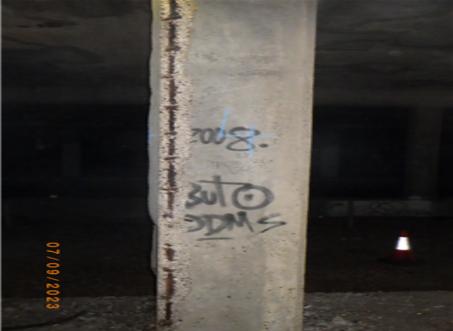
# Photograph #435

View of non-offensive graffiti on the column

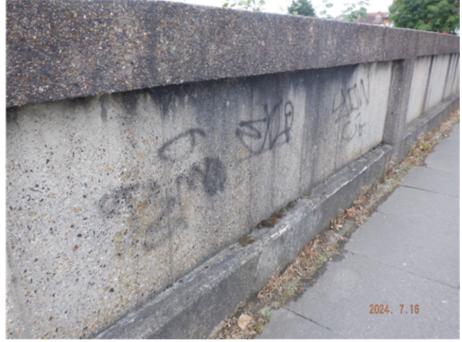
# Photograph #436

View of non-offensive graffiti within public view on Southern RC wall at Ch.185.7m

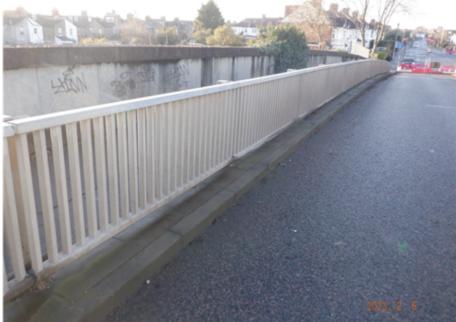
# Photograph #437

General view of North steel parapet

Overall, both North and South steel parapet appears in good condition. No visible defects noted.

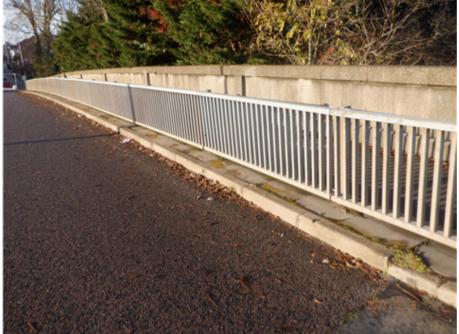
Photograph #438

General view of South steel parapet

Overall, both North and South steel parapet appears in good condition. No visible defects noted.

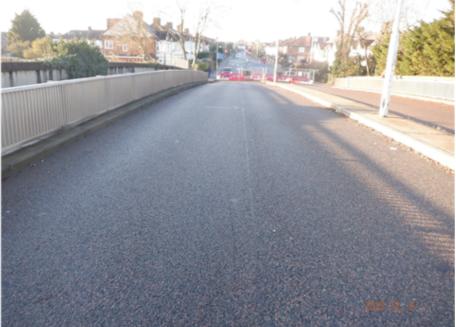
# Photograph #439

General view of Westbound carriageway surfacing

Overall, both Eastbound and Westbound carriageway surfacing appears in good condition. No visible defects noted.

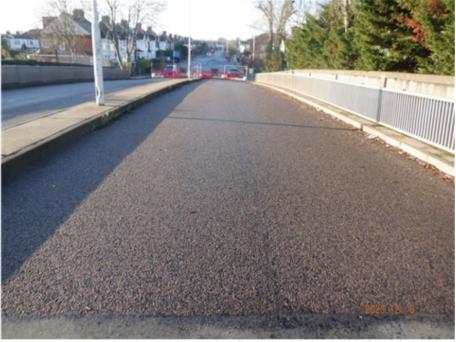
# Photograph #440

General view of Eastbound carriageway surfacing

Overall, both Eastbound and Westbound carriageway surfacing appears in good condition. No visible defects noted.

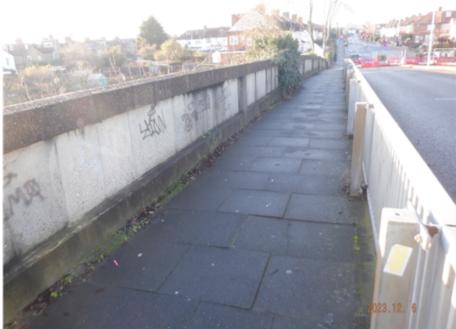
# Photograph #441

General view of South footway surfacing. Note: Vegetation growth and debris at interface with RC parapet

Monitor defect during next schedule inspection

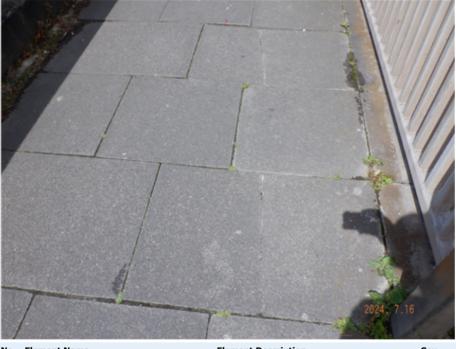
# Photograph #442

View of cracked paving slab at Ch.185m

There was cracked paving slabs on the Southern footway surfacing at Ch.185m

Monitor defect during next schedule inspection

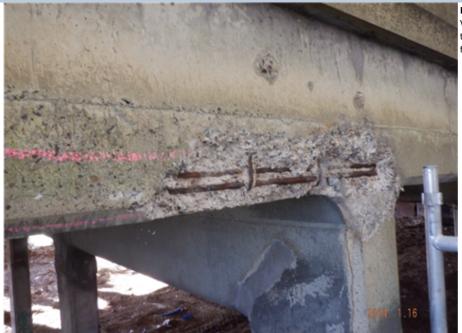
# Photograph #443

View of 1500x410x50mm spalling exposing the reinforcement on the Northern external face

There were multiple areas of spalling exposing the reinforcement on the Northern external face and on the deck soffit, measuring 1500x410x50mm, 800x450x30mm, 350x300x30mm, 400x400x40mm, 600x600x40mm, 1500x1500x50mm and 300x300x35mm.

The reinforcement should clean back to bare metal before an anti-corrosion primer is applied. The areas should be patch repaired with an appropriate cementitious material, ensuring that it is sufficiently 'keyed-in' to the parent concrete.

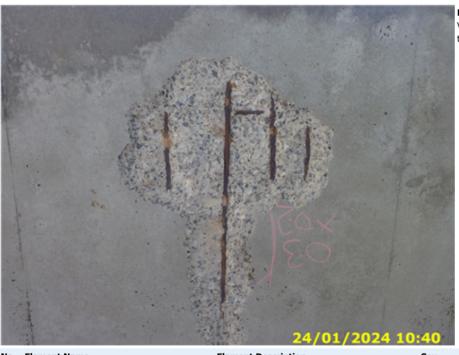
# Photograph #444

View of 800x450x30mm spalling exposing the reinforcement on the deck soffit

There were multiple areas of spalling exposing the reinforcement on the Northern external face and on the deck soffit, measuring 1500x410x50mm, 800x450x30mm, 350x300x30mm, 400x400x40mm, 600x600x40mm, 1500x1500x50mm and 300x300x35mm.

The reinforcement should clean back to bare metal before an anti-corrosion primer is applied. The areas should be patch repaired with an appropriate cementitious material, ensuring that it is sufficiently 'keyed-in' to the parent concrete.
