# **Principal Inspection Report**

Structure Name: Broadmead Road Viaduct

**Identifier:** B4

**Inspection Date:** 14/11/2023

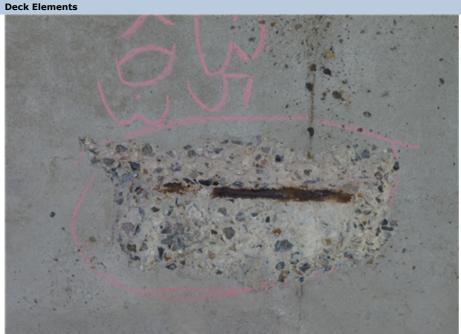
# Photograph #445

View of 350x300x30mm spalling exposing the reinforcement on the deck soffit

There were multiple areas of spalling exposing the reinforcement on the Northern external face and on the deck soffit, measuring 1500x410x50mm, 800x450x30mm, 350x300x30mm, 400x400x40mm, 600x600x40mm, 1500x1500x50mm and 300x300x35mm.

The reinforcement should clean back to bare metal before an anti-corrosion primer is applied. The areas should be patch repaired with an appropriate cementitious material, ensuring that it is sufficiently 'keyed-in' to the parent concrete.

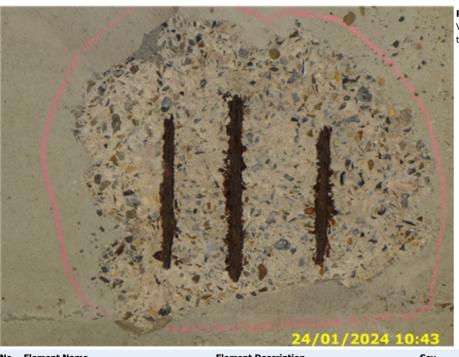
# Photograph #446

View of 400x400x40mm spalling exposing the reinforcement on the deck soffit

There were multiple areas of spalling exposing the reinforcement on the Northern external face and on the deck soffit, measuring 1500x410x50mm, 800x450x30mm, 350x300x30mm, 400x400x40mm, 600x600x40mm, 1500x1500x50mm and 300x300x35mm.

The reinforcement should clean back to bare metal before an anti-corrosion primer is applied. The areas should be patch repaired with an appropriate cementitious material, ensuring that it is sufficiently 'keyed-in' to the parent concrete.

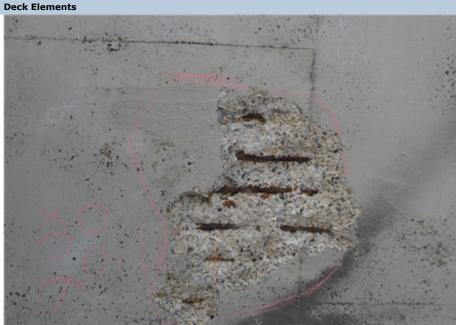
# Photograph #447

View of 600x600x40mm spalling exposing the reinforcement on the deck soffit

There were multiple areas of spalling exposing the reinforcement on the Northern external face and on the deck soffit, measuring 1500x410x50mm, 800x450x30mm, 350x300x30mm, 400x400x40mm, 600x600x40mm, 1500x1500x50mm and 300x300x35mm.

The reinforcement should clean back to bare metal before an anti-corrosion primer is applied. The areas should be patch repaired with an appropriate cementitious material, ensuring that it is sufficiently 'keyed-in' to the parent concrete.

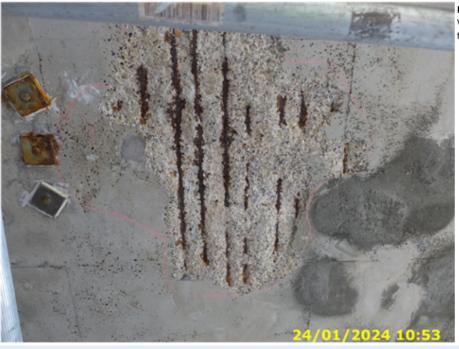
# Photograph #448

View of 1500x1500x50mm spalling exposing the reinforcement on the deck soffit

There were multiple areas of spalling exposing the reinforcement on the Northern external face and on the deck soffit, measuring 1500x410x50mm, 800x450x30mm, 350x300x30mm, 400x400x40mm, 600x600x40mm, 1500x1500x50mm and 300x300x35mm.

The reinforcement should clean back to bare metal before an anti-corrosion primer is applied. The areas should be patch repaired with an appropriate cementitious material, ensuring that it is sufficiently 'keyed-in' to the parent concrete.

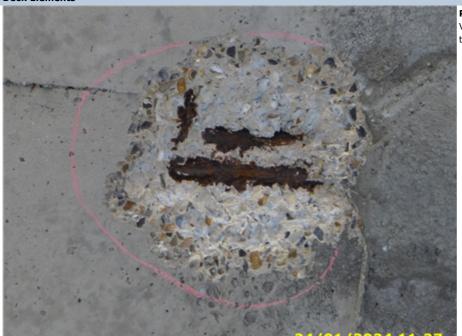
# Photograph #449

View of 300x300x35mm spalling exposing the reinforcement on the deck soffit

There were multiple areas of spalling exposing the reinforcement on the Northern external face and on the deck soffit, measuring 1500x410x50mm, 800x450x30mm, 350x300x30mm, 400x400x40mm, 600x600x40mm, 1500x1500x50mm and 300x300x35mm.

The reinforcement should clean back to bare metal before an anti-corrosion primer is applied. The areas should be patch repaired with an appropriate cementitious material, ensuring that it is sufficiently 'keyed-in' to the parent concrete.

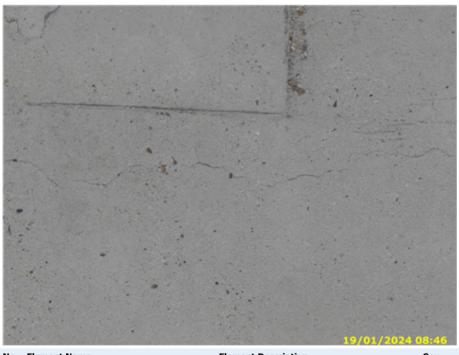
# Photograph #450

Minor shrinkage crack up to 1m in length noted on the deck soffit.

Comment Minor shrinkage crack up to 1mm and 1.3m in length

noted on the deck soffit.

Monitor defect during next schedule inspection

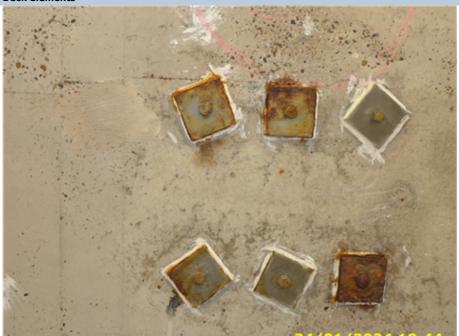
# Photograph #451

View of surface corrosion to the holding down bolts and plate

Minor surface corrosion noted on the holding down bolts and plate

Monitor defect during next schedule inspection

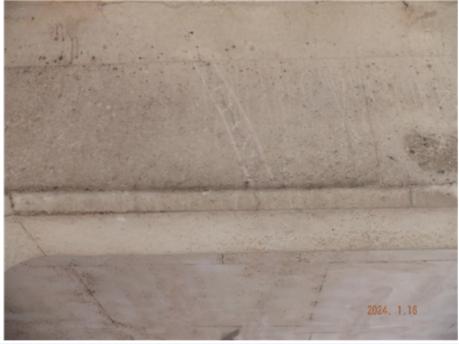
# Photograph #452

View of 2No. full height 1mm shrinkage crack on cross head between C2 and C3.

Minor full height shrinkage cracks noted on cross head between C2 and C3. All other cross heads were in good condition

Monitor defect during next schedule inspection

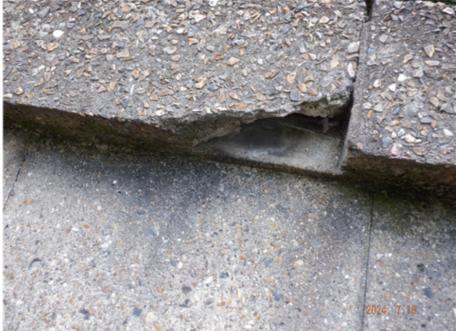
# Photograph #453

View of spalling exposing the reinforcement on the Northern parapet, measured 70x230xx60mm at Ch.192m

There was isolated spalling exposing the reinforcement on the Northern RC parapet wall, measured 140x300xx15mm, 220x70x45mm and 70x230xx60mm at Ch.192m.

Refer to element #1 for remedial works recommendation

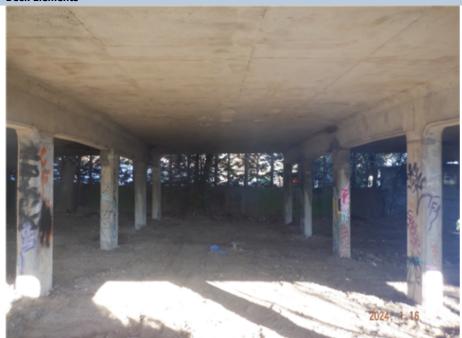
# Photograph #454

Isolated area of spalling exposing the reinforcement on external face at North end and on the deck soffit, measuring 300x300x25mm and 400x300x25mm.

The reinforcement should cleaned back to bare metal before an anti-corrosion primer is applied. The areas should be patch repaired with an appropriate cementitious material, ensuring that it is sufficiently 'keyed-in' to the parent concrete.

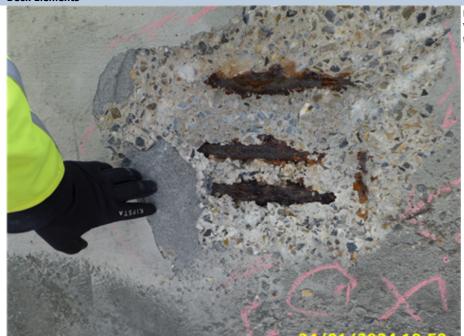
# Photograph #456

View of 400x300x25mm spalling exposing the reinforcement on the deck soffit

Isolated area of spalling exposing the reinforcement on external face at North end and on the deck soffit, measuring 300x300x25mm and 400x300x25mm.

The reinforcement should cleaned back to bare metal before an anti-corrosion primer is applied. The areas should be patch repaired with an appropriate cementitious material, ensuring that it is sufficiently 'keyed-in' to the parent concrete.

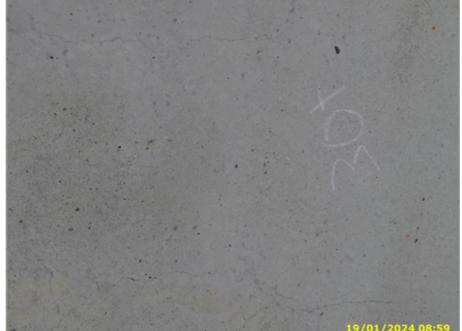
# Photograph #457

Minor shrinkage crack up to 0.6m in length noted on the deck soffit.

Multiple shrinkage cracks noted on the deck soffit, length varies from 0.6m, 0.7m, 1.1m and 1.3m.

Monitor defect during next schedule inspection

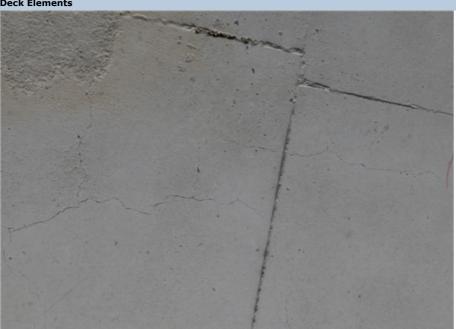
# Photograph #458

Multiple shrinkage crack up to 1.1 m, 0.7 mand 1.3m in length noted on the deck soffit. 14/11/2023

Multiple shrinkage cracks noted on the deck soffit, length varies from 0.6m, 0.7m, 1.1m and 1.3m.

Monitor defect during next schedule inspection

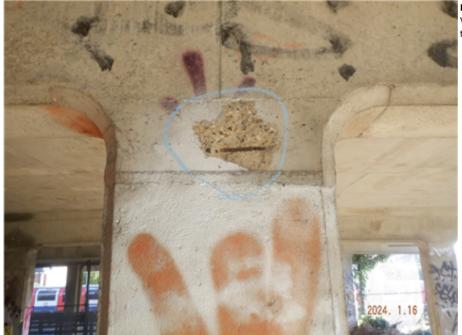
# Photograph #459

View of 140x140x20mm spalling exposing the reinforcement on C3 west face

Refer to element #1 for remedial works recommendation

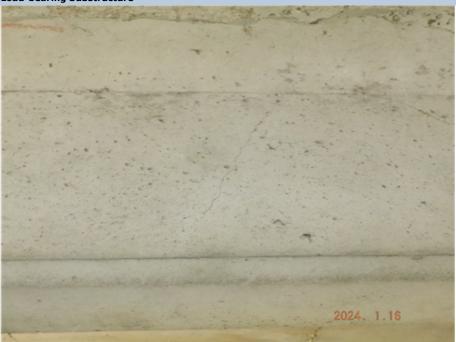
# Photograph #460

View of full height shrinkage crack between

Monitor during next schedule inspection

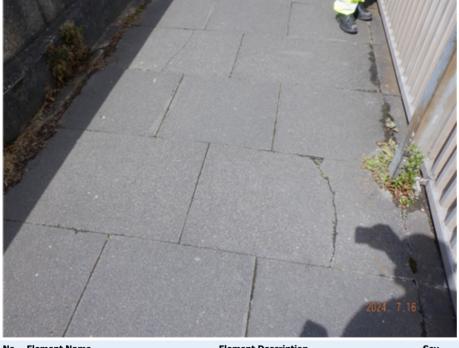
# Photograph #461

View of cracked paving slab at Ch.199m

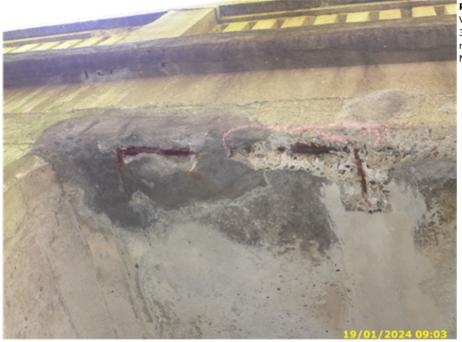
# Photograph #463

View of 450x200x40mm and 300x200x35mm spalling exposing the reinforcement on the edge of deck soffit t North end

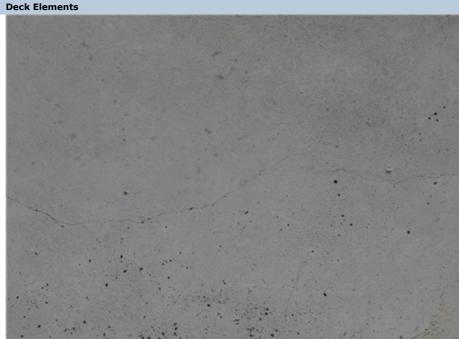
#### Photograph #464

Minor shrinkage crack up to 1.3m in length on the deck soffit.

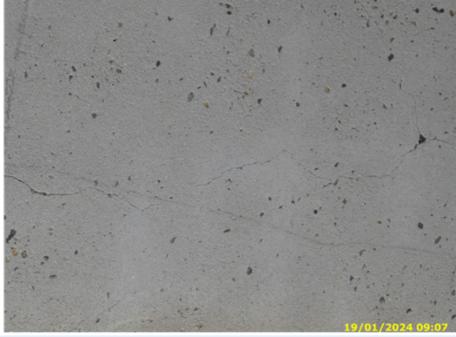
#### Photograph #465

Minor shrinkage crack up to 4.3m in length on the deck soffit.

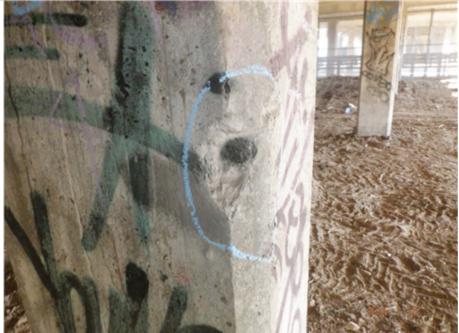
#### Photograph #466

View of 90x70x10mm spalling on the C4 west face

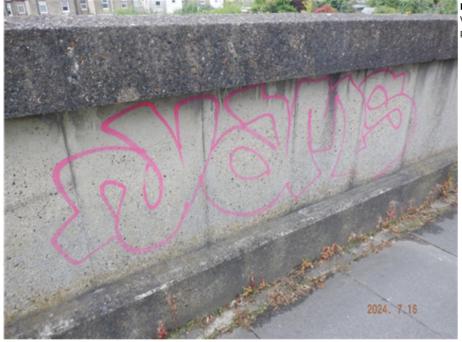
#### Photograph #467

View of non-offensive graffiti on the RC parapet wall

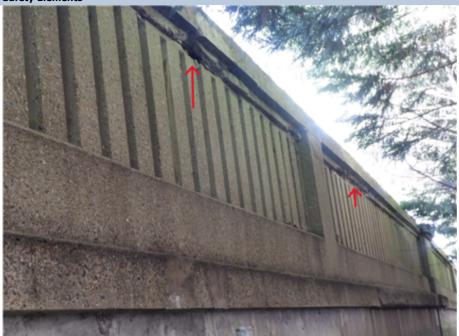
#### Photograph #468

View of minor spalling on the Northern parapet coping external face

Monitor defect during next schedule inspection

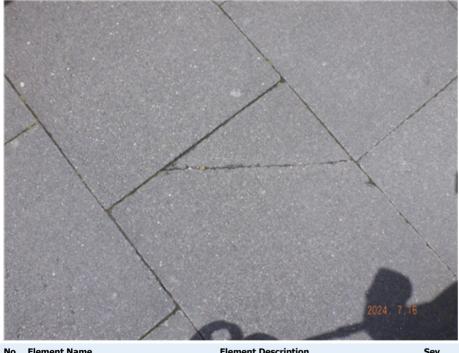
# Photograph #469

View of cracked paving slab at Ch.206m

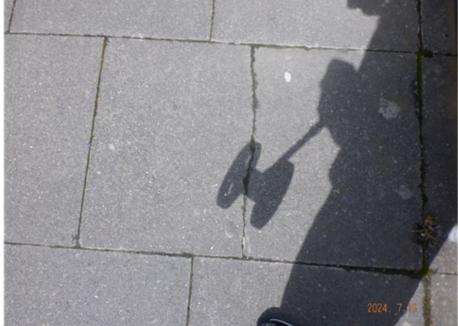
#### Photograph #470

View of cracked paving slab at Ch.202m

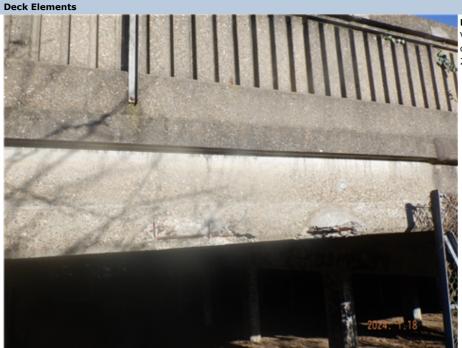
#### Photograph #471

View of spalling exposing the reinforcement on external face at South end, measured 200x700x50mm and 130x600x80mm

The reinforcement should cleaned back to bare metal before an anti-corrosion primer is applied. The areas should be patch repaired with an appropriate cementitious material, ensuring that it is sufficiently 'keyed-in' to the parent concrete.

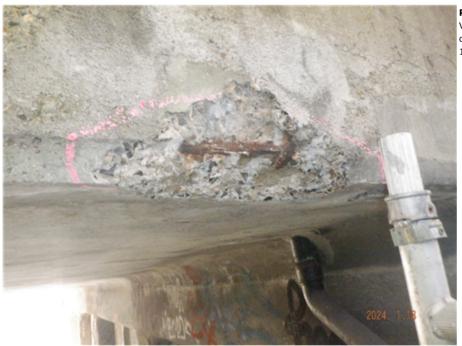
#### Photograph #472

View of spalling exposing the reinforcement on external face at North end, measured 150x370x140mm

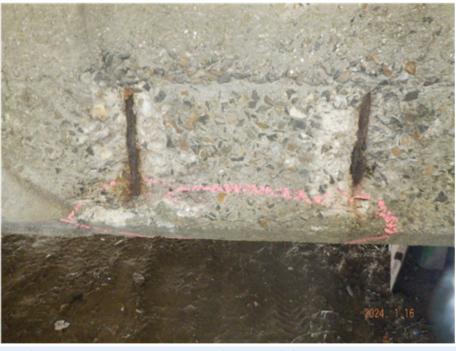
#### Photograph #474

View of spalling exposing the reinforcement on external face at North end, measured 150x150x20mm

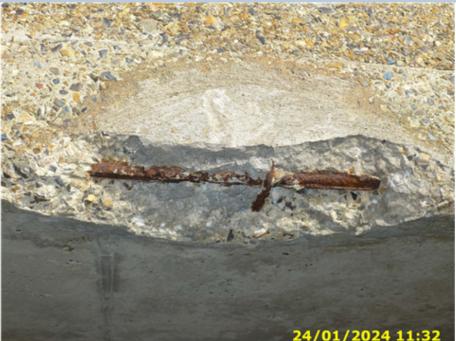
#### Photograph #475

View of 400x200x50mm spalling exposing the reinforcement on the edge of deck soffit

There were multiple areas of spalling exposing the reinforcement on external face at South and on North face, measuring200x700x50mm, 130x600x80mm, 150x370x140mm, 150x150x20mm and on the deck soffit, measuring 400x200x50mm, 1000x400x35mm, 400x250x25mm, 250x250x25mm and 500x500x25mm.

The reinforcement should cleaned back to bare metal before an anti-corrosion primer is applied. The areas should be patch repaired with an appropriate cementitious material, ensuring that it is sufficiently 'keyed-in' to the parent concrete.

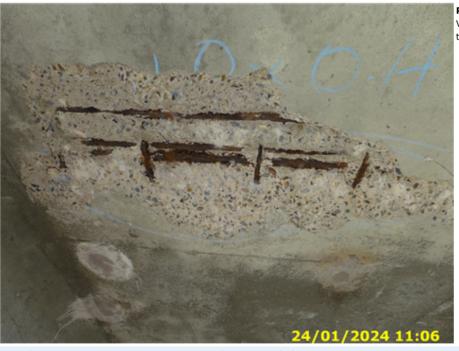
#### Photograph #476

View of 1000x400x35mm spalling exposing the reinforcement on the deck soffit

There were multiple areas of spalling exposing the reinforcement on external face at South and on North face, measuring200x700x50mm, 130x600x80mm, 150x370x140mm, 150x150x20mm and on the deck soffit, measuring 400x200x50mm, 1000x400x35mm, 400x250x25mm, 250x250x25mm and 500x500x25mm.

The reinforcement should cleaned back to bare metal before an anti-corrosion primer is applied. The areas should be patch repaired with an appropriate cementitious material, ensuring that it is sufficiently 'keyed-in' to the parent concrete.

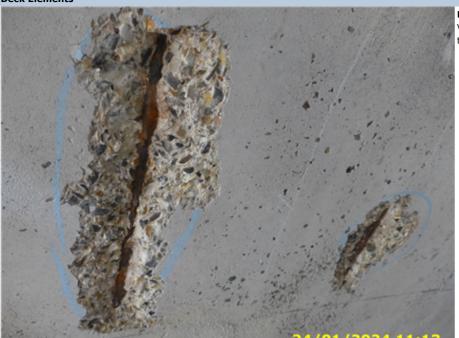
#### Photograph #477

View of 400x250x25mm spalling exposing the reinforcement on the deck soffit

There were multiple areas of spalling exposing the reinforcement on external face at South and on North face, measuring200x700x50mm, 130x600x80mm, 150x370x140mm, 150x150x20mm and on the deck soffit, measuring 400x200x50mm, 1000x400x35mm, 400x250x25mm, 250x250x25mm and 500x500x25mm.

The reinforcement should cleaned back to bare metal before an anti-corrosion primer is applied. The areas should be patch repaired with an appropriate cementitious material, ensuring that it is sufficiently 'keyed-in' to the parent concrete.

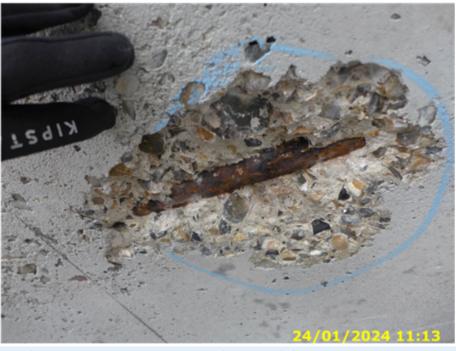
#### Photograph #478

View of 250x250x25mm spalling exposing the reinforcement on the deck soffit

There were multiple areas of spalling exposing the reinforcement on external face at South and on North face, measuring200x700x50mm, 130x600x80mm, 150x370x140mm, 150x150x20mm and on the deck soffit, measuring 400x200x50mm, 1000x400x35mm, 400x250x25mm, 250x250x25mm and 500x500x25mm.

The reinforcement should cleaned back to bare metal before an anti-corrosion primer is applied. The areas should be patch repaired with an appropriate cementitious material, ensuring that it is sufficiently 'keyed-in' to the parent concrete.

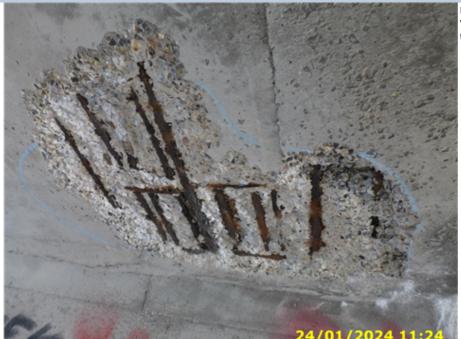
#### Photograph #479

View of 500x500x50mm spalling exposing the reinforcement on the deck soffit

There were multiple areas of spalling exposing the reinforcement on external face at South and on North face, measuring200x700x50mm, 130x600x80mm, 150x370x140mm, 150x150x20mm and on the deck soffit, measuring 400x200x50mm, 1000x400x35mm, 400x250x25mm, 250x250x25mm and 500x500x25mm.

The reinforcement should cleaned back to bare metal before an anti-corrosion primer is applied. The areas should be patch repaired with an appropriate cementitious material, ensuring that it is sufficiently 'keyed-in' to the parent concrete.

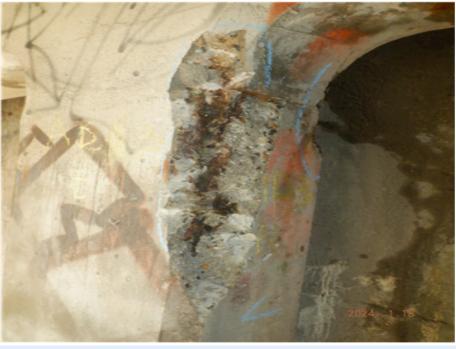
#### Photograph #480

View of 630x150x50mm spalling exposing the reinforcement on C3 north face

There were multiple areas of spalling exposing the reinforcement on the cross head between C3-C4, measuring 630x150x50mm, 260x100x50mm and 630x630x50mm. All other columns were in good condition

**Remedial Works** Refer to element #1 for remedial works recommendation

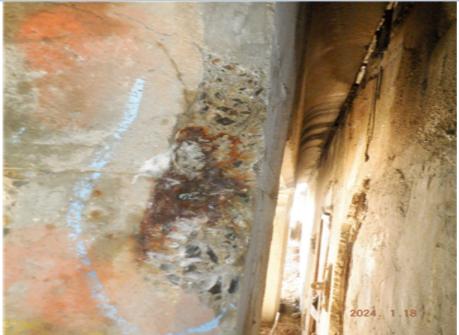
#### Photograph #481

View of 260x100x50mm spalling exposing the reinforcement on C3 north face

There were multiple areas of spalling exposing the reinforcement on the cross head between C3-C4, measuring 630x150x50mm, 260x100x50mm and 630x630x50mm. All other columns were in good condition

Refer to element #1 for remedial works recommendation

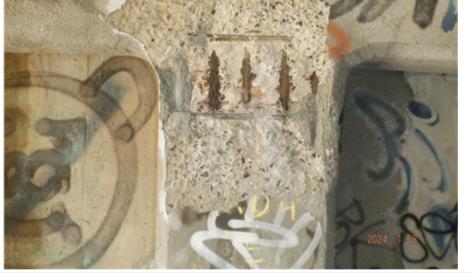
# Photograph #482

View of 630x630x50mm spalling exposing the reinforcement on C4 east face extending to cross head

There were multiple areas of spalling exposing the reinforcement on the cross head between C3-C4, measuring 630x150x50mm, 260x100x50mm and 630x630x50mm. All other columns were in good condition

Refer to element #1 for remedial works recommendation

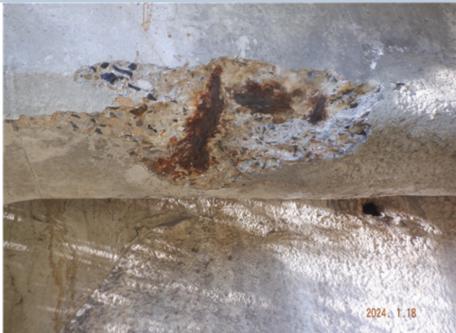
#### Photograph #483

View of full width x350x35mm spalling exposing the reinforcement on the cross head underside extending to east face between C1 and C2

There were multiple areas of spalling exposing the reinforcement on the cross head between C1-C4, measurin140x400x35mm, 200x300x30mm, full width x2105x55mm and full widthx460x40mm.

#### Refer to element #1 for remedial works recommendation

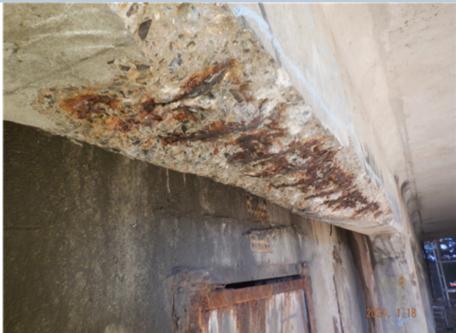
#### Photograph #485

View of full width x2105x55mm spalling exposing the reinforcement on the cross head underside between C2 and C3

There were multiple areas of spalling exposing the reinforcement on the cross head between C1-C4, measurin140x400x35mm, 200x300x30mm, full width x2105x55mm and full widthx460x40mm.

Refer to element #1 for remedial works recommendation

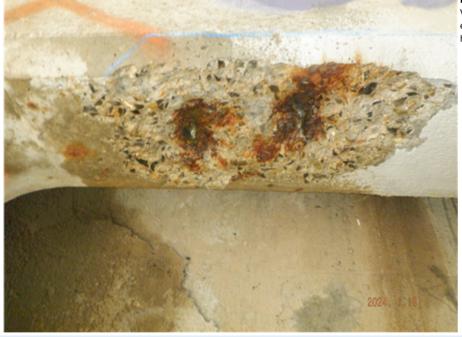
#### Photograph #486

View of full width x460x40mm spalling exposing the reinforcement on the cross head underside between C3 and C4

There were multiple areas of spalling exposing the reinforcement on the cross head between C1-C4, measurin140x400x35mm, 200x300x30mm, full width x2105x55mm and full widthx460x40mm.

Refer to element #1 for remedial works recommendation

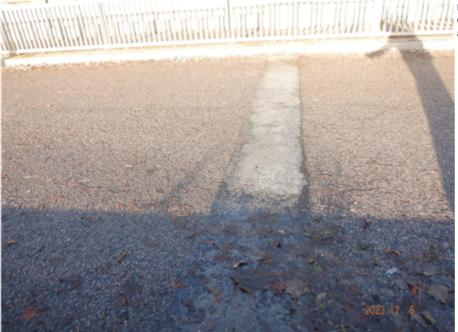
#### Photograph #487

General view of Eastbound carriageway asphalt plug joint

There was longstanding moderate tracking and flow of binder on both eastbound and westbound carriageway surfacing leading to extensive water leakage onto the elements below. This is consistent with 2023 GI.

Replace the existing asphalt plug joint at both ends

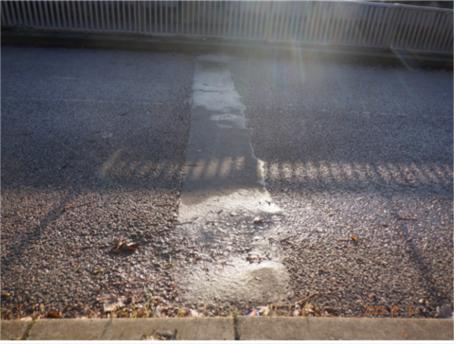
#### Photograph #488 General view of Westbound carriageway asphalt plug joint

There was longstanding moderate tracking and flow of binder on both eastbound and westbound carriageway surfacing leading to extensive water leakage onto the elements below.. This is consistent with 2023 GI.

Replace the existing asphalt plug joint at both ends

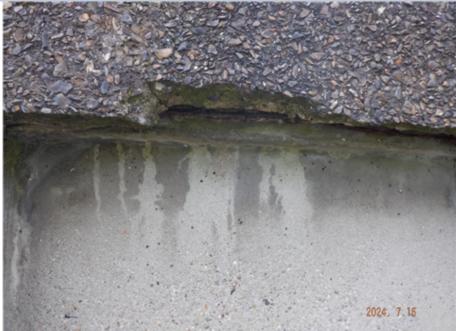
#### Photograph #489

View of 50x240x40mm spalling exposing the reinforcement on South parapet coping at Ch.207.8m

There was isolated area of spalling exposing the reinforcement on South parapet coping at Ch.207.8m, measured 50x240x40mm and 50x280x60mm on the North parapet coping at Ch.209.4m.

The reinforcement should cleaned back to bare metal before an anti-corrosion primer is applied. The areas should be patch repaired with an appropriate cementitious material, ensuring that it is sufficiently 'keyed-in' to the parent concrete.

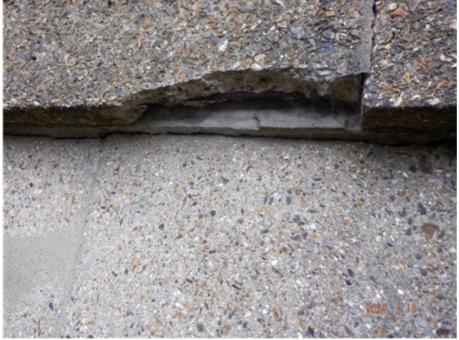
#### Photograph #490

View of 50x280x60mm spalling exposing the reinforcement on North parapet coping at Ch.209.4m

There was isolated area of spalling exposing the reinforcement on South parapet coping at Ch.207.8m, measured 50x240x40mm and 50x280x60mm on the North parapet coping at Ch.209.4m.

The reinforcement should cleaned back to bare metal before an anti-corrosion primer is applied. The areas should be patch repaired with an appropriate cementitious material, ensuring that it is sufficiently 'keyed-in' to the parent concrete.

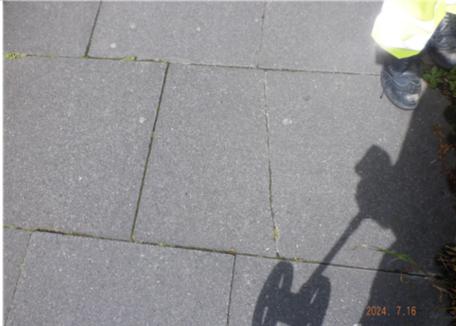
#### Photograph #491

View of cracked paving slab at Ch.213m and Ch.209m

There were cracked paving slabs on the Southern footway surfacing at Ch.209m and Ch.213m

Monitor defect during next schedule inspection

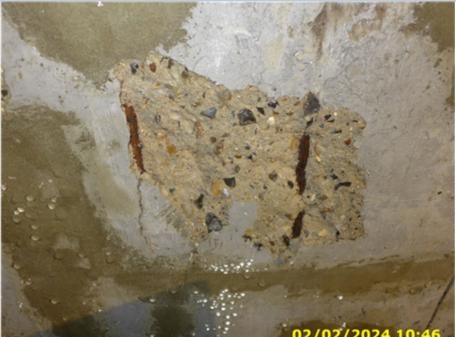
#### Photograph #492

View of 225x225x25mm spalling exposing the reinforcement on the deck soffit

There were multiple areas of spalling exposing the reinforcement on the deck soffit, measuring 225x225x25mm, 50x50x15mm, 70x50x20mm and 200x50x15mm.

The reinforcement should cleaned back to bare metal before an anti-corrosion primer is applied. The areas should be patch repaired with an appropriate cementitious material, ensuring that it is sufficiently 'keyed-in' to the parent concrete.

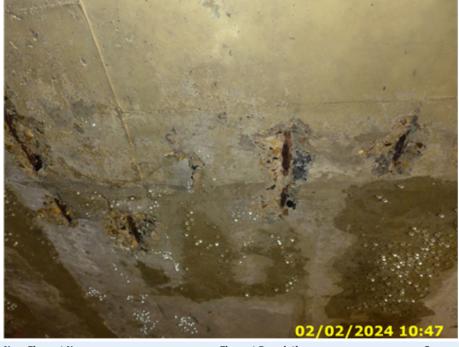
View of multiple spalling spalling exposing the reinforcement on the deck soffit, measured 50x50x15mm and 70x50x20mm

There were multiple areas of spalling exposing the reinforcement on the deck soffit, measuring 225x225x25mm, 50x50x15mm, 70x50x20mm and 200x50x15mm.

The reinforcement should cleaned back to bare metal before an anti-corrosion primer is applied. The areas should be patch repaired with an appropriate cementitious material, ensuring that it is sufficiently 'keyed-in' to the parent concrete.

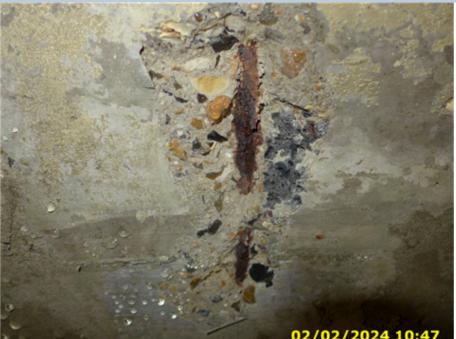
#### Photograph #494

View of 200x50x15mm spalling exposing the reinforcement on the deck soffit

There were multiple areas of spalling exposing the reinforcement on the deck soffit, measuring 225x225x25mm, 50x50x15mm, 70x50x20mm and 200x50x15mm.

The reinforcement should cleaned back to bare metal before an anti-corrosion primer is applied. The areas should be patch repaired with an appropriate cementitious material, ensuring that it is sufficiently 'keyed-in' to the parent concrete.

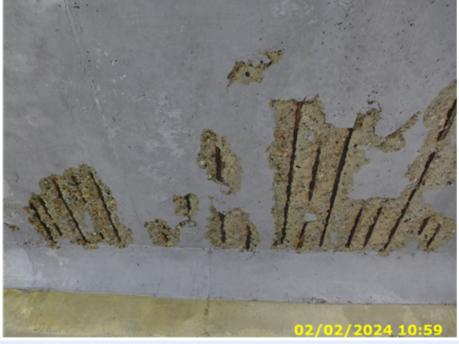
View of multiple spalling exposing the reinforcement on the deck soffit, worse measured 800x800x35mm and 400x600x30mm

There were multiple areas of spalling exposing the reinforcement on the deck soffit. The worst areas measured 800x800x35mm, 400x600x30mm and 400x400x20mm.

Refer to element #1 above for remedial works recommendation

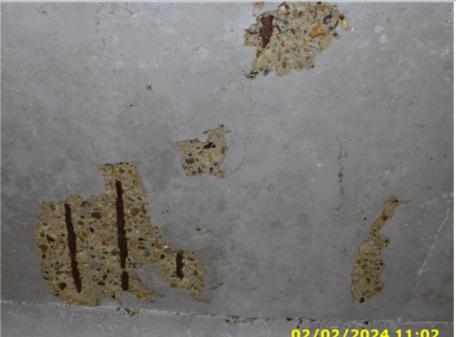
#### Photograph #496

View of 400x400x20mm spalling exposing the reinforcement on the deck soffit

Refer to element #1 above for remedial works recommendation

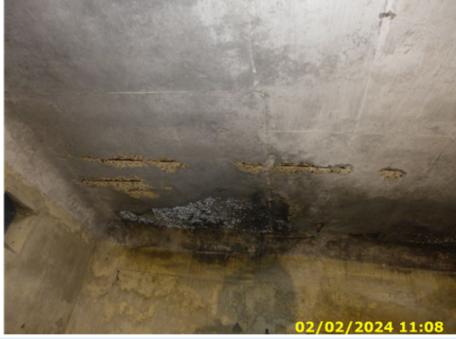
#### Photograph #497

View of multiple spalling exposing the reinforcement on the deck soffit at South, measured, 650x200x20mm and 700x100x20mm

Refer to element #1 above for remedial works recommendation

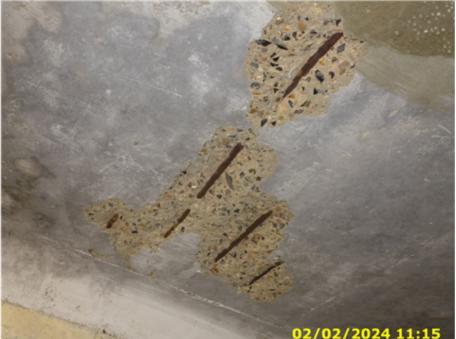
#### Photograph #498

View of multiple spalling exposing the reinforcement on the deck soffit, measured, 500x500x25mm and 250x250x25mm

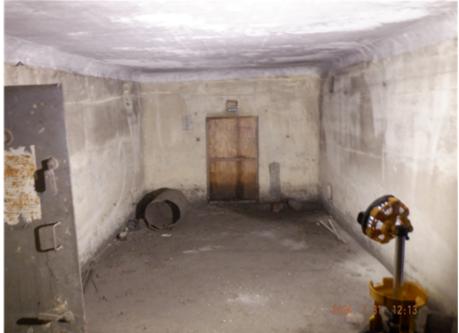
Photograph #500 General view facing East

There was isolated area of spalling exposing the reinforcement on the deck soffit, measuring 1700x200x10mm.

Refer to element #1 above for remedial works recommendation

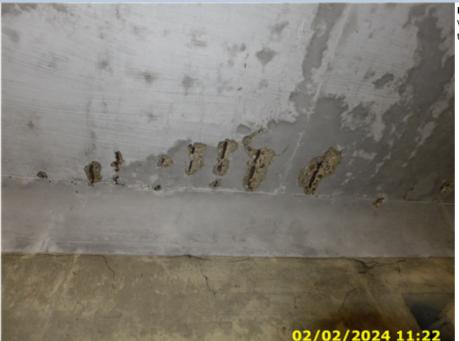
#### Photograph #502

View of 1700x200x10mmspalling exposing the reinforcement on the deck soffit.

There was isolated area of spalling exposing the reinforcement on the deck soffit, measuring 1700x200x10mm.

Refer to element #1 above for remedial works recommendation

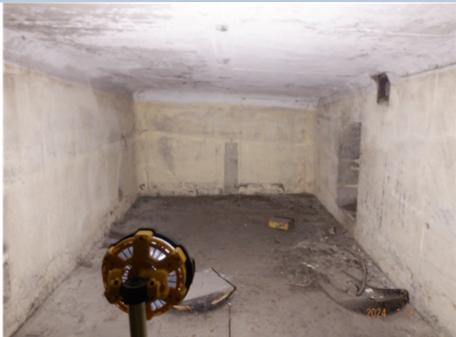
Photograph #504 General view facing West

Overall, room #5 deck soffit appears in good condition. No visible defects recorded during the inspection [none]

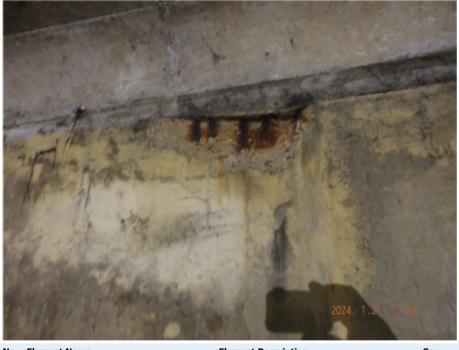
# Photograph #505

View of spalling exposing the reinforcement on Eastern support wall, measured 300x150x25mm. Room #1

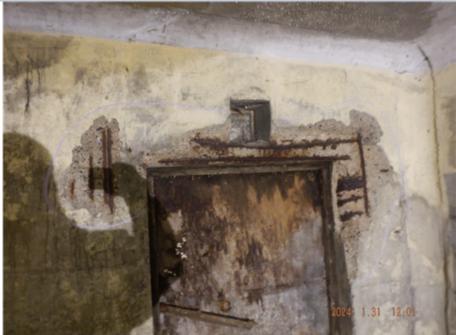
#### Photograph #506

View of spalling exposing the reinforcement on Eastern support wall, measured 950x1400x200mm. Room #2

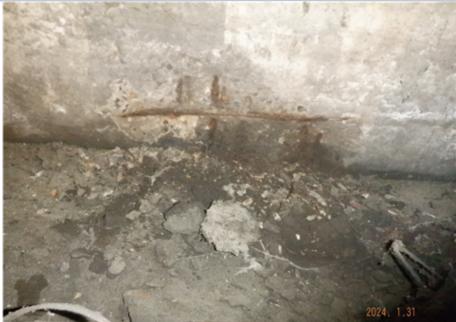
#### Photograph #507

View of 200x500x25mm spalling exposing the reinforcement at base of wall. Room #4

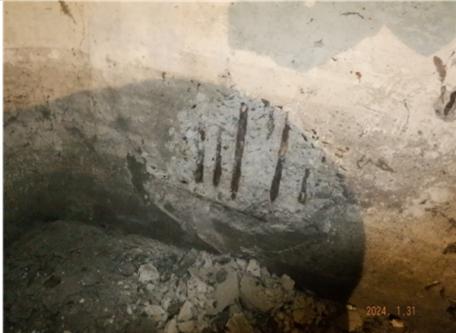
#### Photograph #508

View of 370x400x35mm spalling exposing the reinforcement at base of wall. Room #4

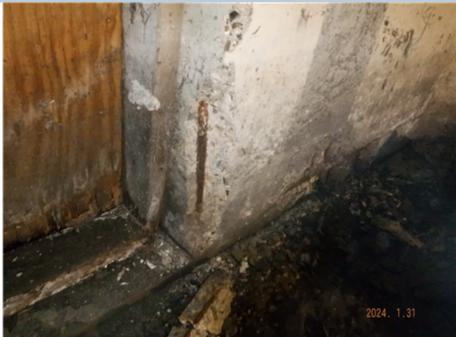
#### Photograph #509

View of 400x100x50mm spalling exposing the reinforcement. Room #4

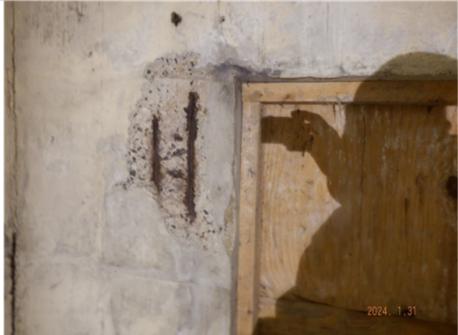
#### Photograph #510

View of 500x270x30mm spalling exposing the reinforcement. Room #5

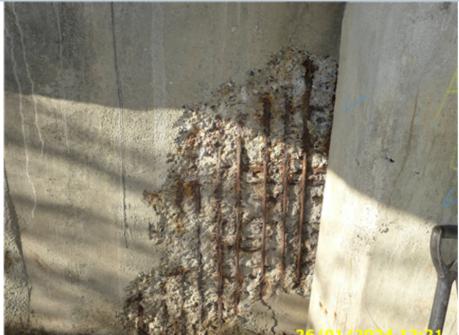
#### Photograph #511

View of 1450x1100x25-30mm spalling exposing the reinforcement on Eastern face of Western support wall

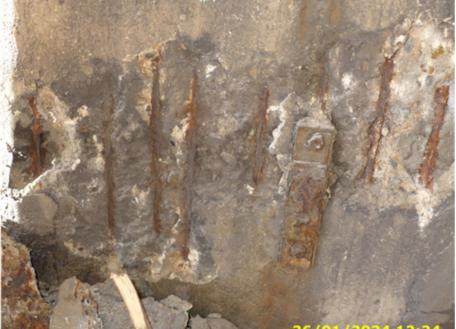
#### Photograph #512

View of 700x400x25-30mm spalling exposing the reinforcement on Eastern face of Western support wall

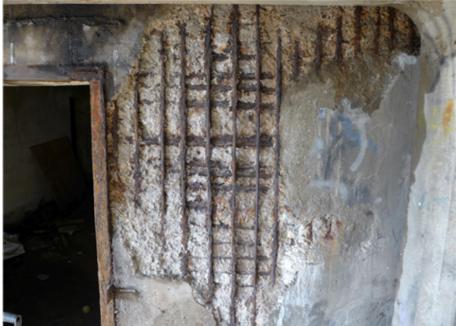
#### Photograph #513

View of 1450x1100x25-30mm spalling exposing the reinforcement on Eastern face of Western support wall

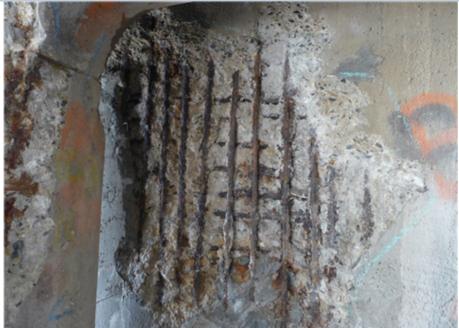
#### Photograph #514

View of 1650x800x30-40mm spalling exposing the reinforcement on Eastern face of Western support wall

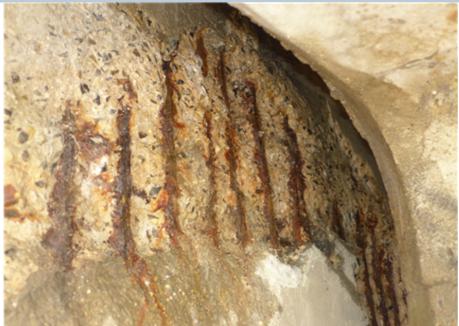
#### Photograph #515

View of 450x600x30mm spalling exposing the reinforcement on Eastern face of Western support wall

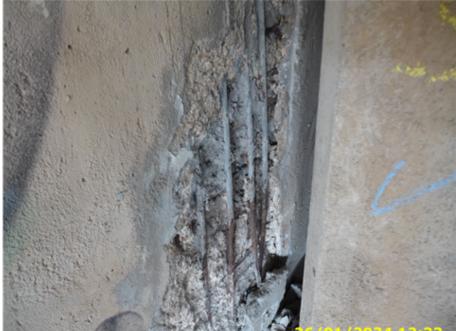
#### Photograph #516

View of 600x2200x50mm spalling exposing the reinforcement on Eastern face of Western support wall

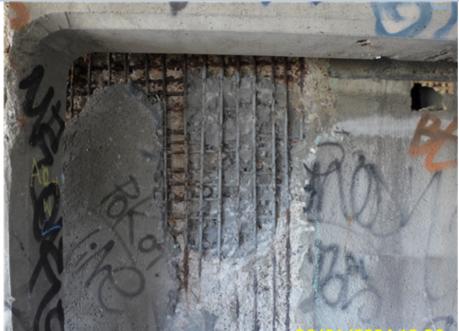
#### Photograph #517

View of 700x2200x80mm spalling exposing the reinforcement on Eastern face of Western support wall

No	Element Name	Element Description	Sev	Ext	Defect	Priority	Works	Cost £k
11	Pier/column	Western support wall	4	D	2.1	Н	Υ	5

There were multiple areas of spalling exposing the reinforcement on the Western face of support wall, measuring 300x150x25mm, 950x1400x200mm, 200x500x25mm, 500x270x30mm, 370x400x35mm and 400x100x50mm. Noted in room #1-2 and room #4-5. Also, on Eastern face of the support wall, measured 1450x1100x25-30mm, 700x400x25-30mm, 1450x1100x25-30mm, 1650x800x30-40mm, 450x600x30mm and 700x2200x80mm.

Refer to element #1 for remedial works recommendation

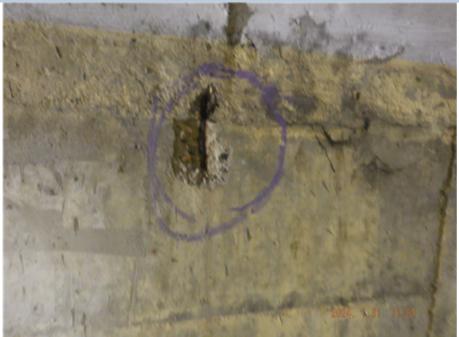
#### Photograph #518

View of spalling with exposing reinforcement on the Northern pier wall, measured 110x60x10mm

No	Element Name	Element Description	Sev	Ext	Defect	Priority	Works	Cost £k
11	Pier/column	Northern pier wall	3	В	2.2	L	Υ	0.2

There was an isolated area of spalling area exposing the reinforcement on the Northern pier wall, measuring 110x60x10mm, 1300x600x10mm and 190x190x30mm. Noted in room #1 and #5.

Refer to element #1 for remedial works recommendation

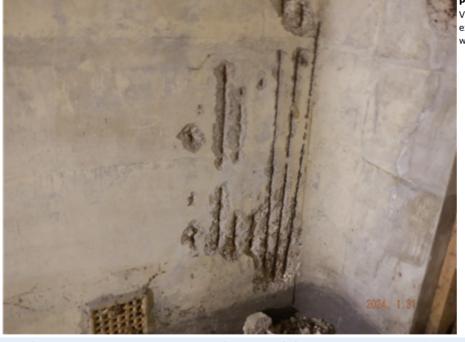
#### Photograph #519

View of 1300x600x10mm spalling with exposing reinforcement on the Northern pier wall

No	Element Name	Element Description	Sev	Ext	Defect	Priority	Works	Cost £k
11	Pier/column	Northern pier wall	3	В	2.2	L	Υ	0.2

There was an isolated area of spalling area exposing the reinforcement on the Northern pier wall, measuring 110x60x10mm, 1300x600x10mm and 190x190x30mm. Noted in room #1 and #5.

Refer to element #1 for remedial works recommendation

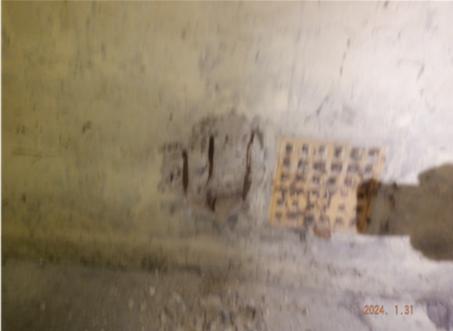
#### Photograph #520

View of 190x190x30mm spalling with exposing reinforcement on the Northern pier wall

No	Element Name	Element Description	Sev	Ext	Defect	Priority	Works	Cost £k
11	Pier/column	Northern pier wall	3	В	2.2	L	Υ	0.2

There was an isolated area of spalling area exposing the reinforcement on the Northern pier wall, measuring 110x60x10mm, 1300x600x10mm and 190x190x30mm. Noted in room #1 and #5.

Refer to element #1 for remedial works recommendation

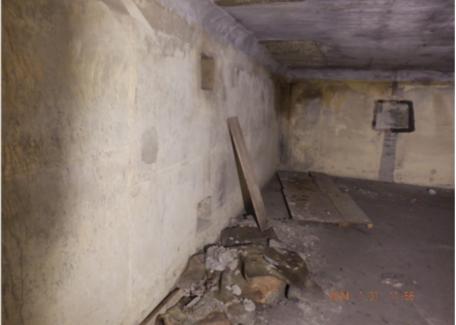
# Photograph #521 Partial view of Southern pier wall - Room #1

No	Element Name	Element Description	Sev	Ext	Defect	Priority	Works	Cost £k
11	Pier/column	Southern pier wall	3	В	2.2	L	Υ	0.35

Isolated area of spalling exposing the reinforcement at bottom of pier, measuring 280x750x30mm and 200x550x40mm. Noted in room #3 and #5

The reinforcement should cleaned back to bare metal before an anti-corrosion primer is applied. The areas should be patch repaired with an appropriate cementitious material, ensuring that it is sufficiently 'keyed-in' to the parent concrete.

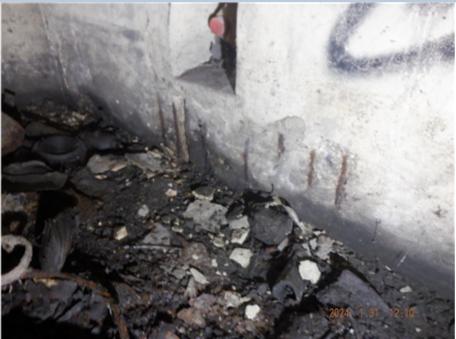
#### Photograph #522

View of 280x750x30mm spalling exposing the reinforcement at bottom of pier - Room #3

No	Element Name	Element Description	Sev	Ext	Defect	Priority	Works	Cost £k
11	Pier/column	Southern pier wall	3	В	2.2	L	Υ	0.35

Isolated area of spalling exposing the reinforcement at bottom of pier, measuring 280x750x30mm and 200x550x40mm. Noted in room #3 and #5

The reinforcement should cleaned back to bare metal before an anti-corrosion primer is applied. The areas should be patch repaired with an appropriate cementitious material, ensuring that it is sufficiently 'keyed-in' to the parent concrete.

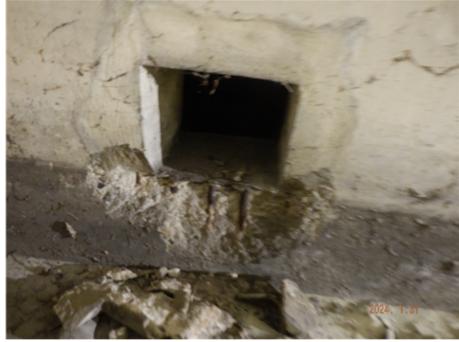
View of 200x550x40mm spalling exposing the reinforcement at bottom of pier - Room #5

No	Element Name	Element Description	Sev	Ext	Defect	Priority	Works	Cost £k
11	Pier/column	Southern pier wall	3	В	2.2	L	Υ	0.35

Isolated area of spalling exposing the reinforcement at bottom of pier, measuring 280x750x30mm and 200x550x40mm. Noted in room #3 and #5

The reinforcement should cleaned back to bare metal before an anti-corrosion primer is applied. The areas should be patch repaired with an appropriate cementitious material, ensuring that it is sufficiently 'keyed-in' to the parent concrete.

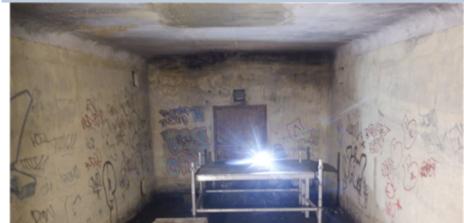
#### Photograph #524

View of widespread graffiti on both pier wall and abutment. Room #3

No	Element Name	Element Description	Sev	Ext	Defect	Priority	Works	Cost £k
20	Finishes: substructure elements	Finishes: substructure elements	2	D		L	Υ	1

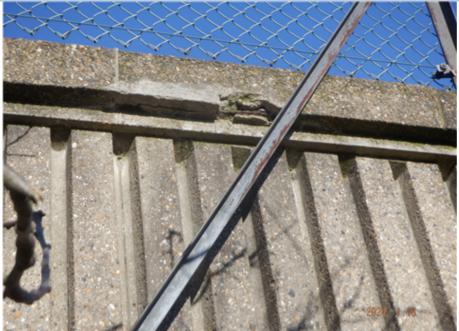
#### Photograph #526

View of spalling exposing the reinforcement on South RC parapet coping

No	Element Name	Element Description	Sev	Ext	Defect	Priority	Works	Cost £k
23	Handrail/parapets/safety fences	Handrail/parapets/safety fences	3	В	2.2	L	Υ	0.3

There was 2No. areas of spalling exposing the reinforcement on the Southern parapet coping external face and 2No. on internal face, measured 80x270x40mm at Ch.214.3m and 50x550x40mm at Ch.222.3m

The reinforcement should clean back to bare metal before an anti-corrosion primer is applied. The areas should be patch repaired with an appropriate cementitious material, ensuring that it is sufficiently 'keyed-in' to the parent concrete.

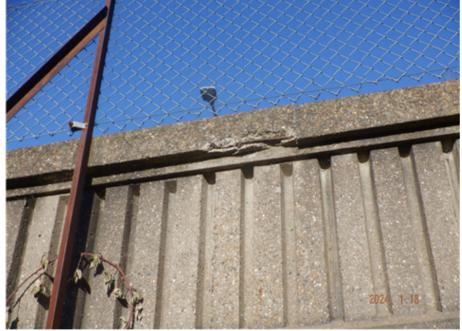
#### Photograph #527

View of spalling exposing the reinforcement on South RC parapet coping

No	Element Name	Element Description	Sev	Ext	Defect	Priority	Works	Cost £k
23	Handrail/parapets/safety fences	Handrail/parapets/safety fences	3	В	2.2	L	Υ	0.3

There was 2No. areas of spalling exposing the reinforcement on the Southern parapet coping external face and 2No. on internal face, measured 80x270x40mm at Ch.214.3m and 50x550x40mm at Ch.222.3m

The reinforcement should clean back to bare metal before an anti-corrosion primer is applied. The areas should be patch repaired with an appropriate cementitious material, ensuring that it is sufficiently 'keyed-in' to the parent concrete.

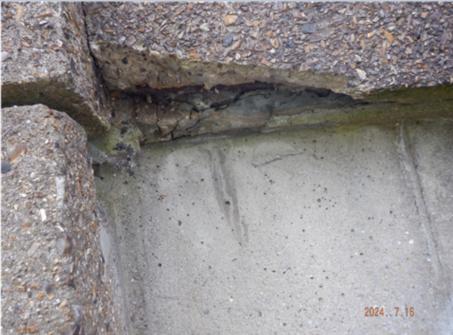
#### Photograph #528

View of spalling exposing the reinforcement on South RC parapet coping, measured 80x270x40mm at Ch.214.3m

No	Element Name	Element Description	Sev	Ext	Defect	Priority	Works	Cost £k
23	Handrail/parapets/safety fences	Handrail/parapets/safety fences	3	В	2.2	L	Υ	0.3

There was 2No. areas of spalling exposing the reinforcement on the Southern parapet coping external face and 2No. on internal face, measured 80x270x40mm at Ch.214.3m and 50x550x40mm at Ch.222.3m

The reinforcement should clean back to bare metal before an anti-corrosion primer is applied. The areas should be patch repaired with an appropriate cementitious material, ensuring that it is sufficiently 'keyed-in' to the parent concrete.

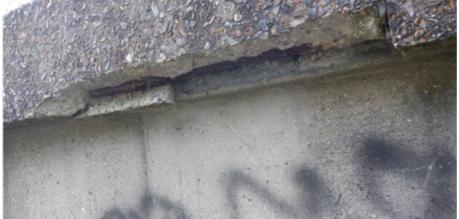
# Photograph #529 View of spalling exposing the reinforcement on South RC parapet coping, measured 50x550x40mm at Ch.222.3m

SECOND .		BOLDS SECTION DESCRIPTION OF SECURITIONS AND ADMINISTRATION OF SECURITIONS AND ADMINISTRATION OF SECURITIONS AND ADMINISTRATION OF SECURITIONS AND ADMINISTRATION OF SECURITION OF SECURITION AND ADMINISTRATION	ALC: U						
No	Element Name	Element Description	Sev	Ext	Defect	Priority	Works	Cost £k	
23	Handrail/parapets/safety fences	Handrail/parapets/safety fences	3	В	2.2	L	Υ	0.3

There was 2No. areas of spalling exposing the reinforcement on the Southern parapet coping external face and 2No. on internal face, measured 80x270x40mm at Ch.214.3m and 50x550x40mm at Ch.222.3m

The reinforcement should clean back to bare metal before an anti-corrosion primer is applied. The areas should be patch repaired with an appropriate cementitious material, ensuring that it is sufficiently 'keyed-in' to the parent concrete.

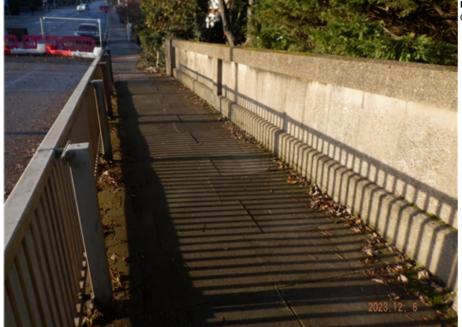
#### Photograph #534

General view of North footway surfacing

No	Element Name	Element Description	Sev	Ext	Defect	Priority	Works	Cost £k
25	Footway/verge/footbridge	Footway/verge/footbridge	2	В	3.5	L	N	
	surfacing	surfacing

There were minor cracked paving slab on the Southern footway at Ch.218m.

Monitor defects during next schedule inspection

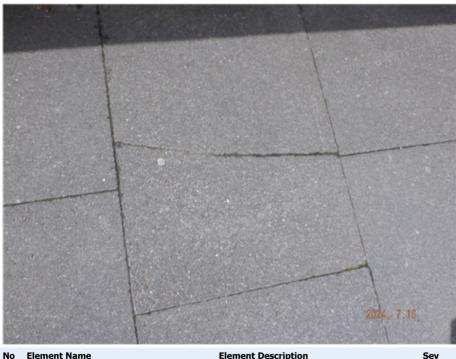
#### Photograph #535

View of minor cracked paving slab on South footway at Ch.218m.

No	Element Name	Element Description	Sev	Ext	Defect	Priority	Works	Cost £k
25	Footway/verge/footbridge surfacing	Footway/verge/footbridge surfacing	2	В	3.5	L	N

There were minor cracked paving slab on the Southern footway at Ch.218m.

Monitor defects during next schedule inspection

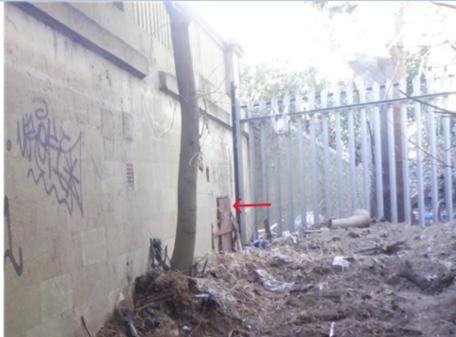
Photograph #536
View of North access doors

No	Element Name	Element Description	Sev	Ext	Defect	Priority	Works	Cost £k
39	Other ancillary elements on	North and South access doors	2	Е	1.1	L	N	
	structure

There was surface corrosion on the Northern access door.

Monitor defect during next schedule inspection

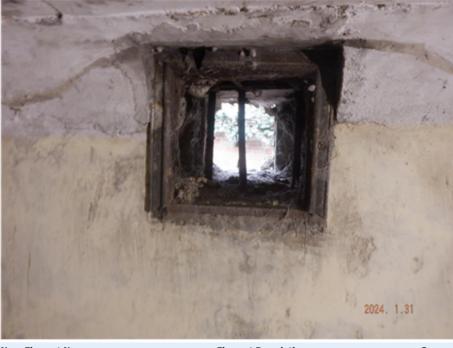
#### Photograph #537

View of the missing airbrick on the Northern infill blockwork wall from inside

No	Element Name	Element Description	Sev	Ext	Defect	Priority	Works	Cost £k
39	Other ancillary elements on	Airbrick	3	В		L	Υ	0.3
	structure

There was a missing airbrick on the Northern infill blockwork wall.

Replace missing airbrick

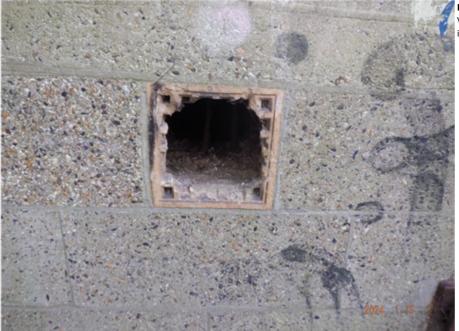
#### Photograph #538

View of the missing airbrick on the Northern infill blockwork wall

There was a missing airbrick on the Northern infill blockwork wall.

Replace missing airbrick

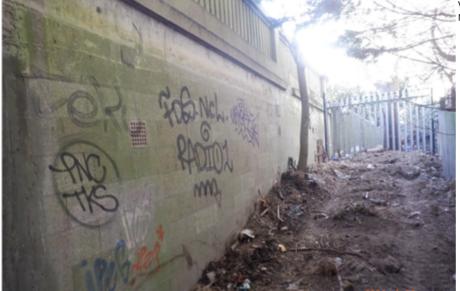
#### Photograph #539

View of non-offensive graffiti on the Northern blockwork wall

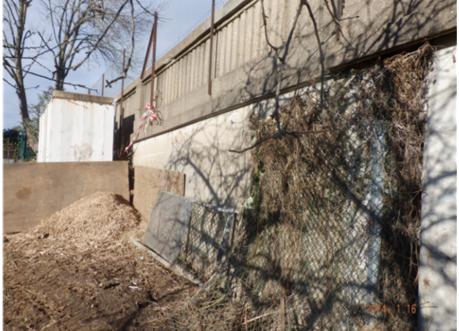
#### Photograph #540

Partial view of Southern infill blockwork wall

Remove graffiti under routine maintenance

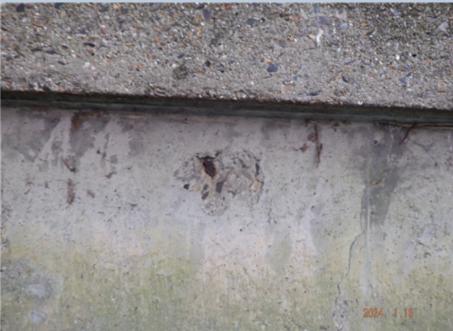
#### Photograph #542

View of isolated area of spalling exposing the reinforcement on the North blockwork wall, measured 100x100x15mm

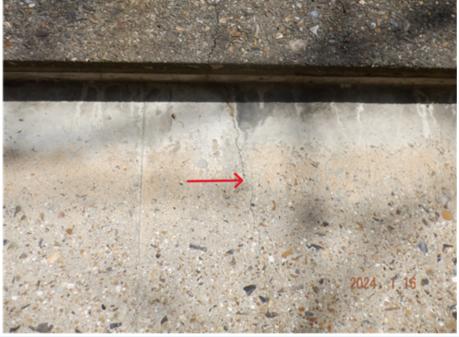
#### Photograph #543

View of 1mm vertical shrinkage crack on the Southern infill blockwork wall

No	Element Name	Element Description	Sev	Ext	Defect	Priority	Works	Cost £k
39	Other ancillary elements on	Infill blockwork wall	2	В	2.3	L	N	
	structure
